# Historic Resource Survey Form

PENNSYLVANIA HISTORICAL AND MUSEUM COMMISSION  
Bureau for Historic Preservation

Key # \_\_001901, 001920, 001930\_\_\_\_\_  
 ER # \_\_2016-8477-001\_\_\_\_\_

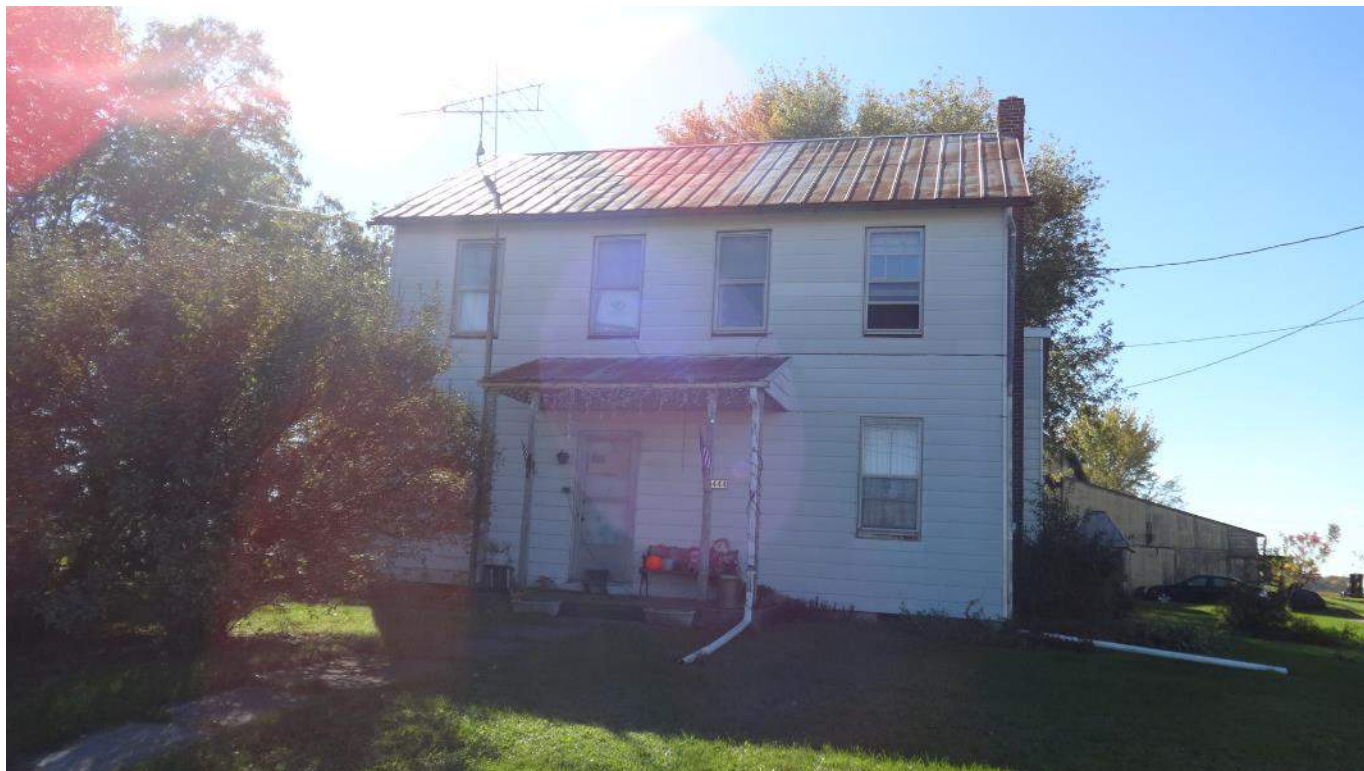
Photograph 1 – Façade (northeast elevation) of the Poist Farm dwelling; looking southwest.

The ca. 1880, four-over-four dwelling is situated approximately 45 feet west of Oxford Avenue. The building is four bays wide, two bays deep, and two-and-a-half stories tall. It has a side-gable roof covered in standing seam metal on the front pitch and asphalt shingle on the rear pitch. The foundation is made of stone, and the walls have been covered in aluminum siding. The windows are wood and have vinyl storm coverings, and the doors are vinyl replacements. There is a centered portico on the façade, an exterior red brick chimney on the northwest elevation, and an addition on the north bay of the rear elevation.

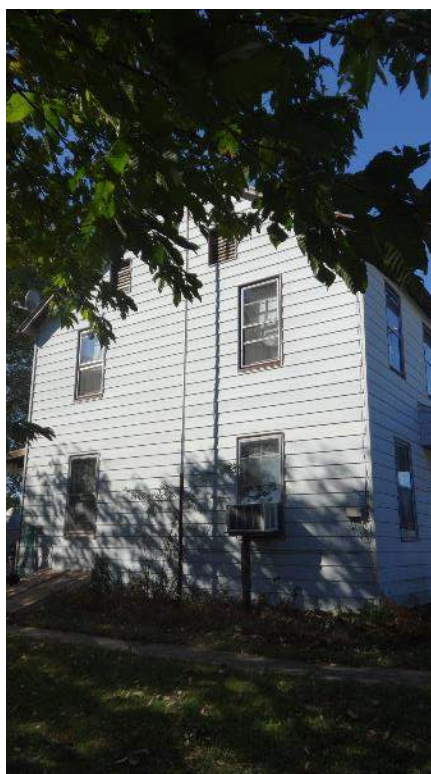
Photograph 2 – Side (southeast elevation) of the Poist Farm dwelling; looking northwest.

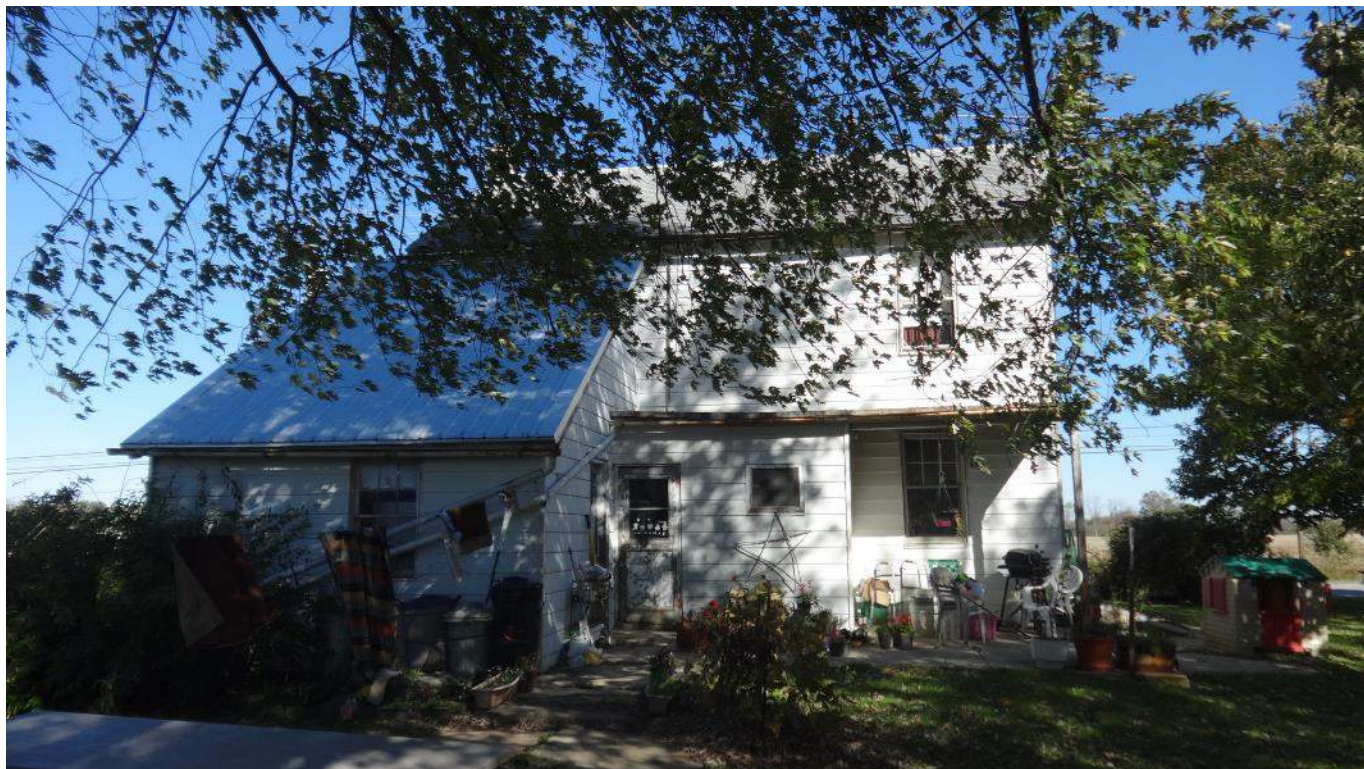
Photograph 3 – Rear (southwest elevation) of the Poist Farm dwelling; looking northeast.

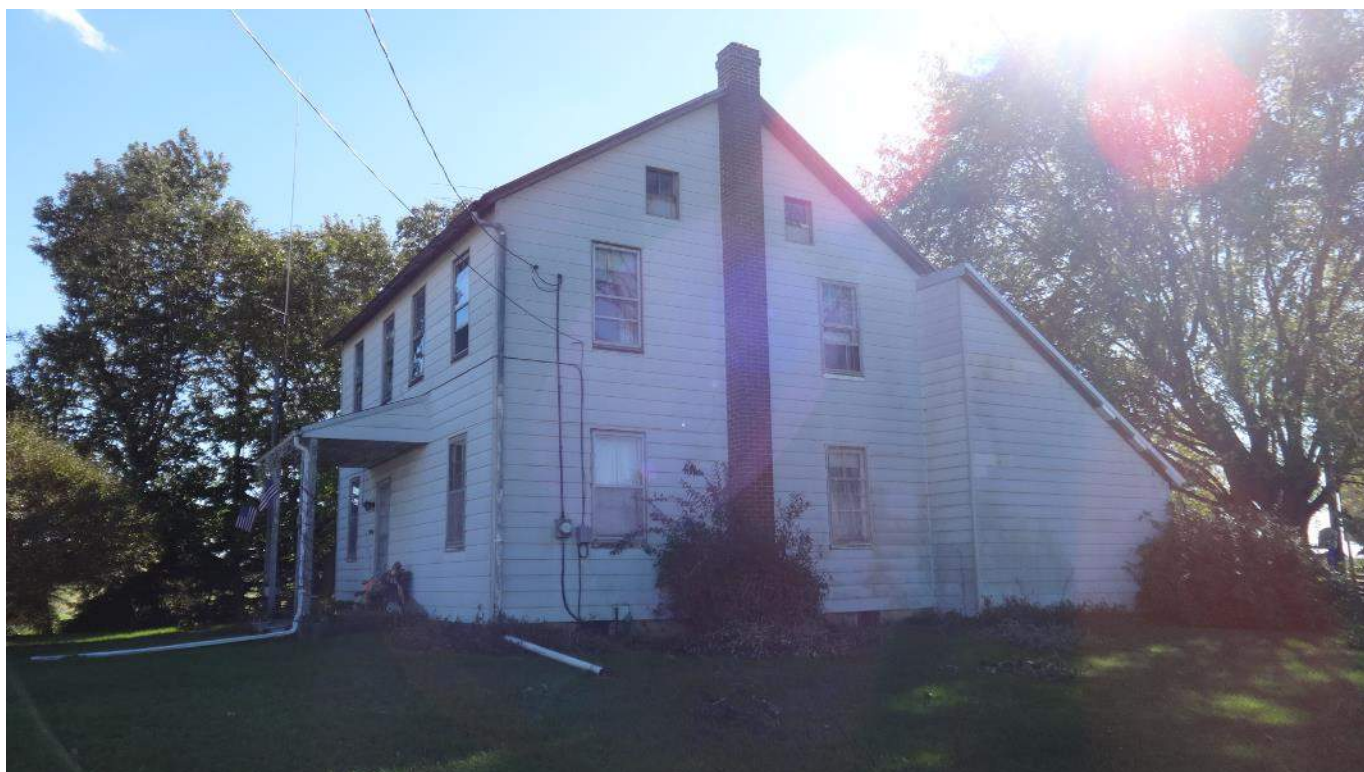
Photograph 4 – Side (northwest elevation) of the Poist Farm dwelling; looking southeast.

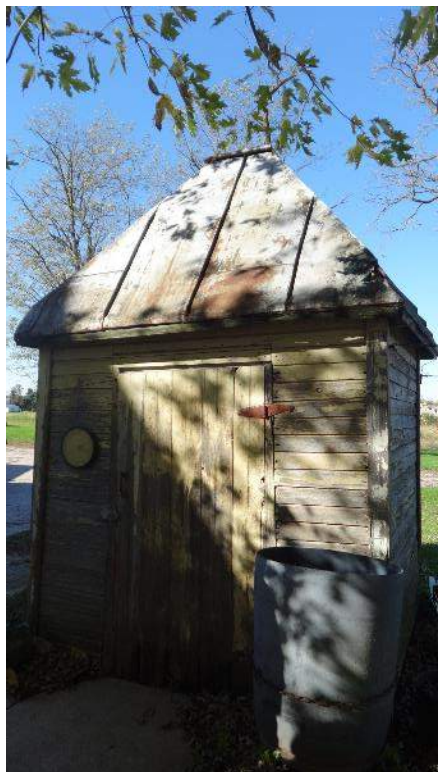
Photograph 5 – Façade (southeast elevation) of the Poist Farm pump house; looking northwest.

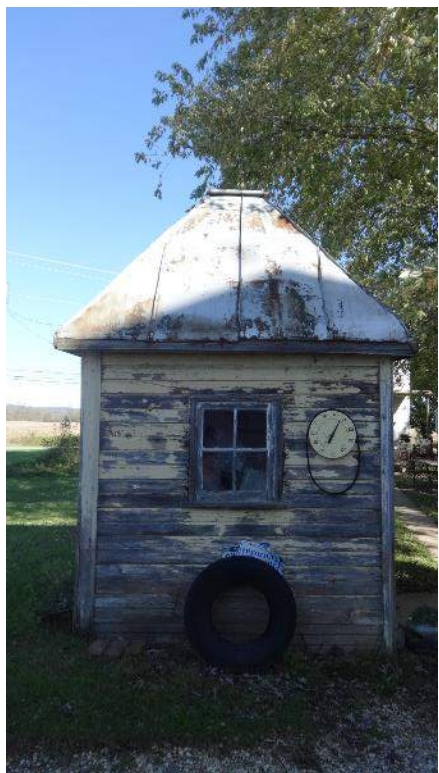
Photograph 6 – Side (southwest elevation) of the Poist Farm pump house; looking northeast.

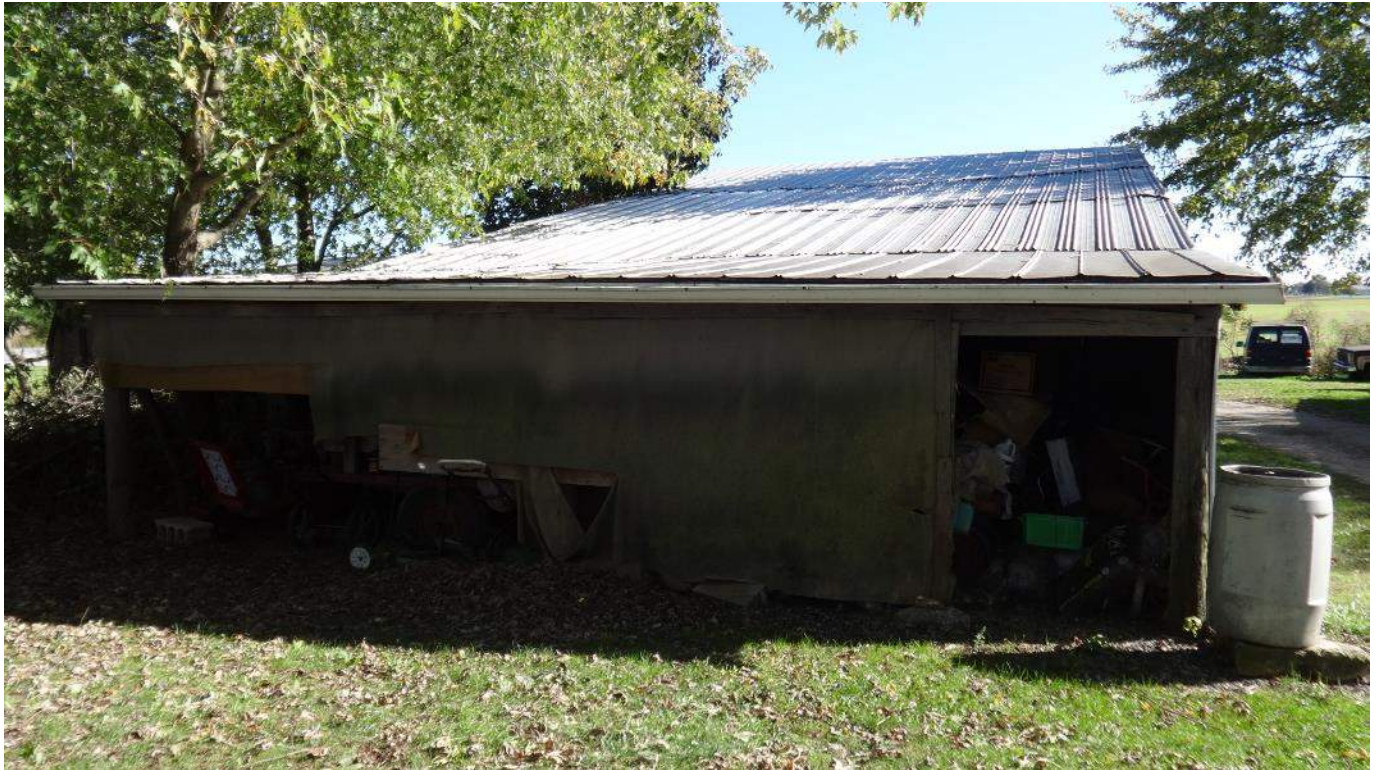
Photograph 7 – Northwest elevaton of the original Poist Farm chicken coop; looking southeast.

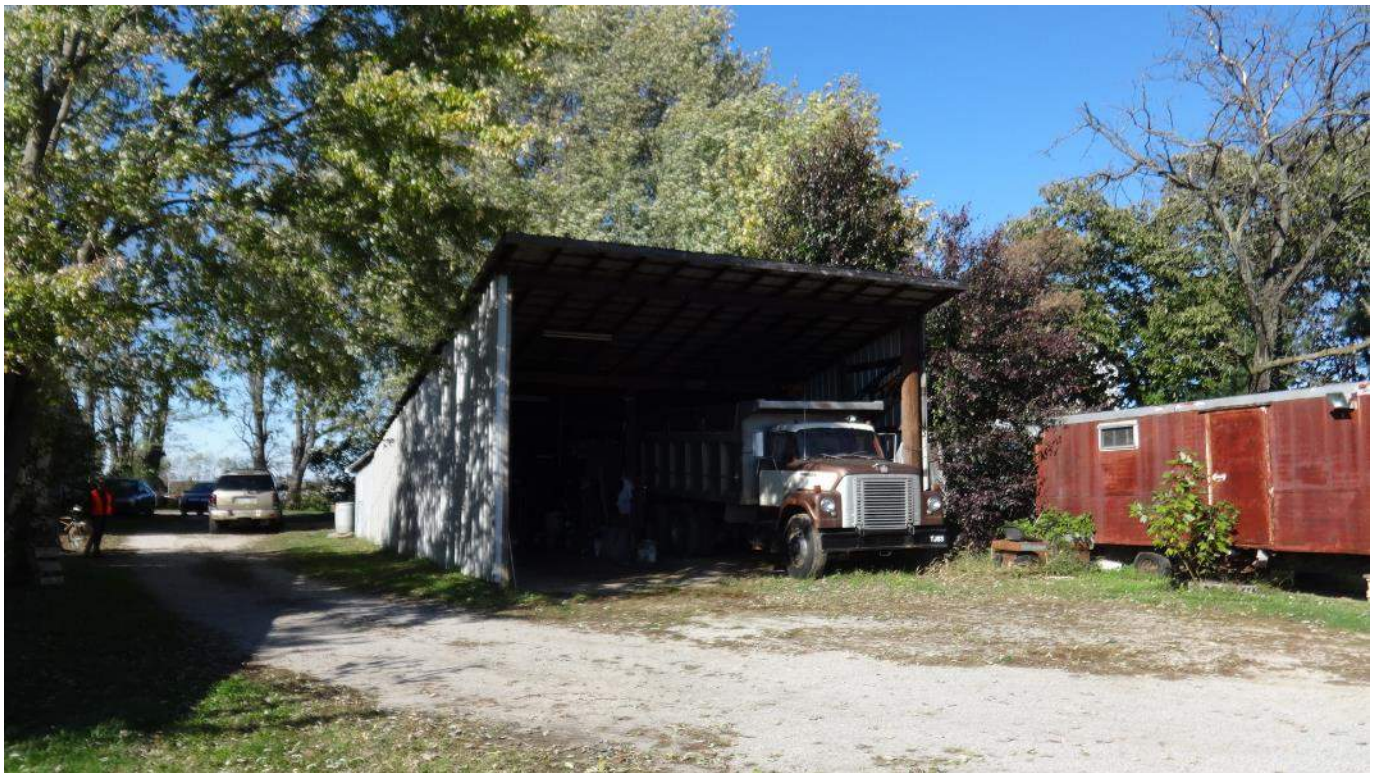
Photograph 8 – Southeast and southwest elevatons of the Poist Farm garage; looking north.

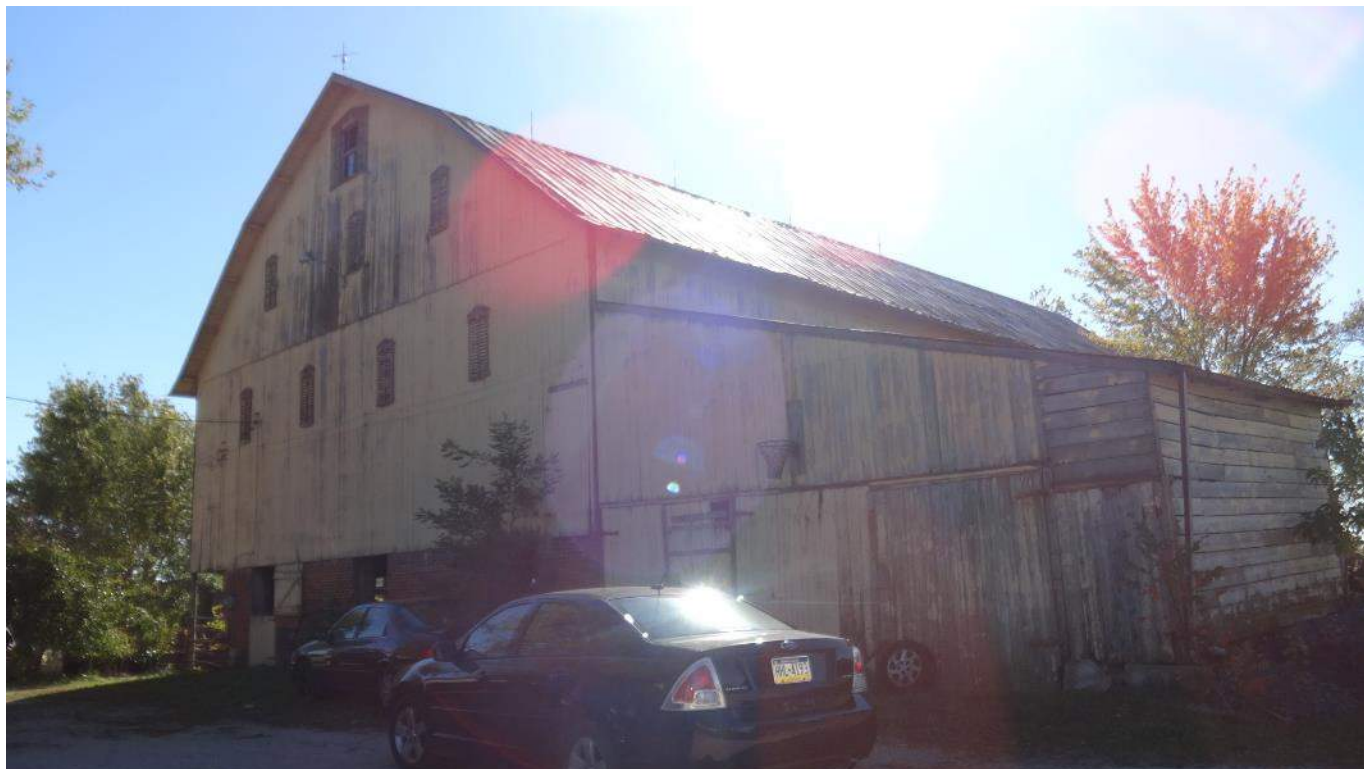
Photograph 9 – Northeast elevaton of the Poist Farm barn and addition; looking southwest.

The lower level of the northeast elevation is brick, and the overhang of the forebay occupies the southern bay. Evenly spaced along the rest of the lower level is a wood Dutch door and two wooden windows sashes both missing glass. Evenly spaced across the upper elevation are four vent openings. The lower level of the gable has three, evenly spaced vent openings and beneath the gable peak is a two-over-six, wood window, with wood shutters, and a pyramidal wood pediment (Photograph 9).

A 55-foot by 85-foot, ca. 1932, banked Pennsylvania Barn is located approximately 90 feet southwest of the dwelling. Its gambrel roof is clad in standing seam metal, and the foundation is a combination of stone and brick. The lower level is clad in red brick, and the upper levels are vertical wood panel. Unless otherwise noted, upper-level fenestration is filled with a pair of arched vents topped with a triangular wood pediment. There is a two-bay by two-bay, one-story addition, with a shed roof on the northwest elevation and a one-bay by one-bay, one story addition on the southwest elevation. The forebay spans the width of the southeast elevation.

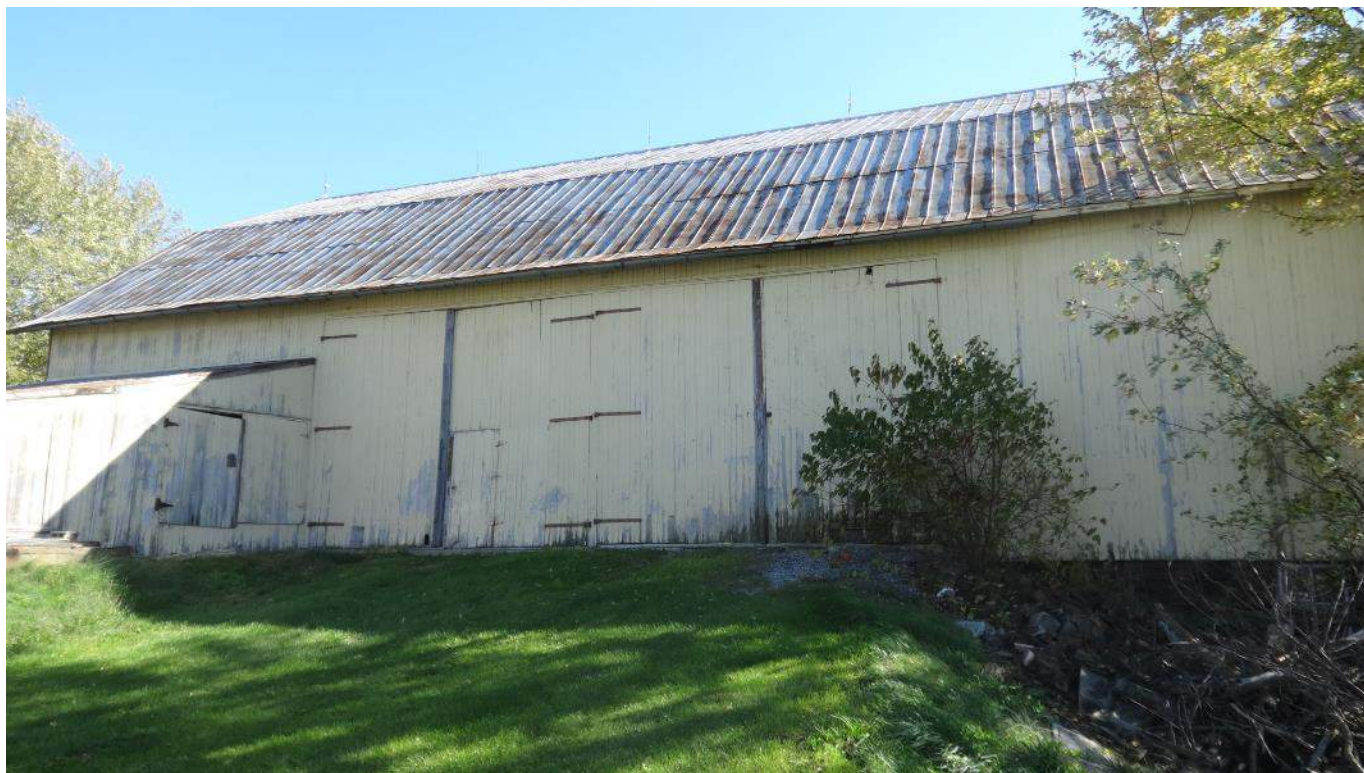
Photograph 10 – Northwest elevaton of the Poist Farm barn; looking southeast.

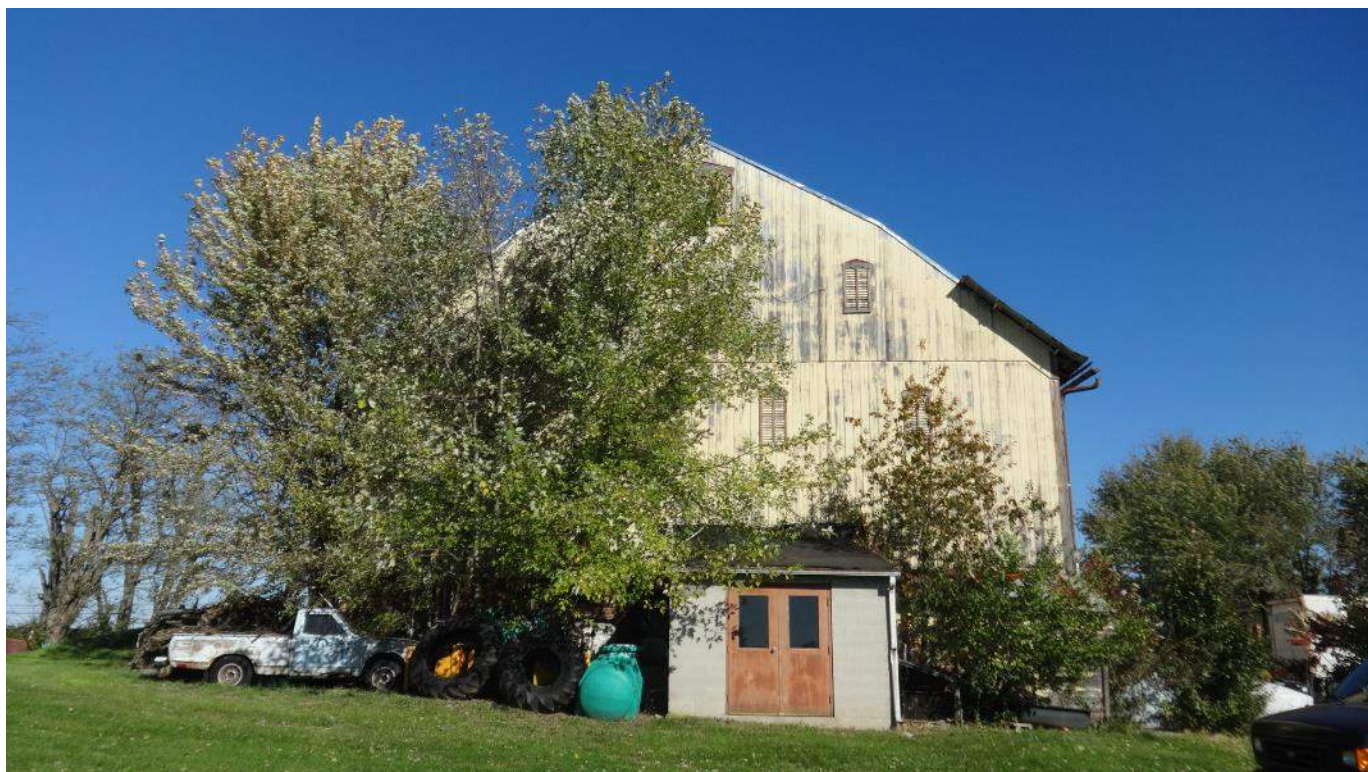
Photograph 11 – Southwest elevation of the Poist Farm barn; looking northeast.

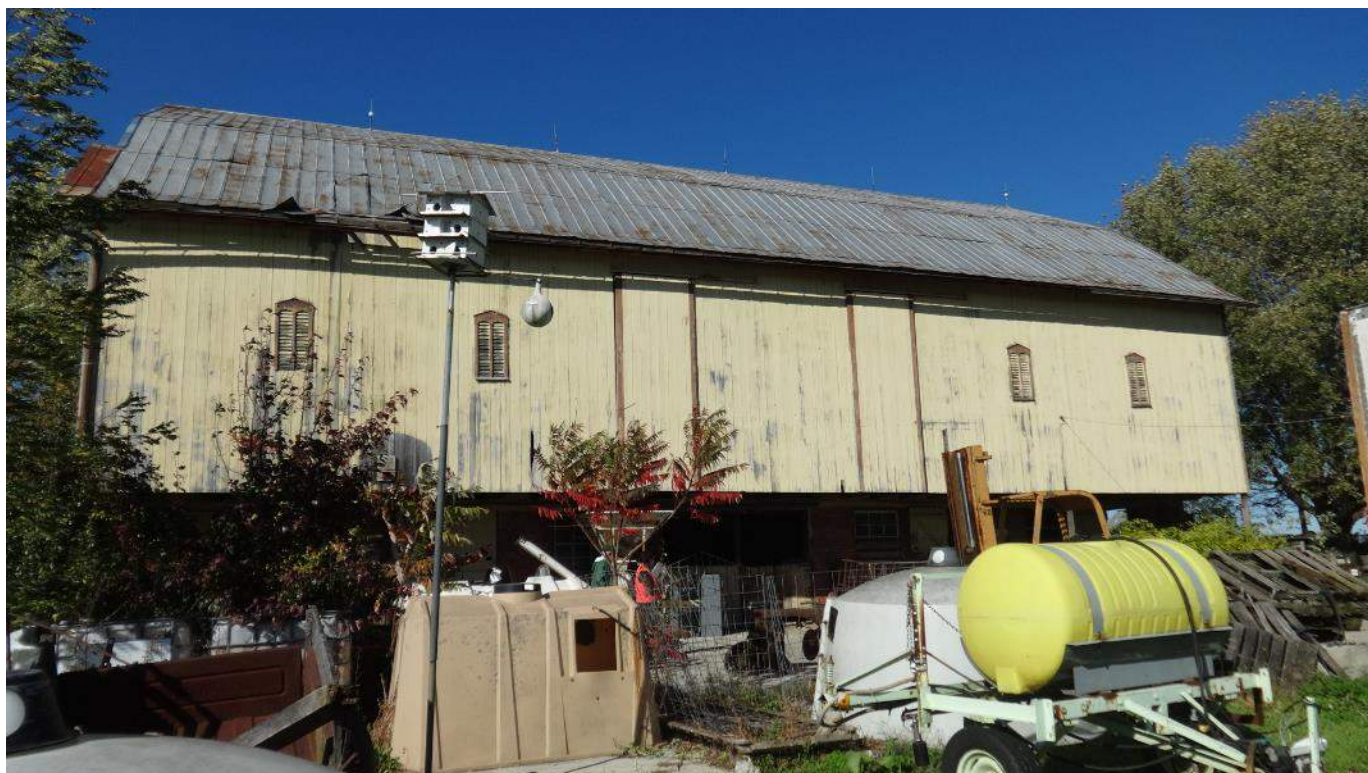
Photograph 12 – Southeast elevation of the Poist Farm barn; looking northwest.

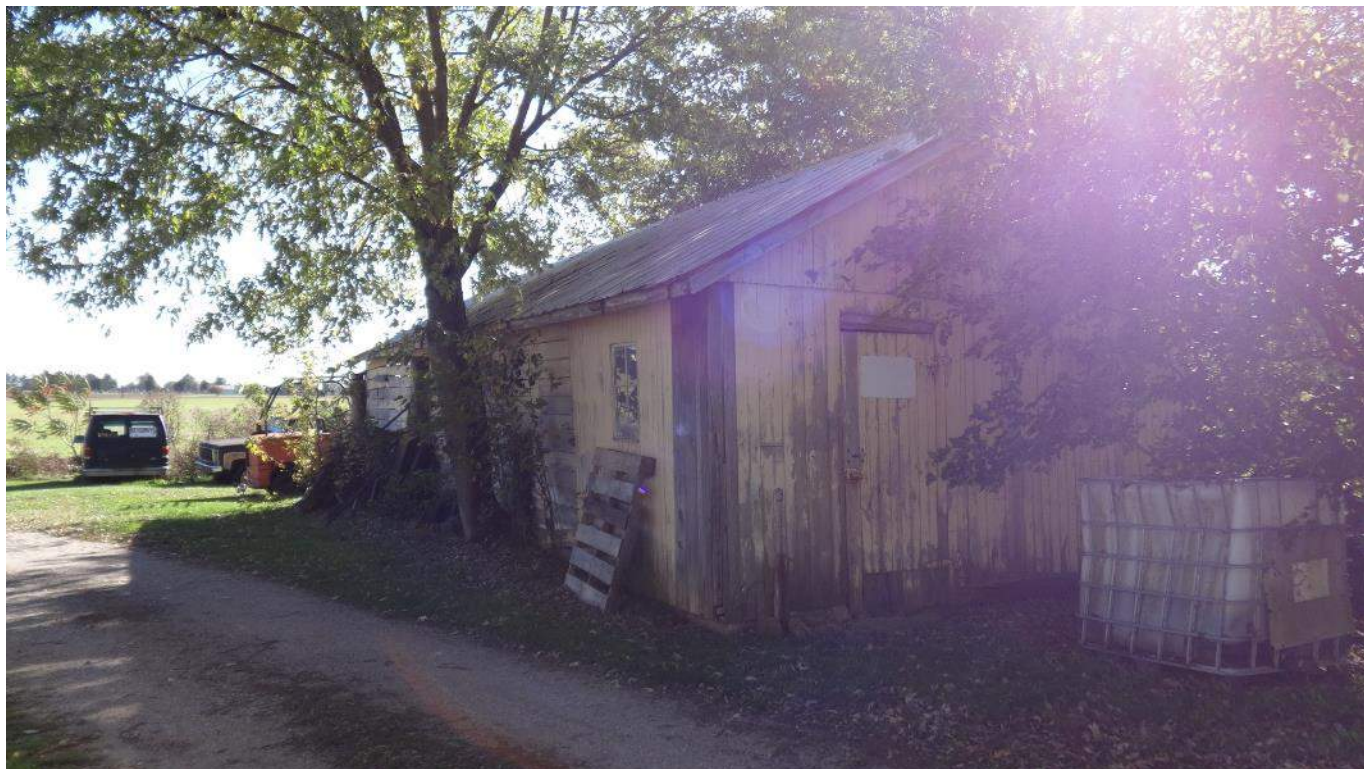
Photograph 13 – North and east elevations of the Poist Farm hog house; looking south.

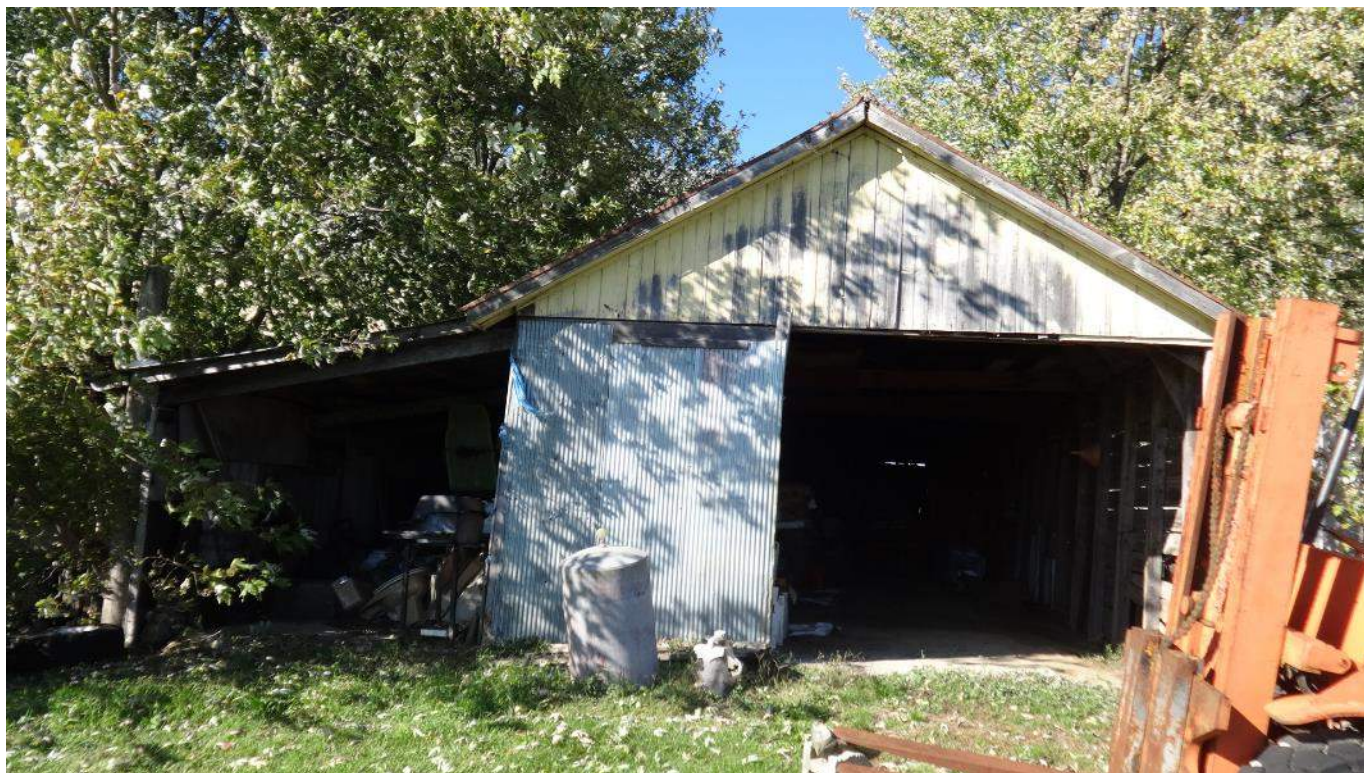
Photograph 14 – South elevation of the Poist Farm hog house; looking north.

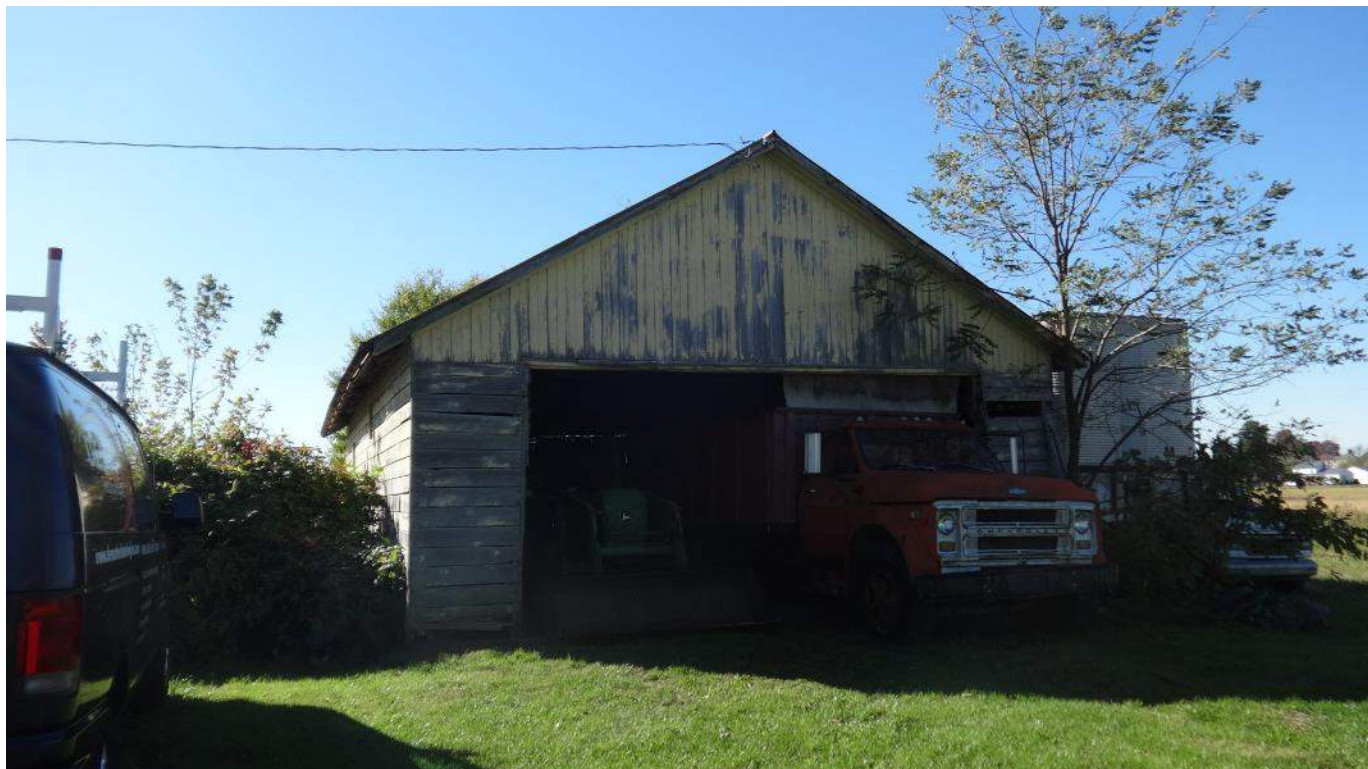
Photograph 15 – Northeast elevation of the Poist Farm corn crib; looking southwest.

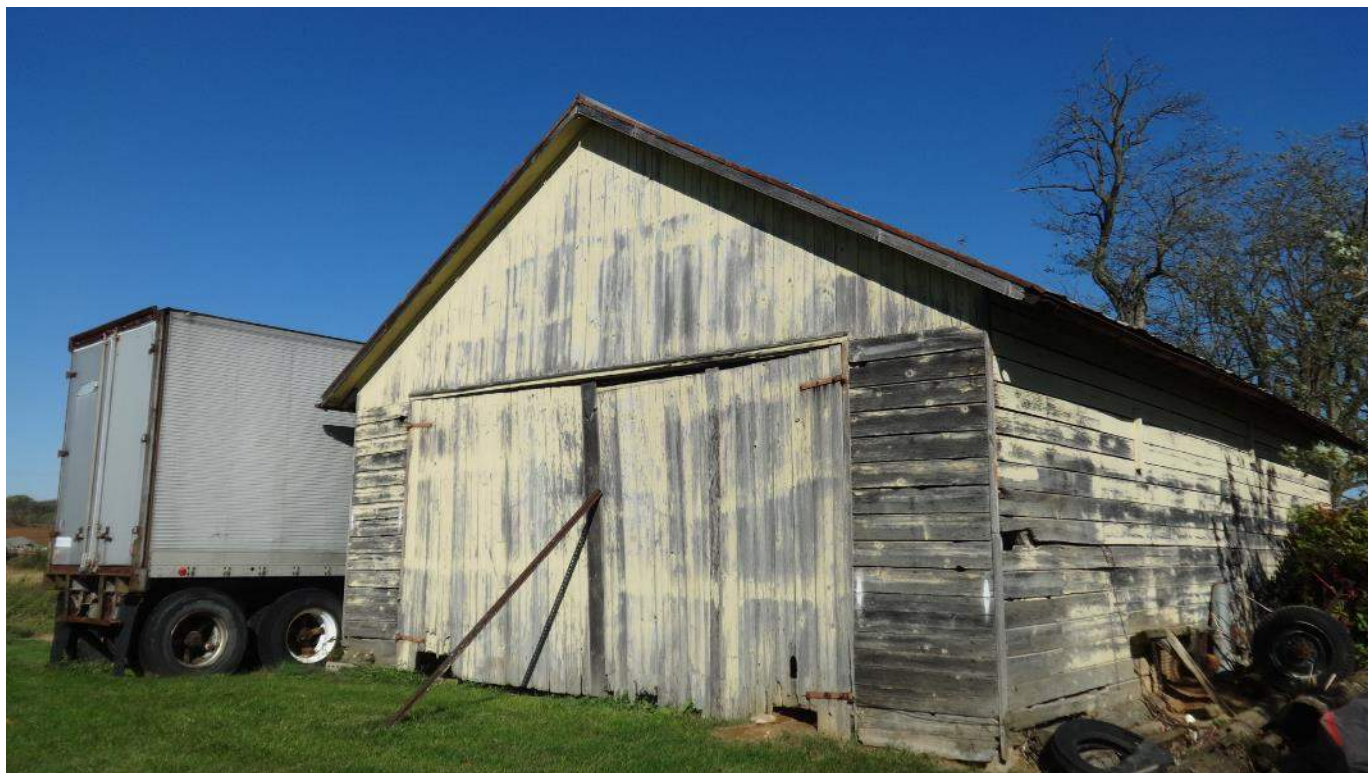
Photograph 16 – Southwest and southeast elevations of the Poist Farm corn crib; looking northeast.

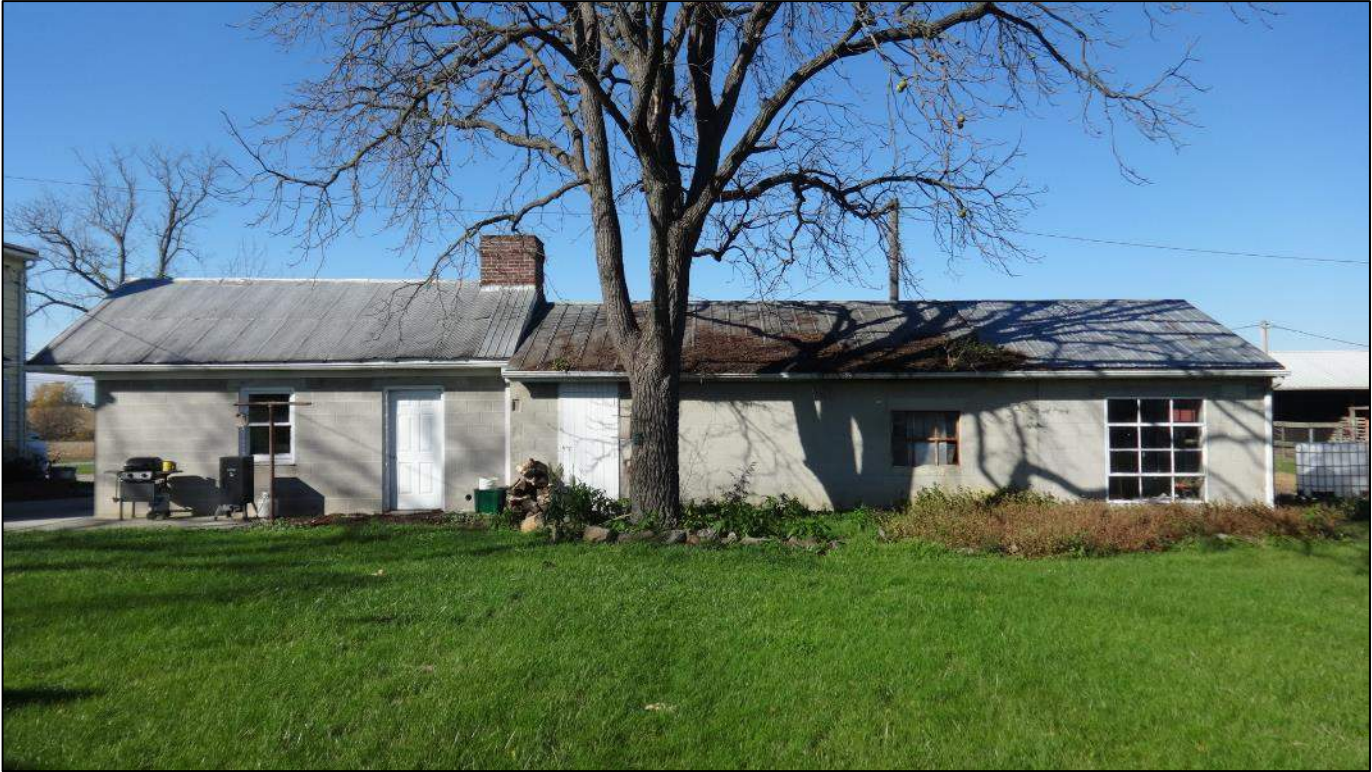
Photograph 21 – Side (south elevation) of the Divine Chapel milkhouse; looking north.

The side, south elevation has a centered, one-over-one, wood window and a six-panel door on the easternmost portion of the original milkhouse section. From west to east along the three-bay addition, is a wood panel door, a slightly off-center, six-pane, metal window, and a twelve-pane, vinyl window (Photograph 21). The rear, east elevation has a single centered, twelve-pane, metal window. The roof gable has been covered in standing seam metal siding (Photograph 22).

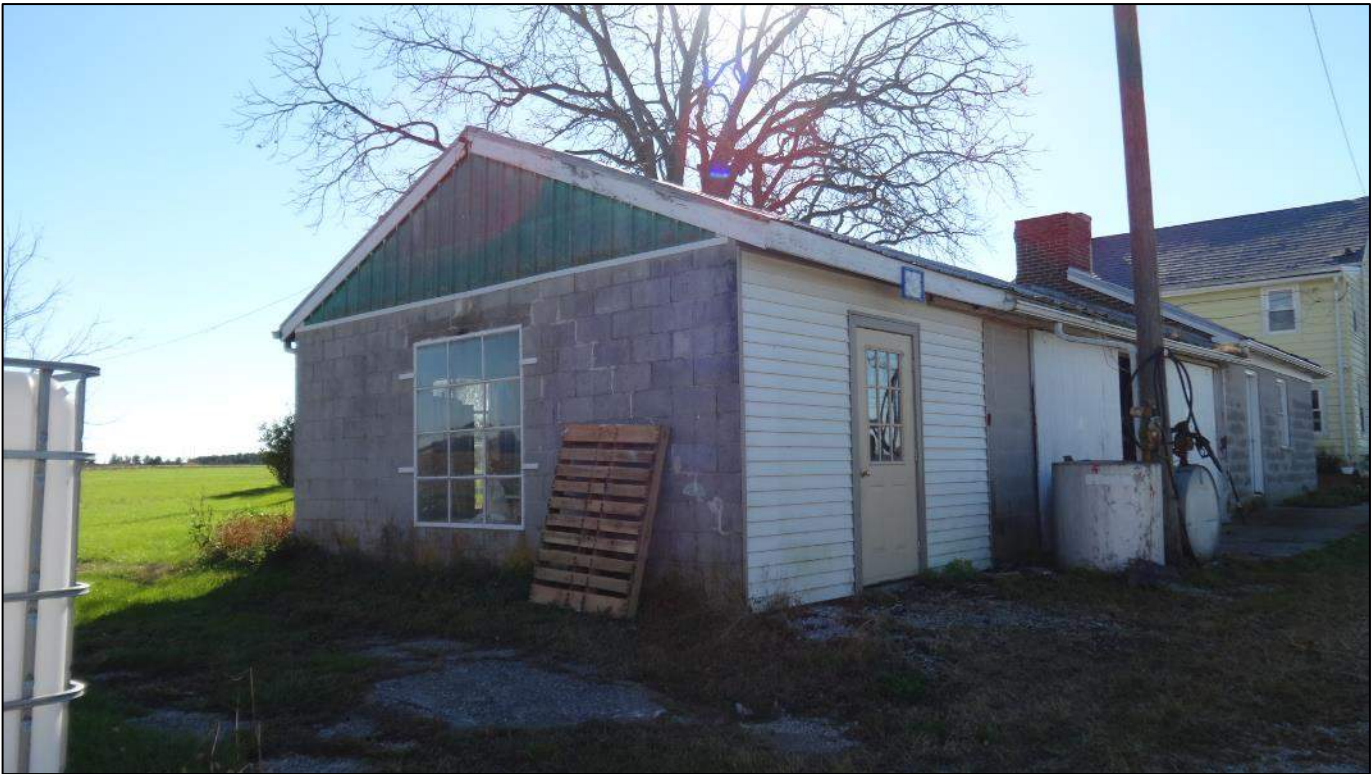
Photograph 22 – Rear (east elevation) and side (north elevation) of the Divine Chapel milkhouse; looking southwest.

The side, north elevation has a centered, one-over-one, wood window and a six-panel door on the easternmost bay of the original milkhouse section. From east to west, the three-bay addition has a two-bay opening with a sliding, wood panel, garage door, and a six-pane, two-panel, vinyl door. The westernmost bay has been covered in vinyl siding (Photograph 22).

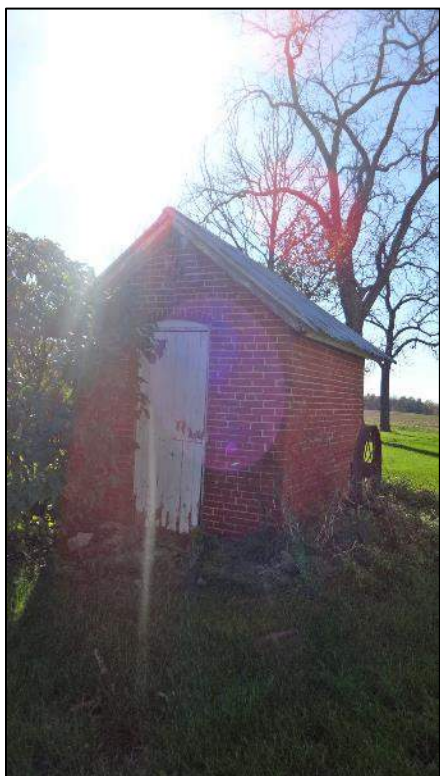
Photograph 23 – Front (east elevation) and side (north elevation) of the Divine Chapel smokehouse; looking west.

The ca. 1860 smokehouse is situated about 33 feet southeast of the house. The brick building, laid in common bond, is 10-foot by 10-foot with a front gable, corrugated metal roof, and brick foundation. The façade (east

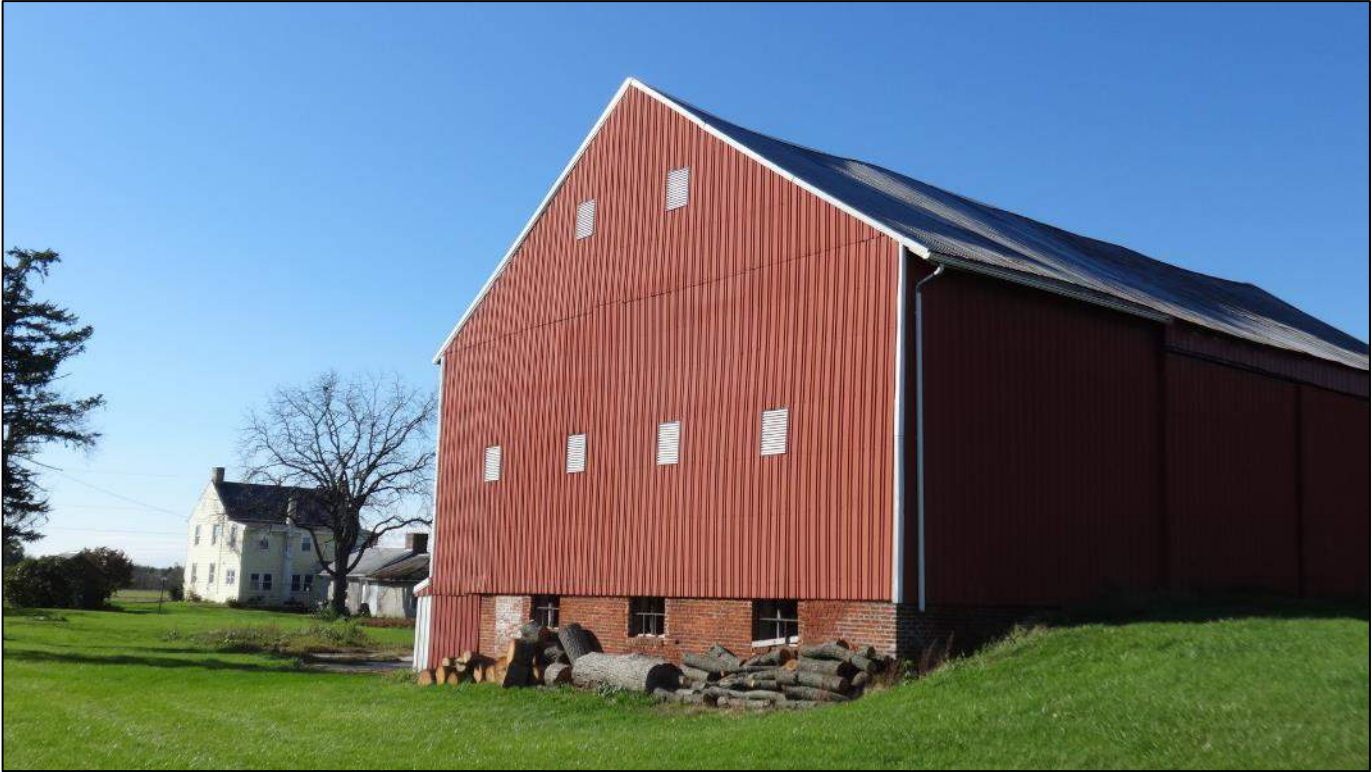
Photograph 25 – Facade (east elevation) and side (south elevation) of the Divine Chapel barn; looking northwest.

The east elevation is banked with a large, centered, two-bay, sliding, metal equipment door. At the northern edge of the north equipment door is a pedestrian door. Part of the lower level that is visible adjacent to the bank at the north end of the elevation has a single, wood, hopper window with a structural jack arch (Photograph 25).

The western bay of the south side elevation's ground level has been covered in corrugated metal while the remaining bays are brick. Three wood windows are evenly-spaced across the brick bays and are in various degrees of deterioration. The upper level has four evenly spaced openings infilled with metal vents. Two infilled openings are centered in the gable peak (Photograph 25).

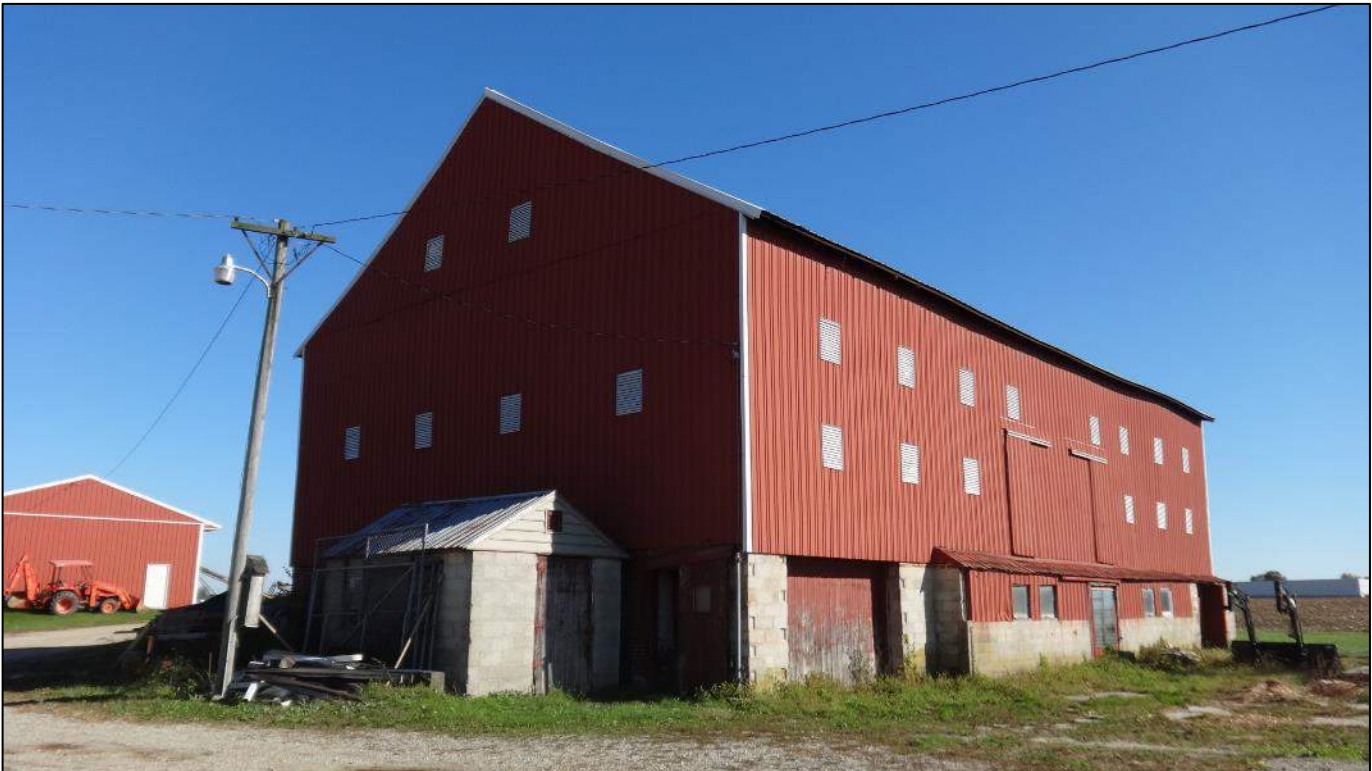
Photograph 26 – Rear (west elevation) and side (north elevation) of the Divine Chapel barn; looking southeast.

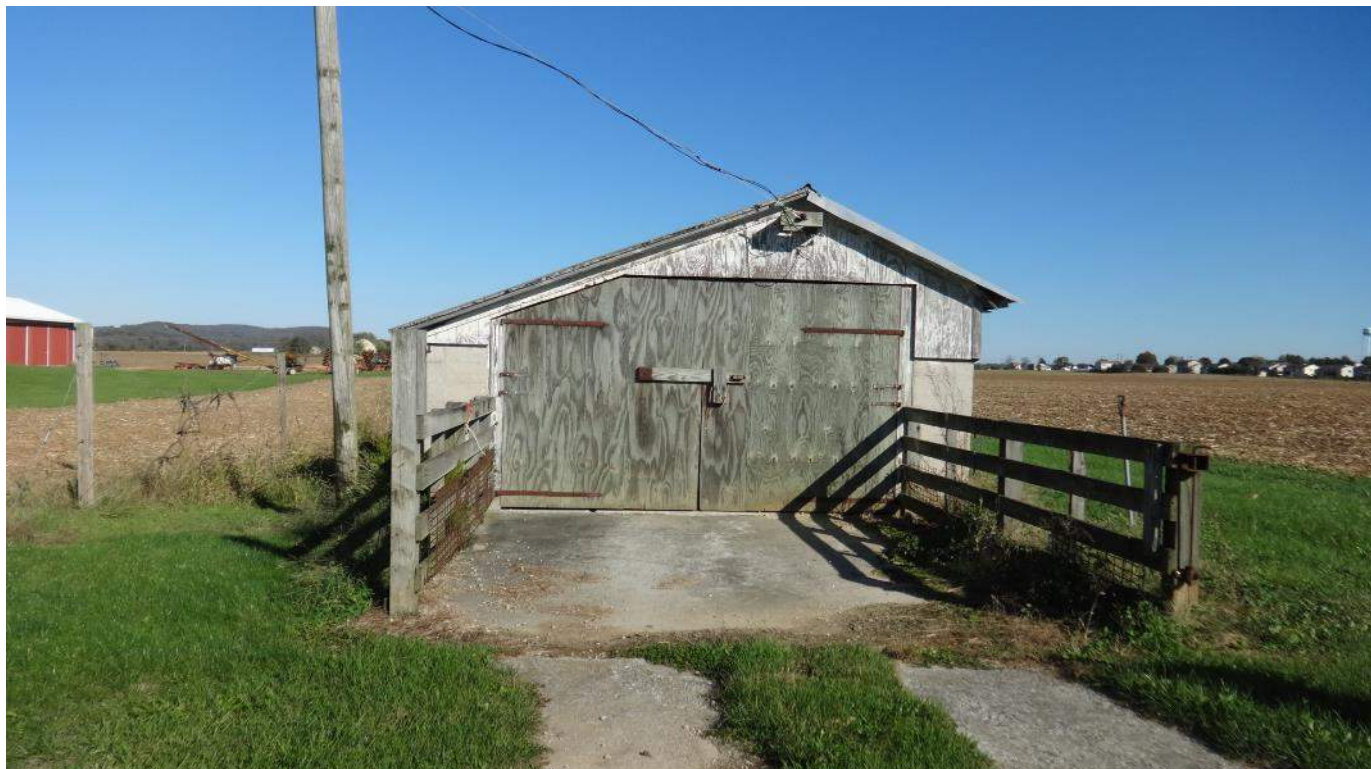
Photograph 27 – Façade (west elevation) of the Divine Chapel hog house, looking east.

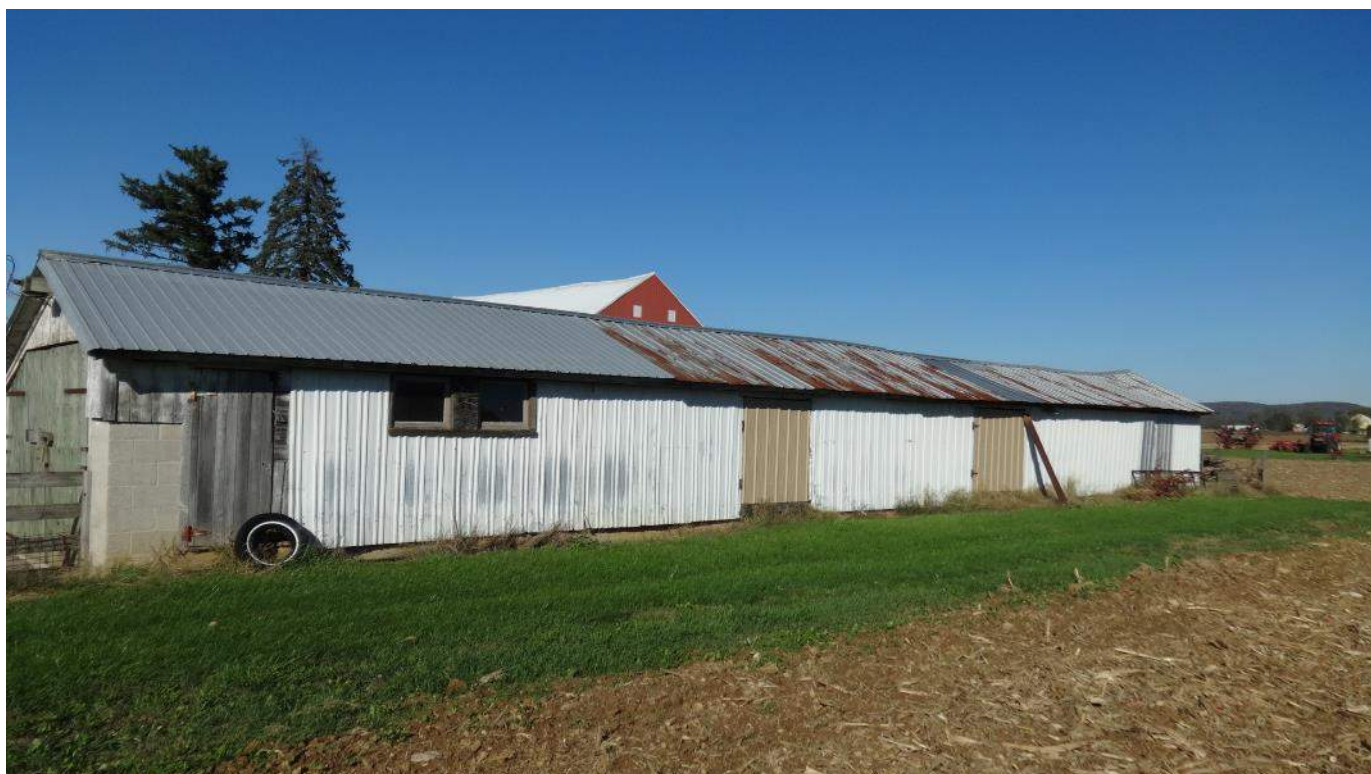
Photograph 28 – Side (north elevation) of the Divine Chapel hog house, looking south.

(Photograph 27). The north elevation is solid CMU with no fenestration (Photograph 28). The east elevation is CMU on the lower portion, and wood panel on the upper with a single slightly south-of-center doorway that is covered with a wood panel gate (Photograph 29). The south elevation on the westernmost bay has CMU walls and a wood panel door. The second bay has corrugated metal walls with a set of wood awning windows just below the roof line. The remaining three bays also have corrugated metal walls with three evenly dispersed corrugated metal doors (Photograph 30).
