# Historic Resource Survey Form

PENNSYLVANIA HISTORICAL AND MUSEUM COMMISSION  
Bureau for Historic Preservation

Key # \_\_001901, 001920, 001930\_\_\_\_\_  
 ER # \_\_2016-8477-001\_\_\_\_\_

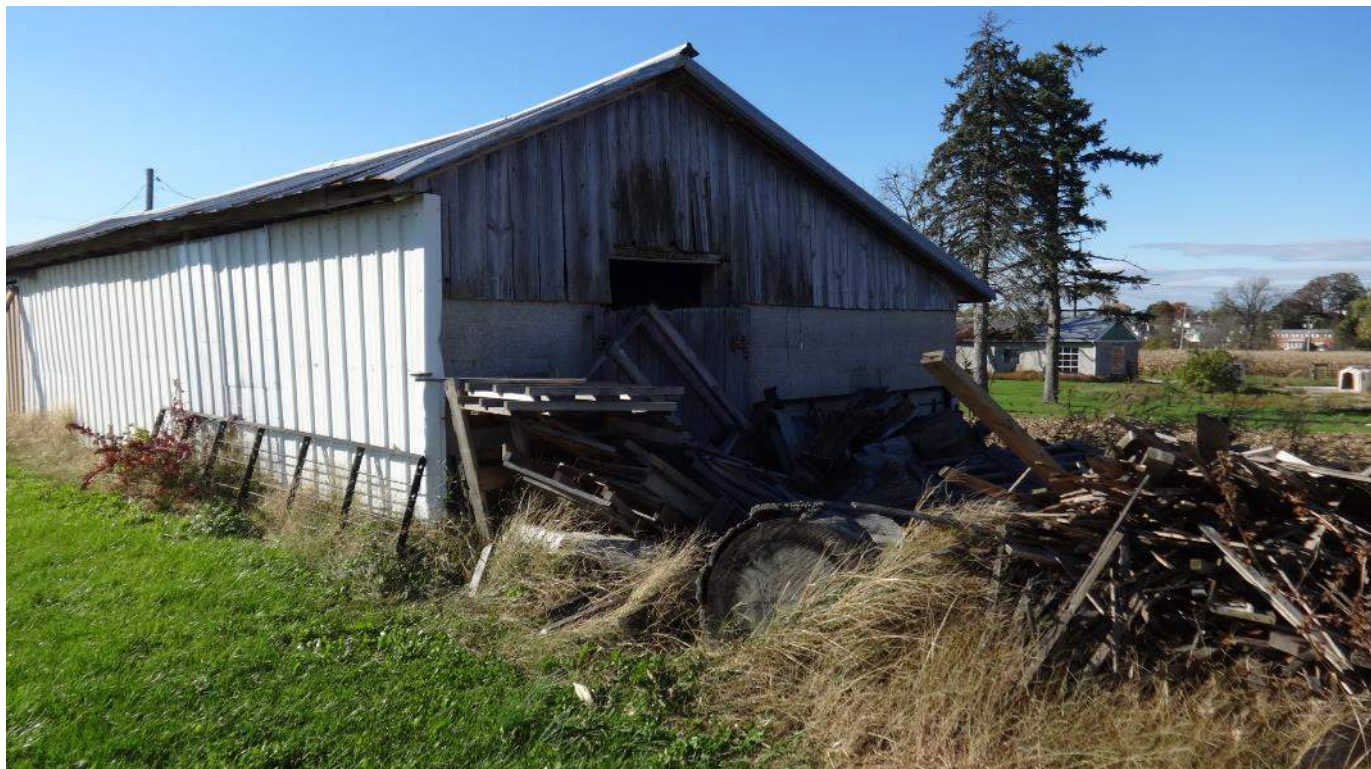
Photograph 29 – Rear (east elevation) of the Divine Chapel hog house, looking west.

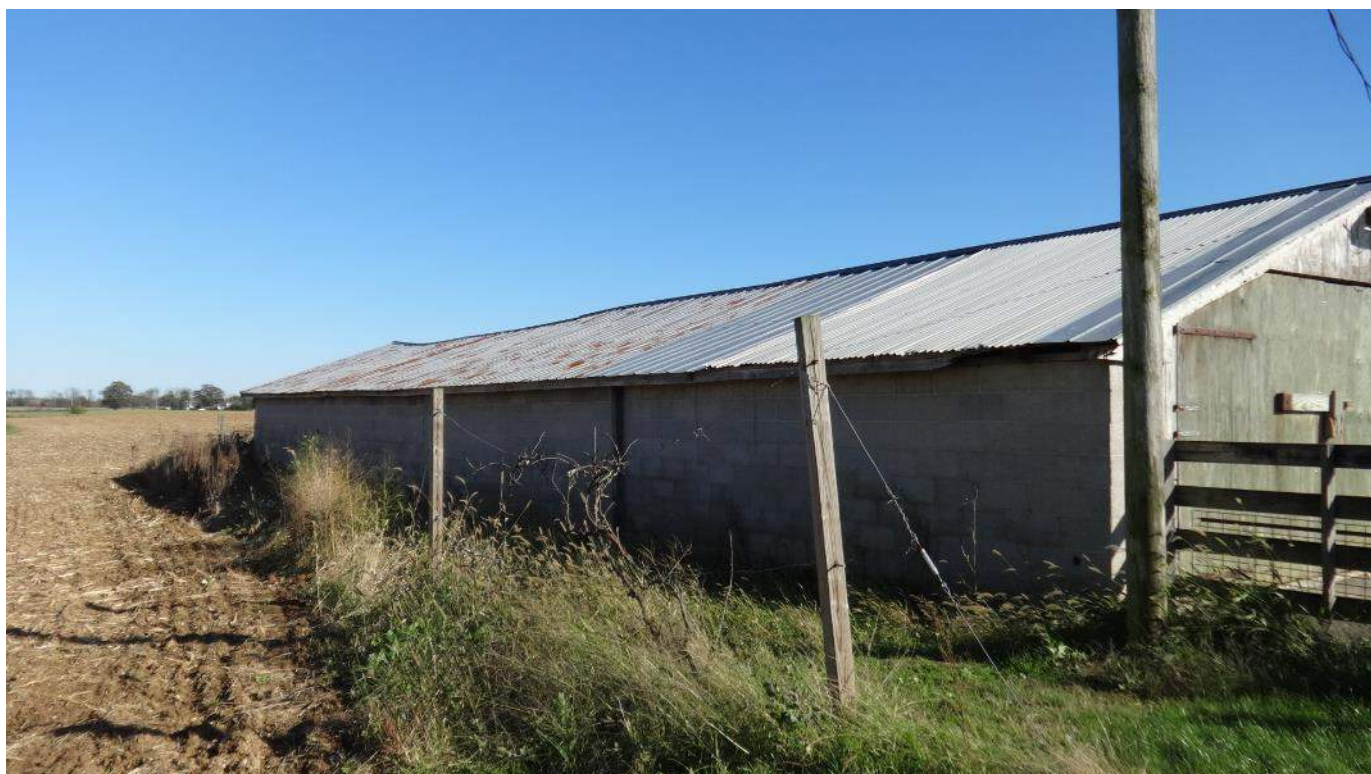
Photograph 30 – Side (south elevation) of the Divine Chapel hog house, looking northeast.

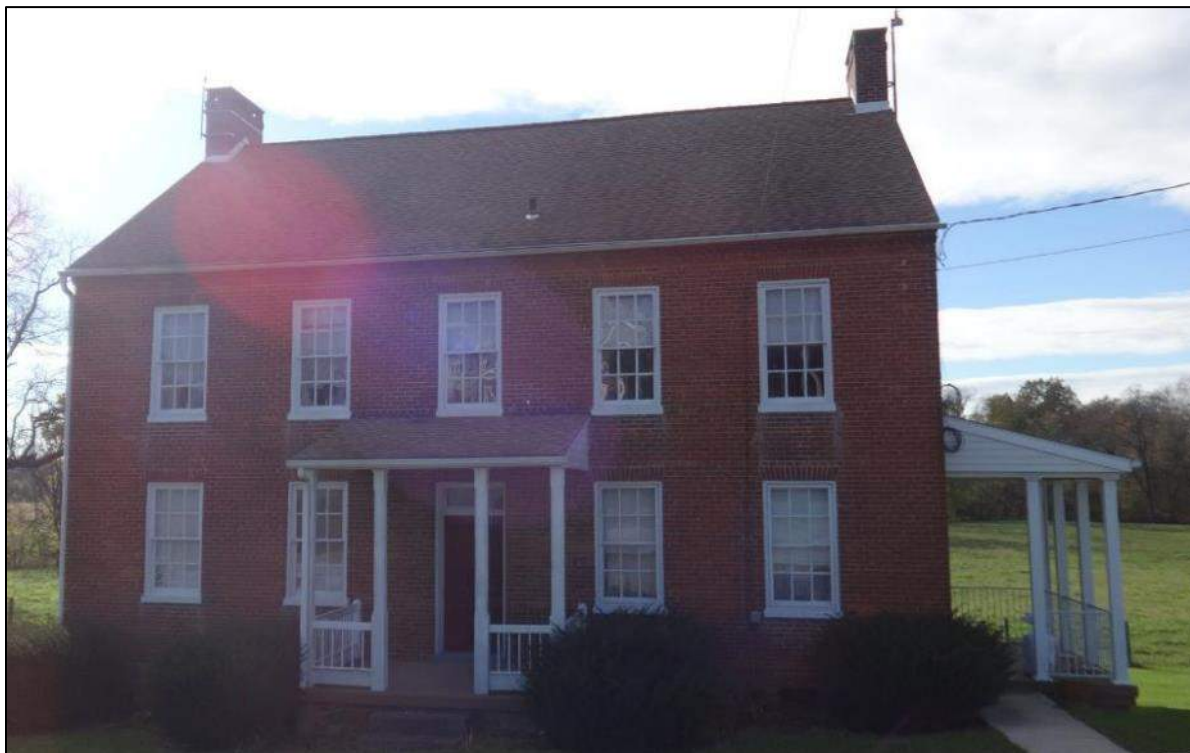
Photograph 31 – Façade (east elevation) of the Enders Farm dwelling; looking west.

The façade (east elevation) features a centered, one-bay portico with a asphalt-shingle shed roof, wood supports, and wood balustrades. Two stone steps lead up to the replacement composite wood portico floor that sits on a stone foundation. The front door, centered beneath the portico, is an early or original, four-panel, wood door with a split-light transom and stone slab threshold. On each side of the entryway are two individual windows. The second floor features five windows dispersed symmetrically over the first-floor openings (Photograph 31).

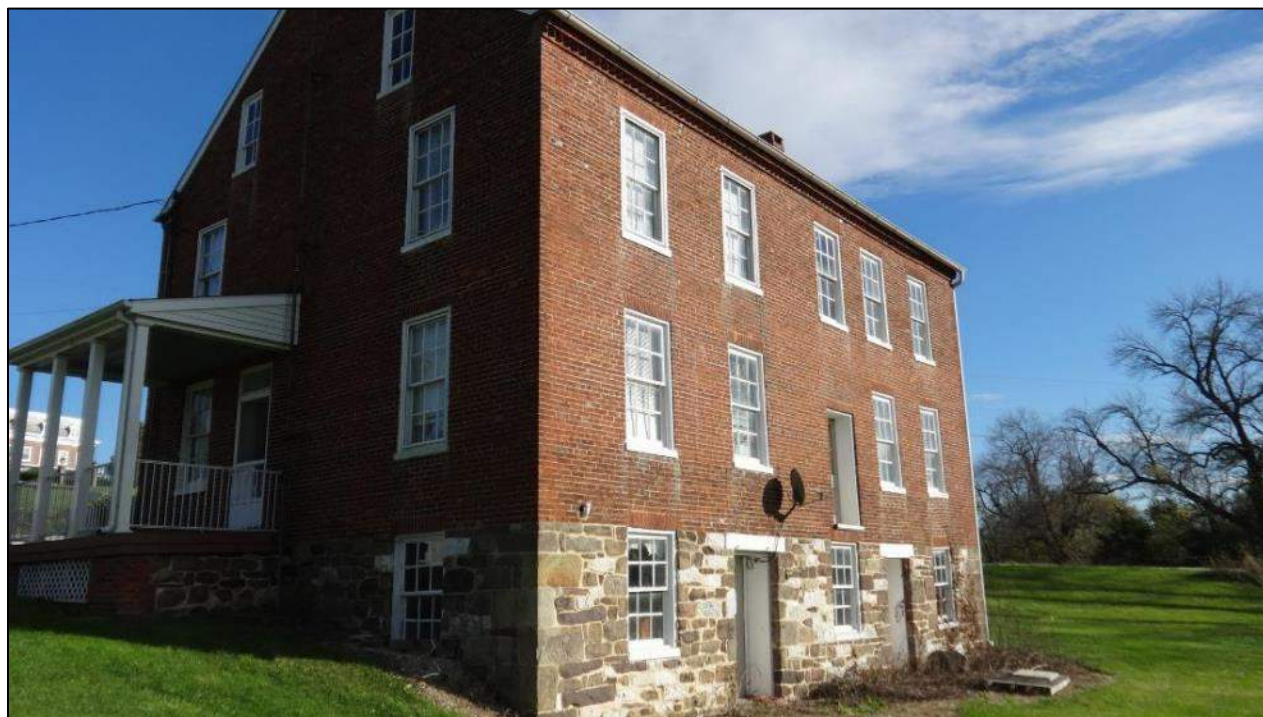
Photograph 32 – Side (north elevation) and rear (west elevation) of the Enders Farm dwelling; looking southeast.

A second single-story portico is located along the eastern half of the north gable elevation. The portico has a shed roof clad with asphalt shingles, composite flooring, vinyl supports, and vinyl balustrades with a brick and stone pier foundation and wood lattice infill. Beneath the portico is a six-panel, wood door with a storm door and split-light, wood transom with storm covering. To the east of the door, also beneath the portico, is a single window. There is a second, first-floor window on the western portion of the north elevation. Two windows are located on the second floor, vertically aligned above the first-floor windows. At the attic level, there are two windows, and at the basement level is a single window vertically aligned with the windows above (Photograph 32).

side of the door, there are two individual windows, aligned over the basement level openings. The second floor has five windows aligned above the first-floor openings (Photograph 32).

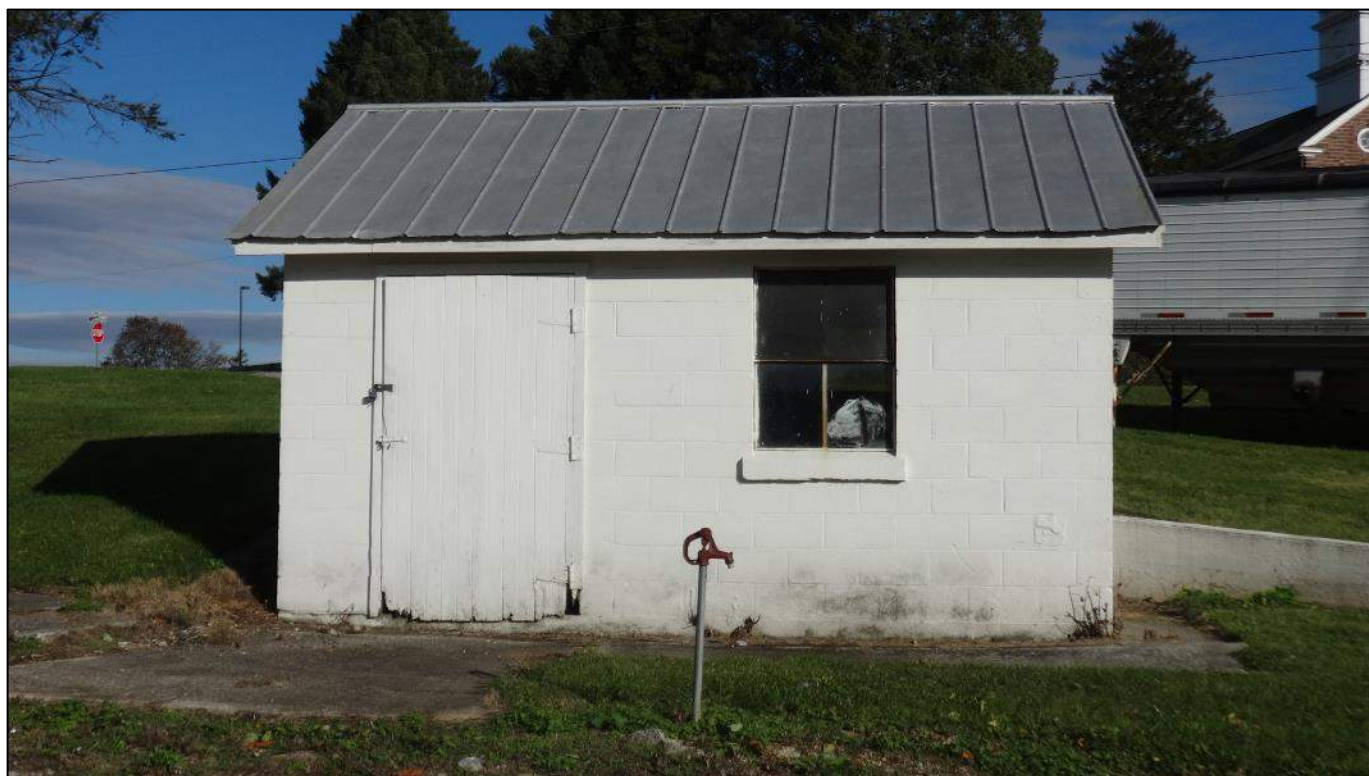
Photograph 34 – Façade (west elevation) of the Enders Farm milk house; looking east.

The mid-twentieth century milkhouse is approximately 94 feet northeast of the house. The 15-foot by 18-foot building has a standing seam metal, side gable roof, with CMU walls and foundation. The west elevation has a wood panel door and a two-over-two, fixed, metal window (Photograph 34). On the south elevation, there is an additional wood panel door. The gable is clad with wood siding and pierced by a gable vent (Photograph 35). The east elevation has two window openings with metal frames, but no sash or glazing; there is also a small, rectangular cement slab at grade. On the north elevation, there is a window opening with a metal frame, but no sash or glazing as well as wood siding in the gable and a gable vent (Photograph 36).

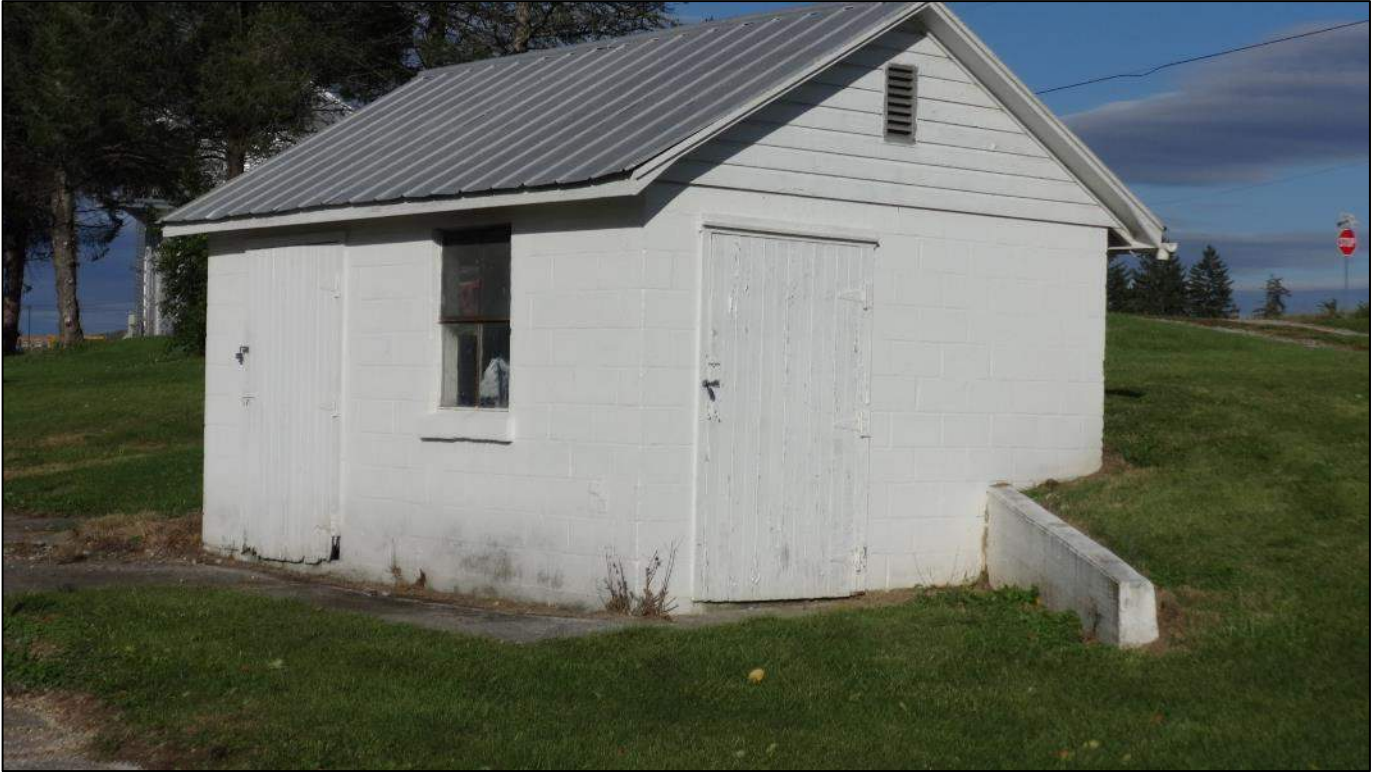
Photograph 35 – Façade (west elevation) and side (south elevation) of the Enders Farm milk house; looking northeast.

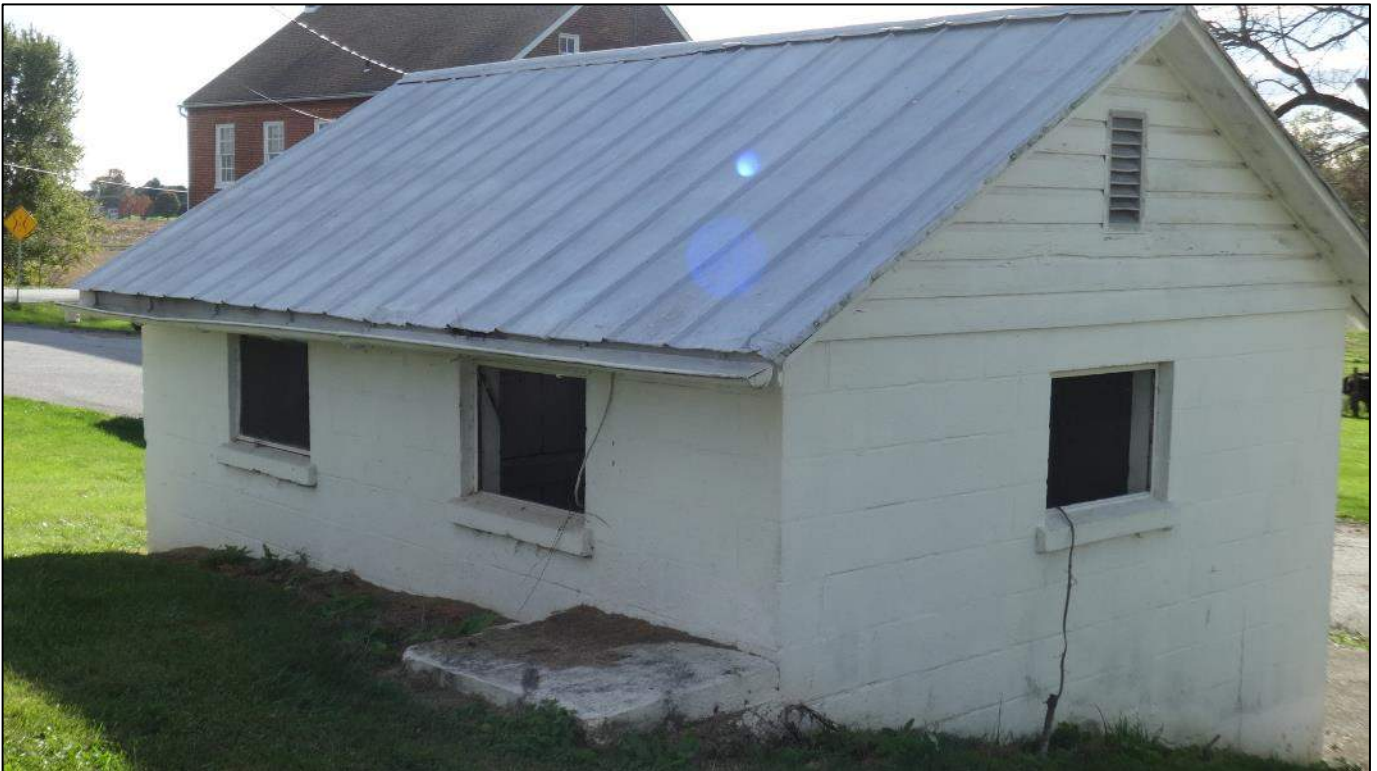
Photograph 36 – Rear (east elevation) and side (north elevation) of the Enders Farm milk house; looking southwest.

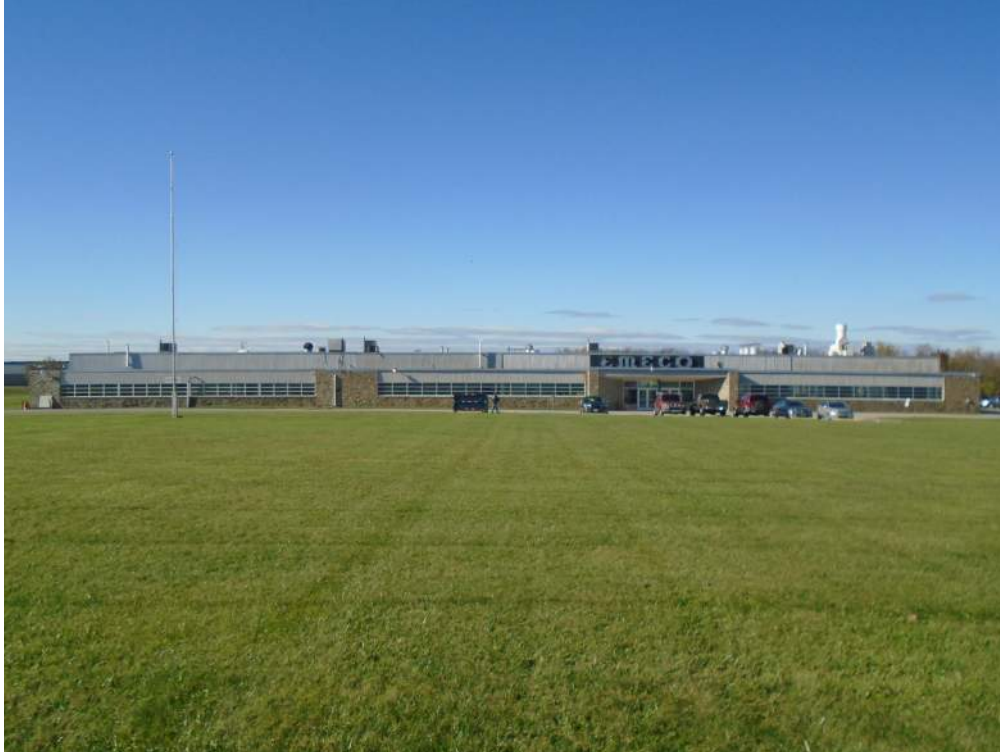
**Photograph 1:** Overview of the Emeco building facade (southwest), showing the original 1950s building and 1968 addition (right to left). Looking northwest.

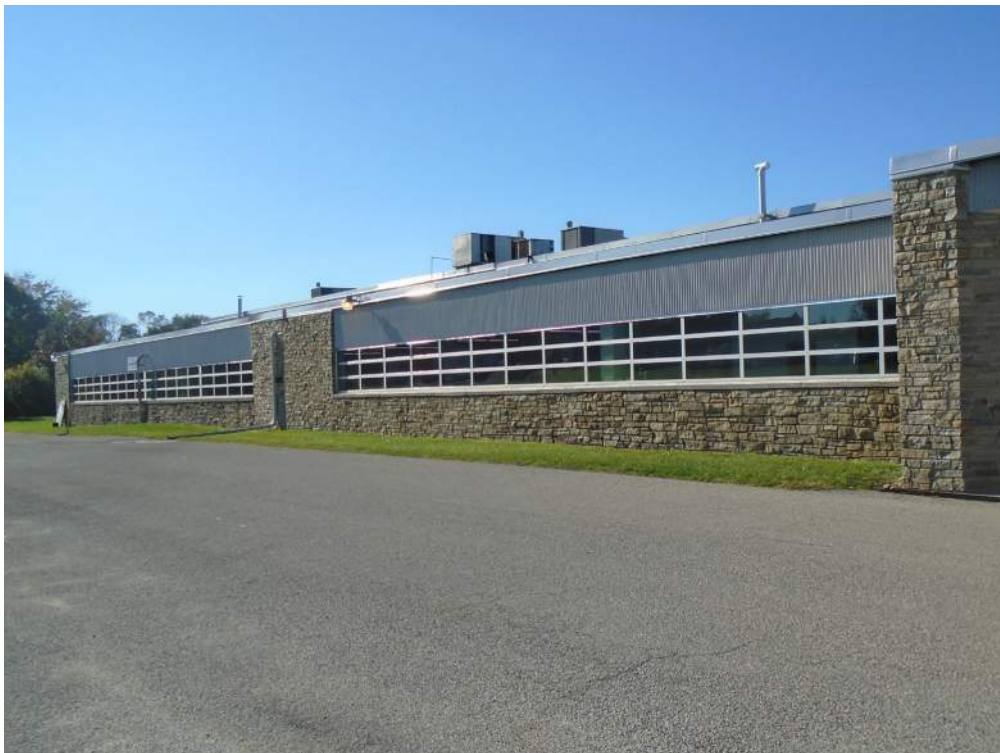
**Photograph 2:** The 1968 addition and 1950s building (left to right), showing the replacement ribbon windows and corrugated metal infill above. Looking southwest.

The façade is divided horizontally into three sections consisting of ledgestone-pattern cladding, aluminum ribbon windows, and corrugated aluminum (*Photograph 2*). The ribbon windows and corrugated aluminum on the one-story office section are slightly recessed from the face of the stone, but all three materials are almost equal in height. Full-height stone-clad columns anchor the corners and separate the 1950s building from the 1968 addition. The original windows at the 1950s building were three rows of awning windows at least 14 sashes in length but have been replaced with fixed, aluminum ribbon windows of the same configuration. The corrugated aluminum in place above the ribbon windows replaced thin stone or concrete panels (*Photograph 19*). The primary entrance is characterized by a projecting portico with a polished aluminum cap, corrugated metal fascia, and ledgestone-clad walls (*Photograph 3*). The walls of the portico are splayed inward towards the doors. The entrance features two sets of replacement aluminum and glass double-doors with single-light sidelights and transoms.

The complex has lost integrity of materials since the original ribbon windows, entrance doors, and stone or concrete paneling above the windows at the façade have been replaced. The replacement windows attempt to maintain the original configuration of three, stacked lights, but the lack of depth, thickness of muntins, and change of operation affect the character of the fenestration. As the façade is the only designed elevation with a clear style, and the ribbon windows are intrinsic to the style and character, the loss of this historic material is significant.

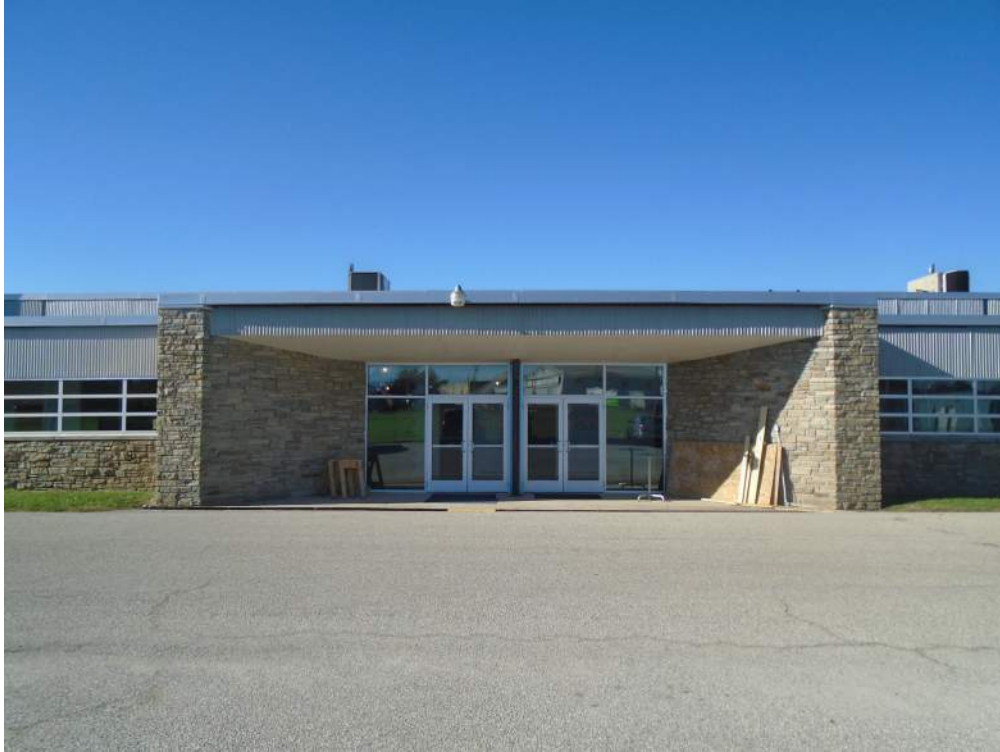
**Photograph 3:** Detail view of the Emeco building entrance. Looking northwest.

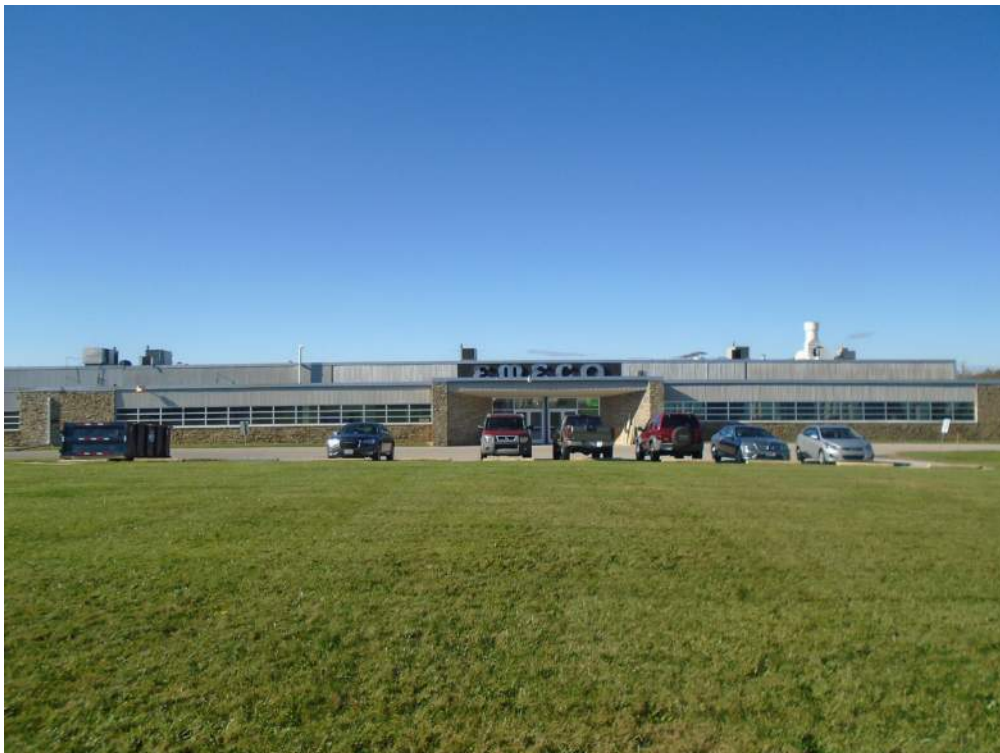
**Photograph 4:** The original 1950s building, showing the one-and-one-half factory and Emeco signage behind the office facade. Looking northwest.

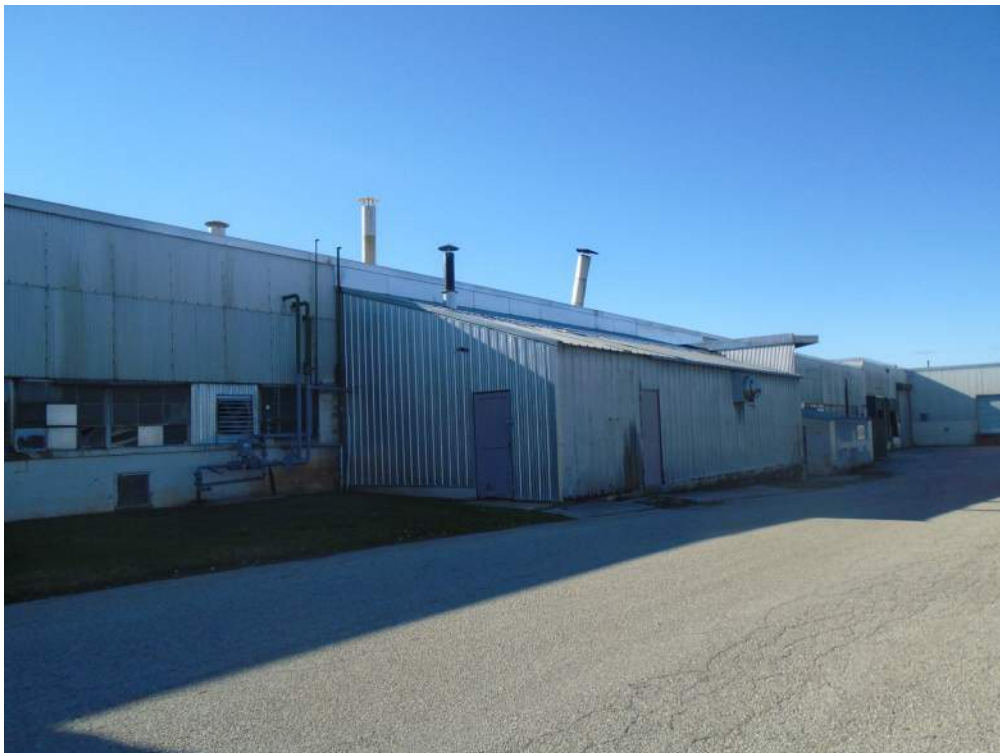
**Photograph 5:** The 1950s building, showing the northeast elevation of the one-story portion (far left) and the one-and-one-half-story factory.

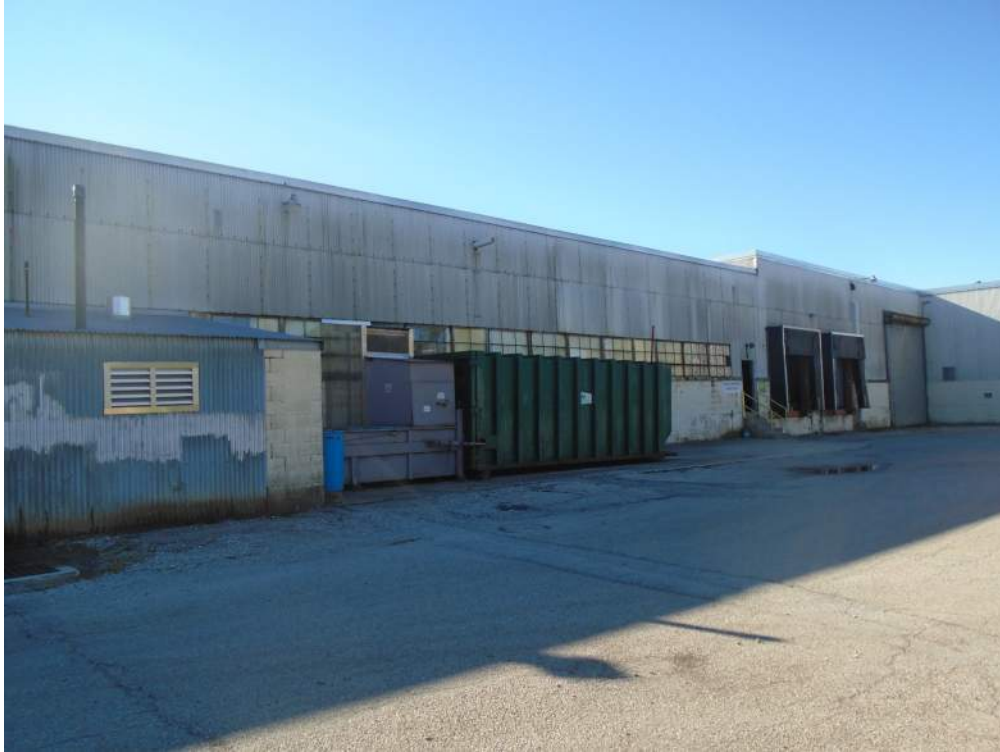
**Photograph 6:** The northeast elevation of the 1950s factory building, showing the two aluminum-clad, attached structures. Looking northwest.

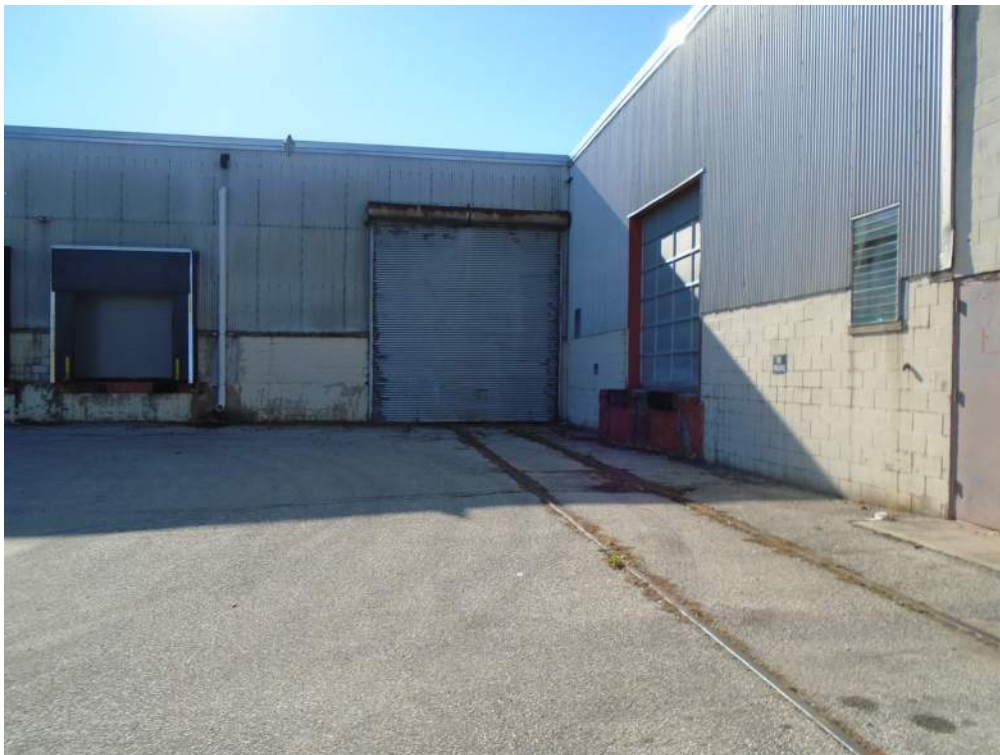
**Photograph 7:** Detail view of the northeast elevation of the 1950s factory building. Looking northwest.

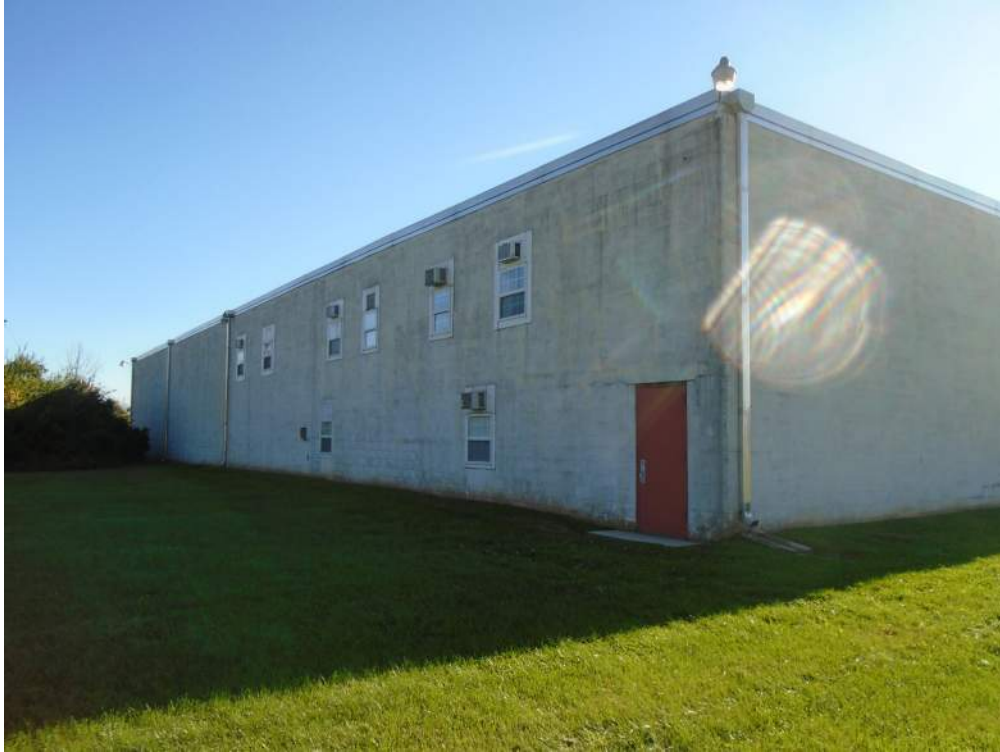
**Photograph 10:** The unattached, CMU building east of the factory complex. Looking east.

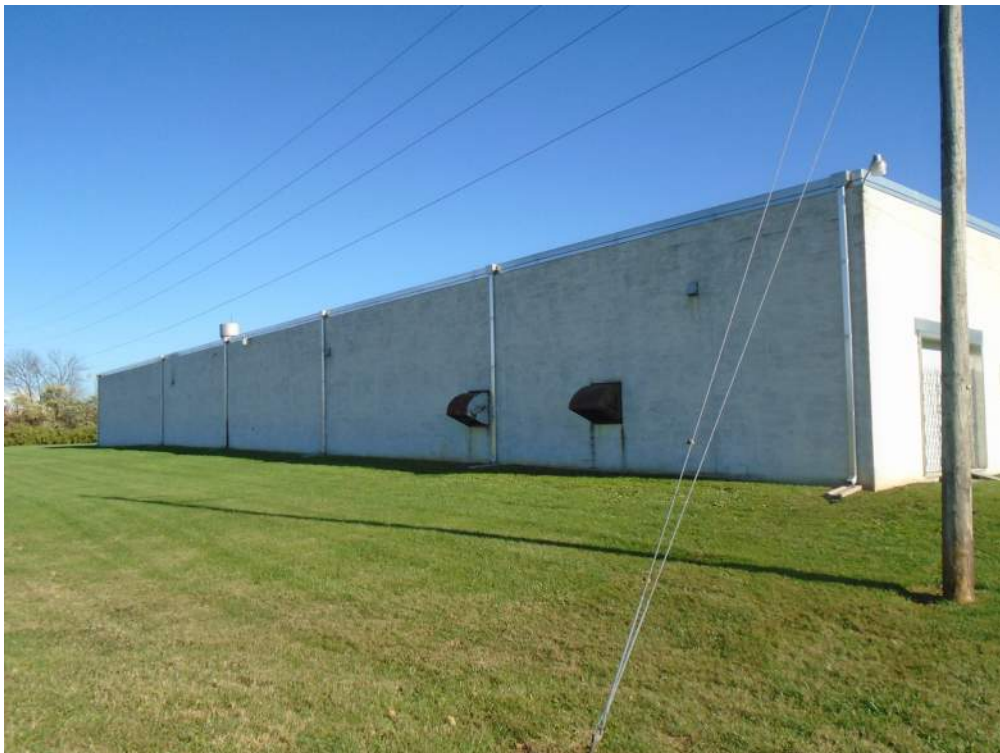
**Photograph 11:** The post-1971 addition, showing the northeast elevation and part of the northwest elevation. Looking south.

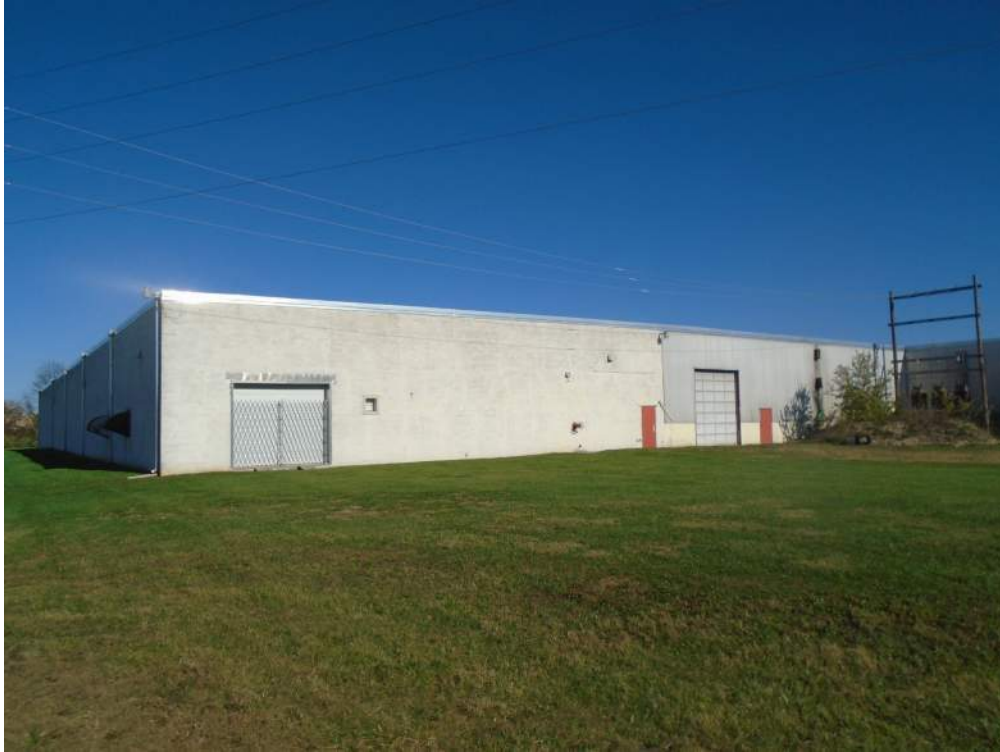
**Photograph 12:** The post-1971 addition, showing the northwest elevation. Looking northeast.

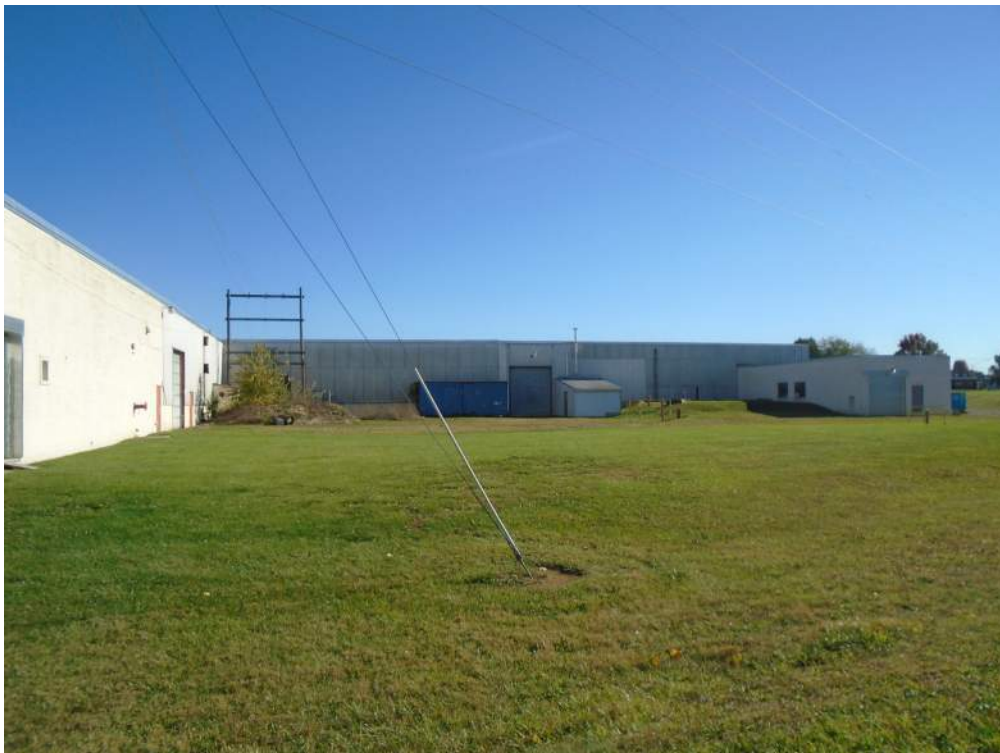
**Photograph 13:** The post-1971 and late 1960s additions (left to right), showing the southwest elevation. Looking east.

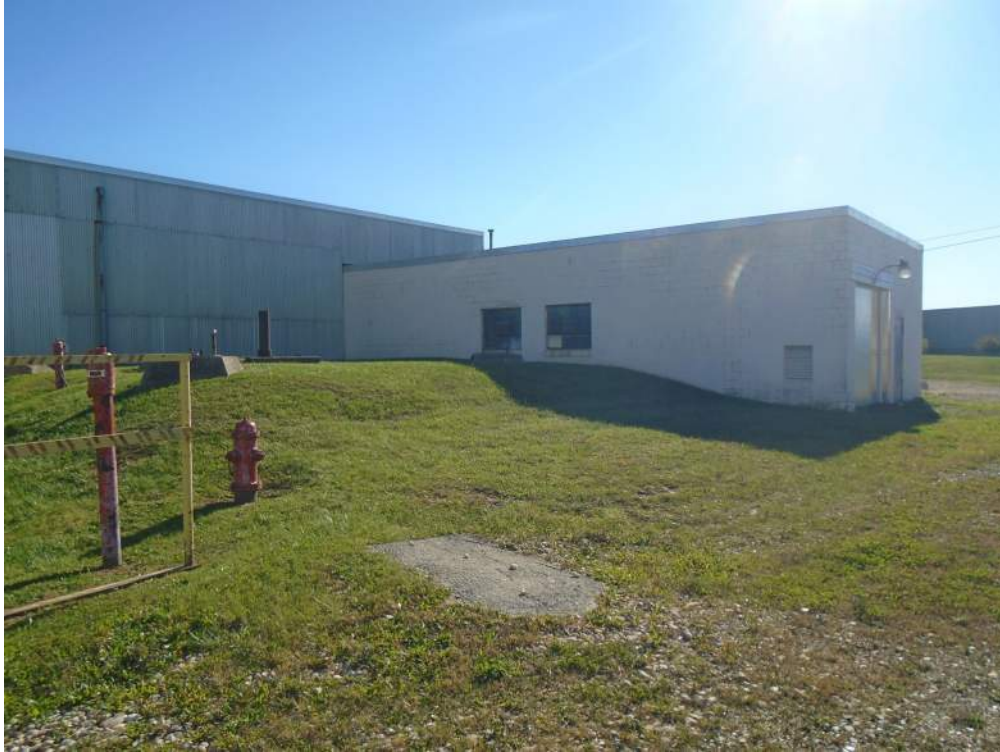
**Photograph 14:** The 1950s building and 1968 addition (left to right), showing the northwest elevation. Looking southeast.

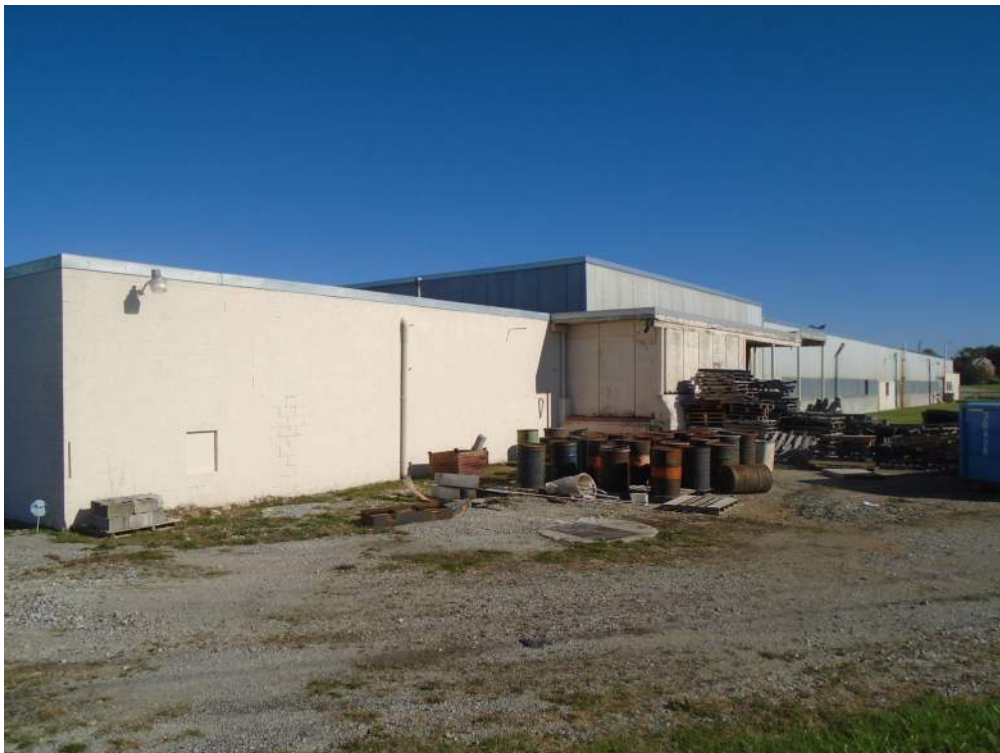
**Photograph 15:** Detail view of the CMU structure attached to the 1968 addition. Looking southwest.

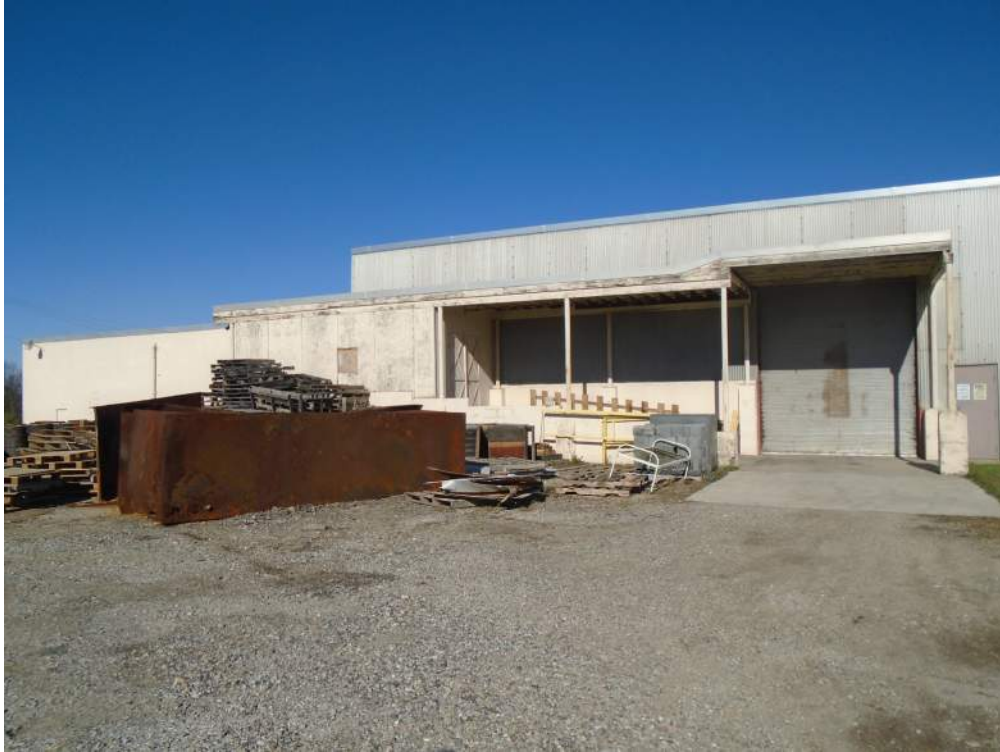
**Photograph 16:** The 1968 addition, showing the southwest elevation including the CMU structure at the far left. Looking southeast.

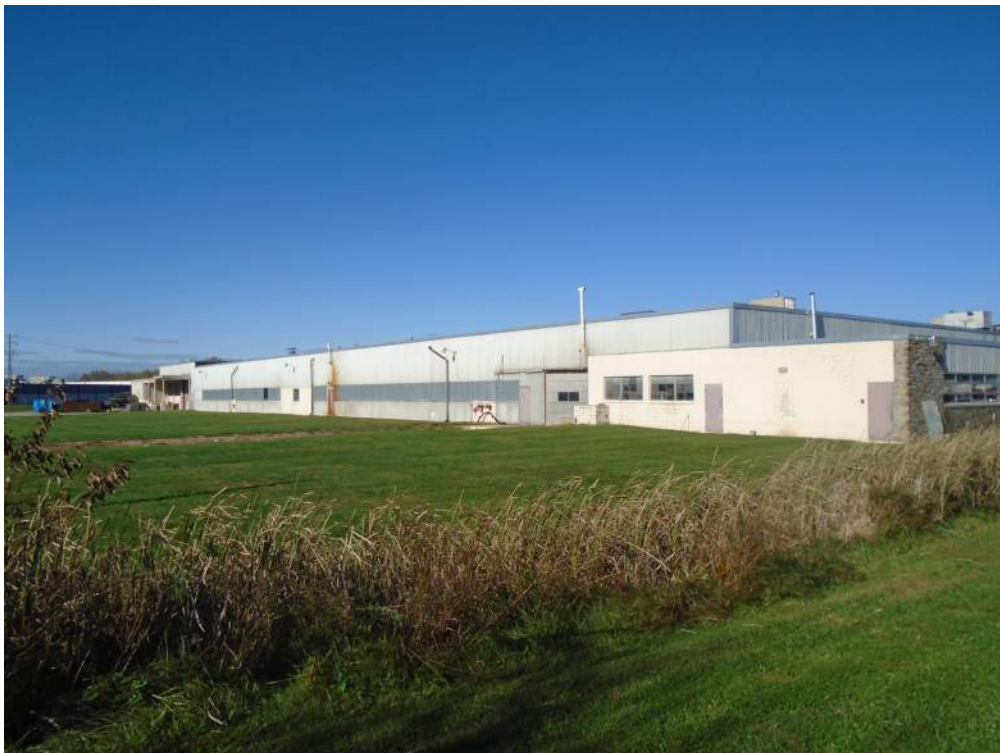
**Photograph 17:** Detail view of the southwest elevation of the 1968 addition, showing the partially enclosed loading dock. Looking northeast.

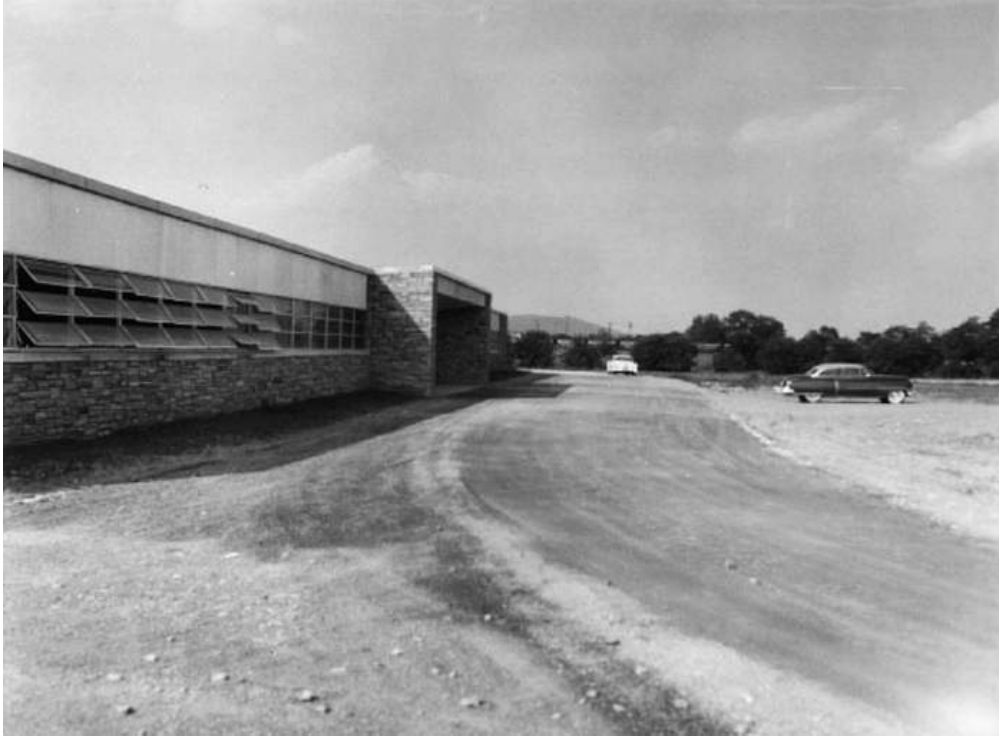
**Photograph 18:** The southwest elevation of the 1968 addition, showing the one-and-one-half-story factory and one-story, CMU offices (left to right).

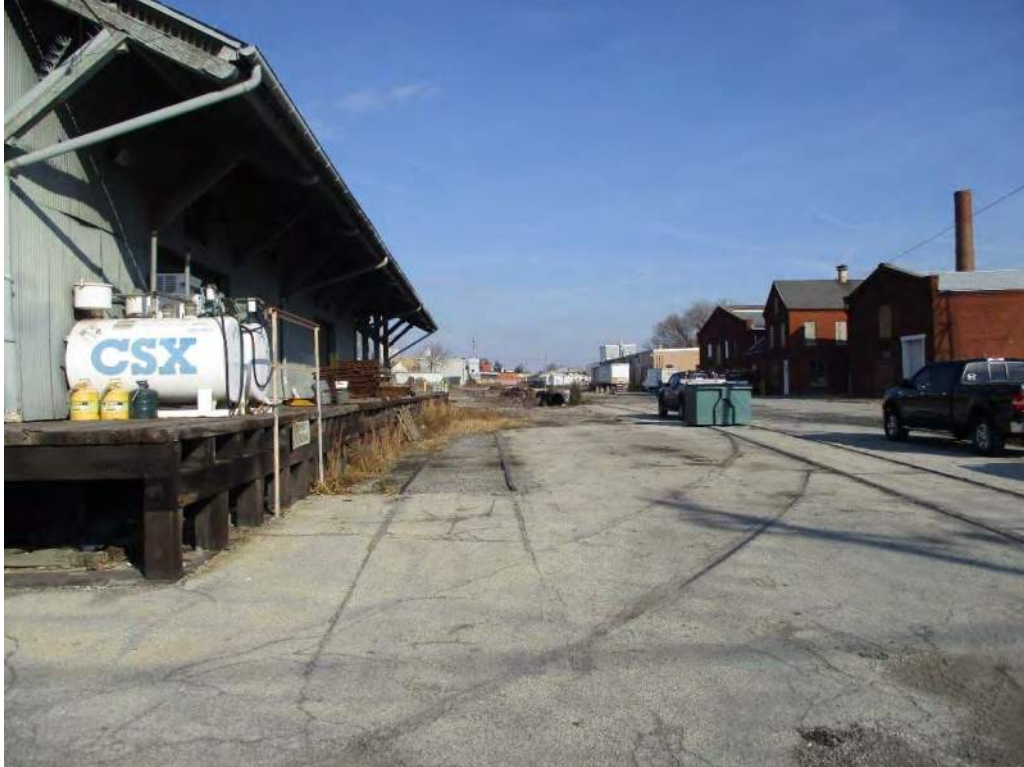
Photograph 1: View of the spur of the former Gettysburg Railroad at Hanover, which accessed the Western Maryland Freight Depot (Key No. 073592), looking east.

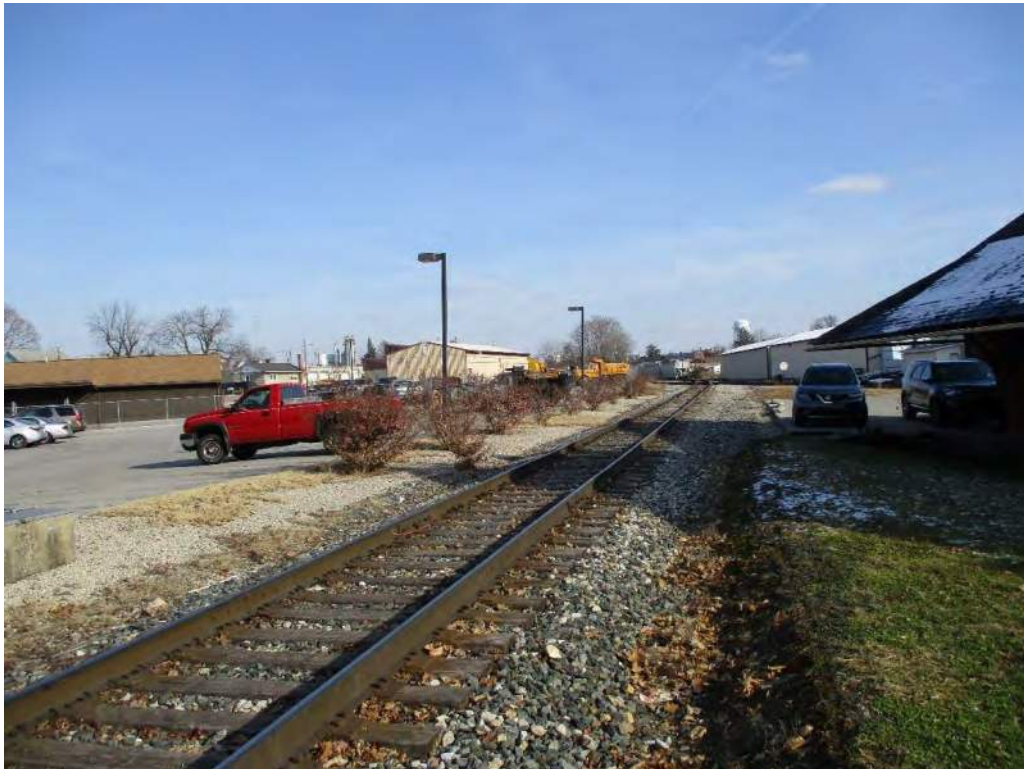
Photograph 2: View of the former Gettysburg Railroad alignment, in Hanover, which accessed the Hanover (Union) Station (at right), looking east.
