# Historic Resource Survey Form

PENNSYLVANIA HISTORICAL AND MUSEUM COMMISSION  
Bureau for Historic Preservation

Key # \_\_001901, 001920, 001930\_\_\_\_\_  
 ER # \_\_2016-8477-001\_\_\_\_\_

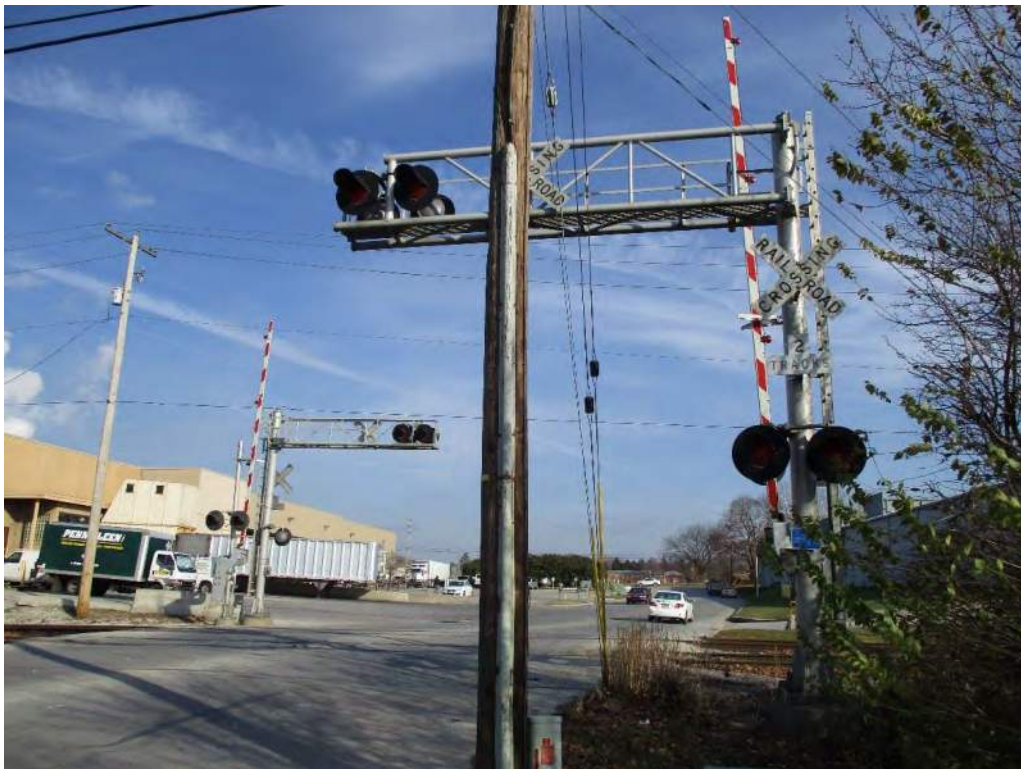
Photograph 6: View of the grade crossing signals (typical), in Hanover at the Kindig Lane crossing, looking east.

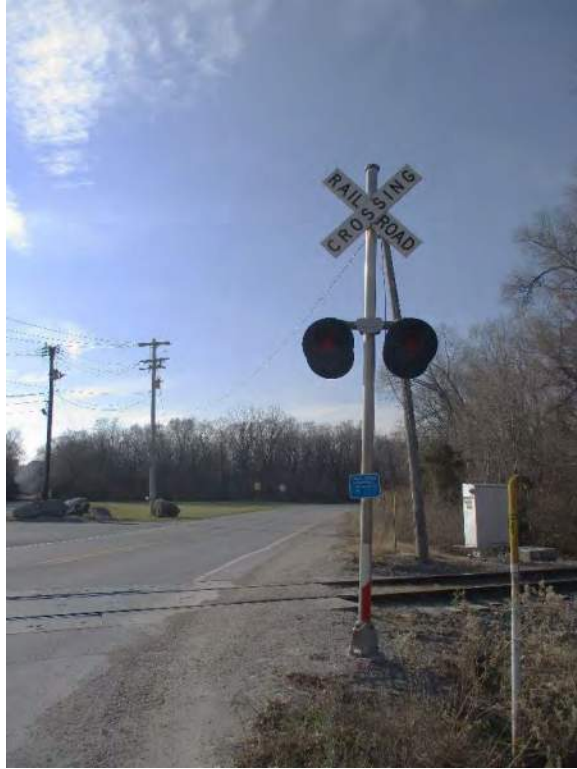
Photograph 9: View of the grade crossing signal, outside of Hanover, at the Hanover Street crossing, looking west.

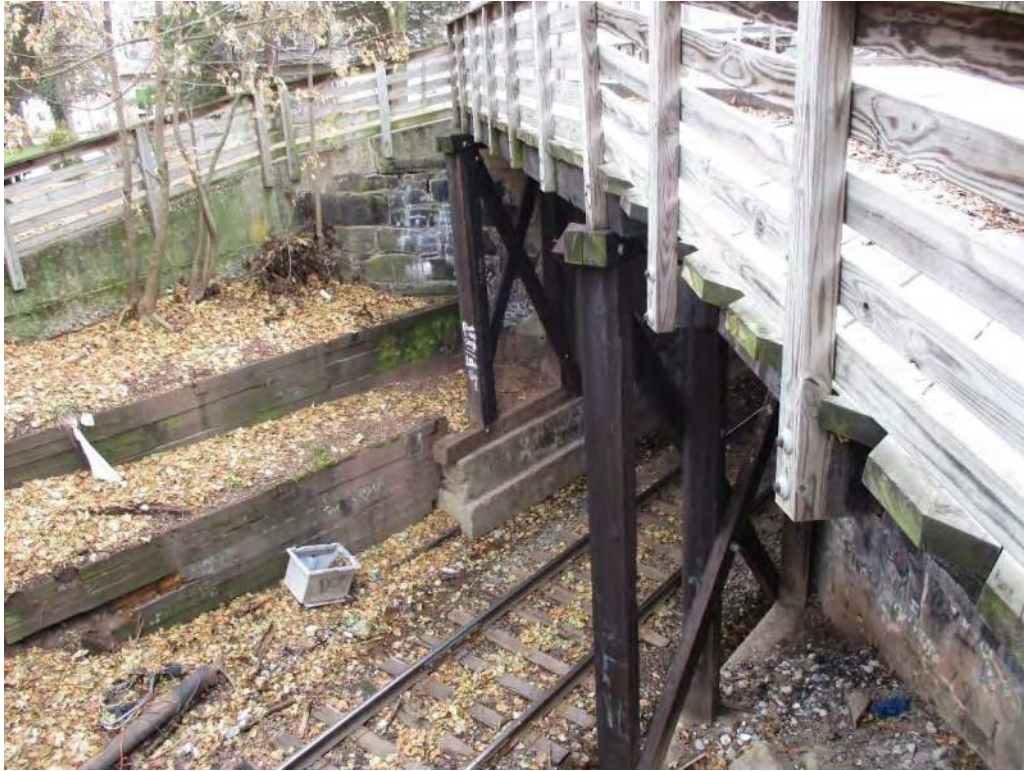
Photograph 15: View of the High Street Bridge (Key No. 083678) (Bridge 2), New Oxford, looking northwest.

\*According to PennDOT's Historic Bridge Survey data, a wood stringer bridge that was found eligible by PHMC on 5/9/1984 was removed, according to PennDOT records. That bridge was previously recorded under Key No. 086378 and determined eligible as a Road Related (Vehicular) resource. Bridge 2 is therefore non-contributing.

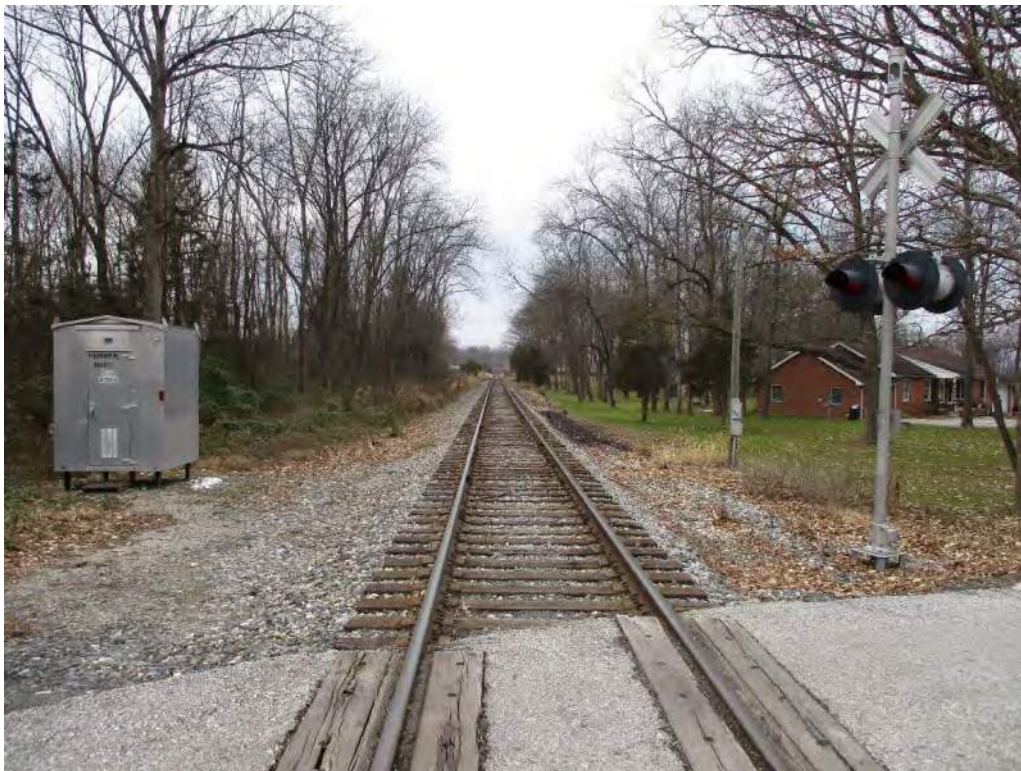
Photograph 22: View of the former Gettysburg Railroad alignment, approaching Gettysburg, from the Flickinger Road crossing looking west.

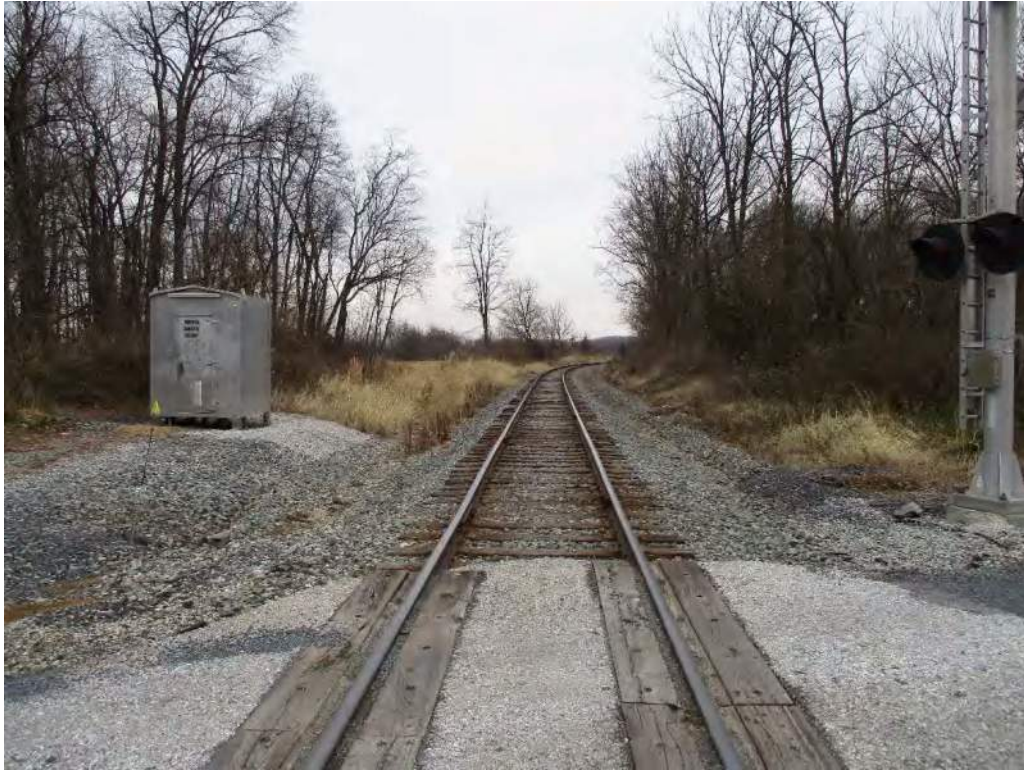
Photograph 23: View of the former Gettysburg Railroad alignment, approaching Gettysburg, from the Smith Road crossing looking east.

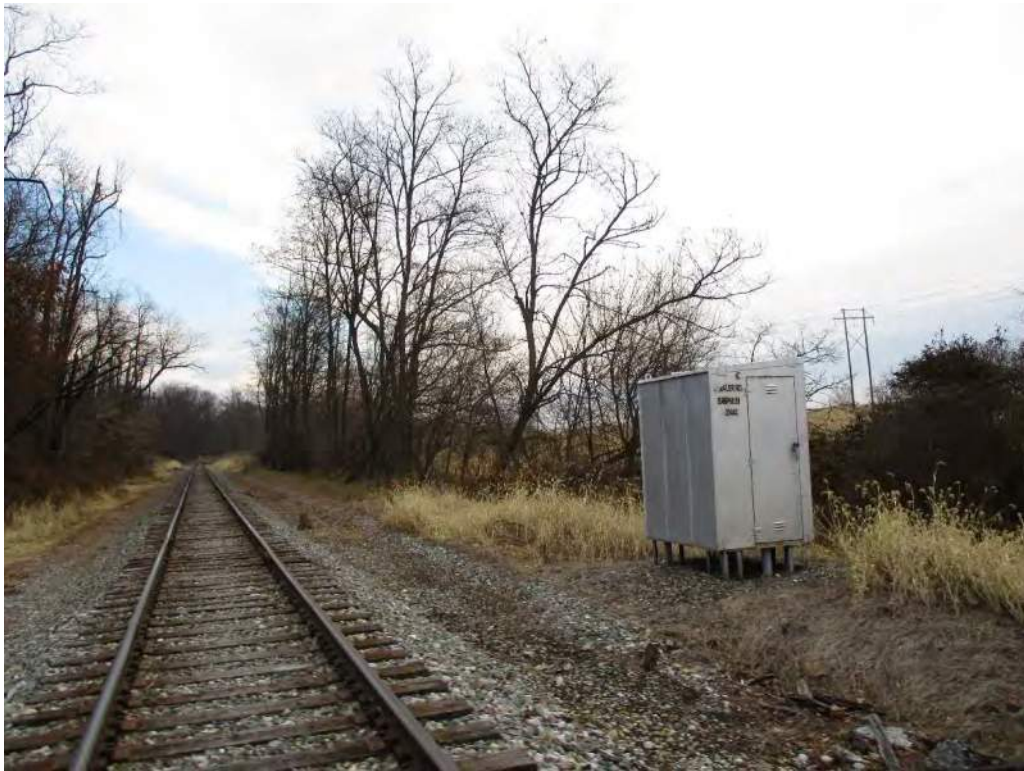
Photograph 24: View of the former Gettysburg Railroad alignment, approaching Gettysburg, from the Shealer Road crossing, looking northeast.

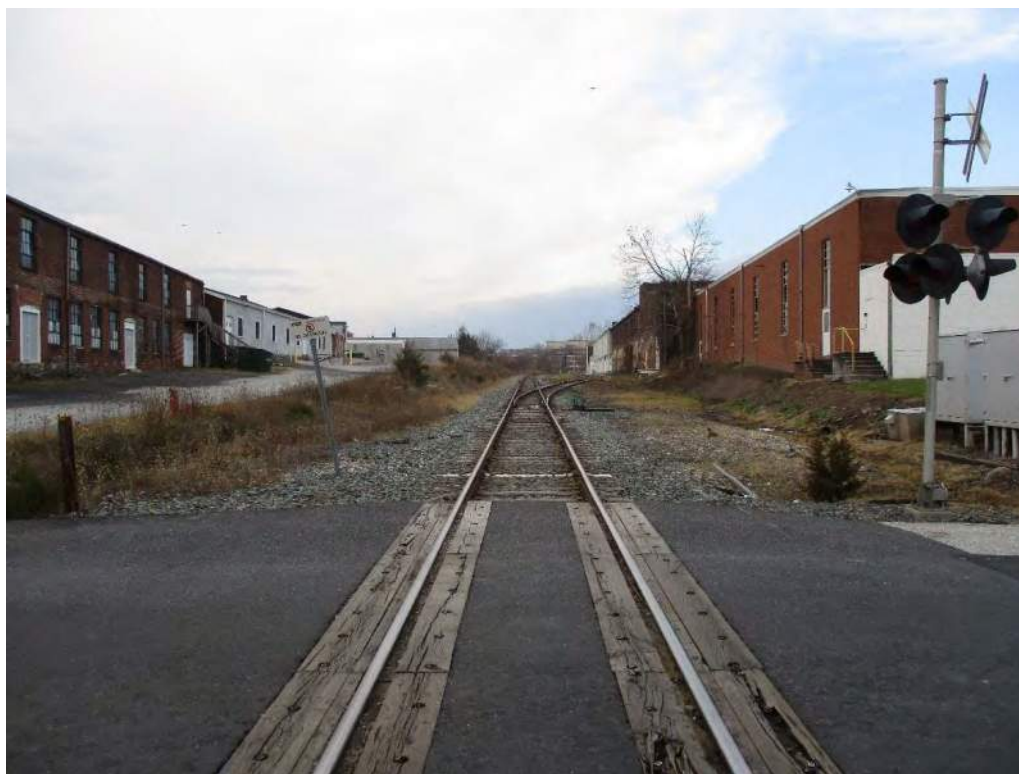
Photograph 25: View of the former Gettysburg Railroad alignment, entering Gettysburg, from the North 4<sup>th</sup> Street crossing, looking west.

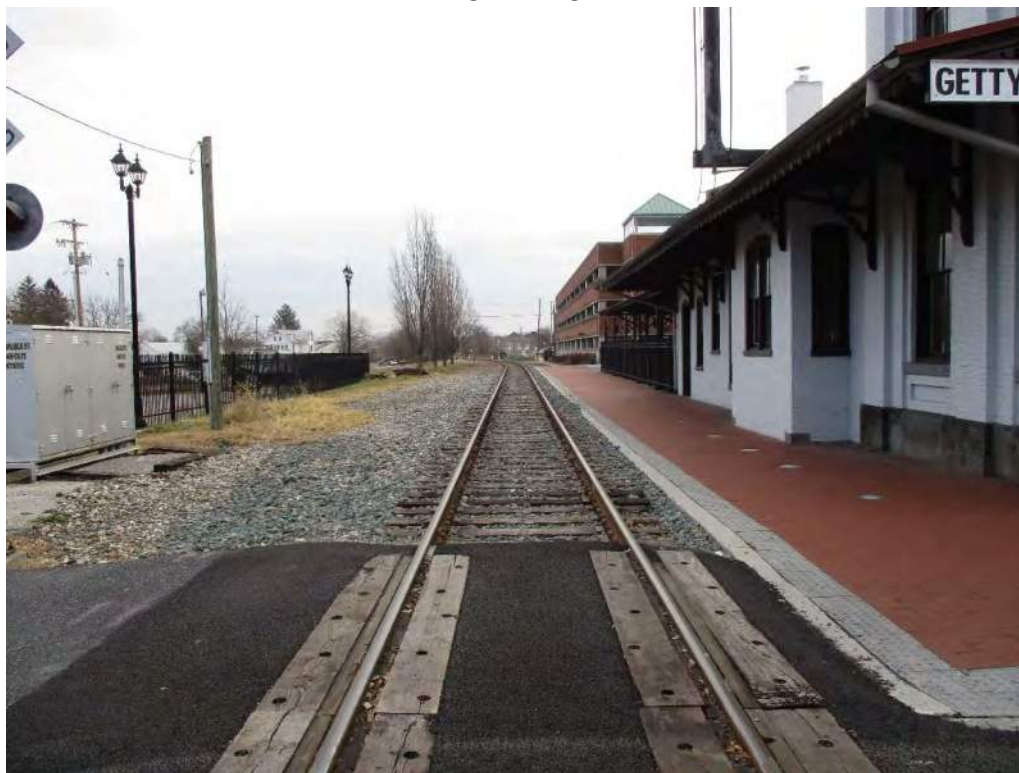
Photograph 26: View of the former Gettysburg Railroad alignment, toward its former historic termination at the Gettysburg Station, Gettysburg, from the Carlisle Street crossing, looking east.

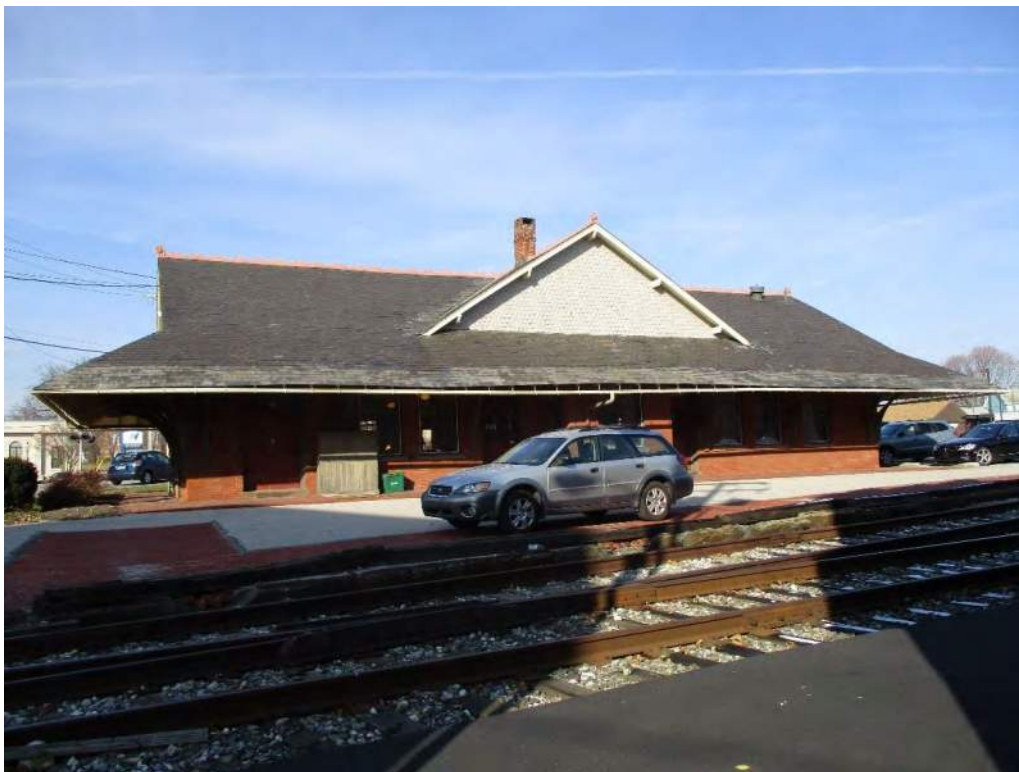
Photograph 27: View of the façade of the Hanover (Union) Passenger Station (facing the tracks of the former Pennsylvania Railroad), looking north.

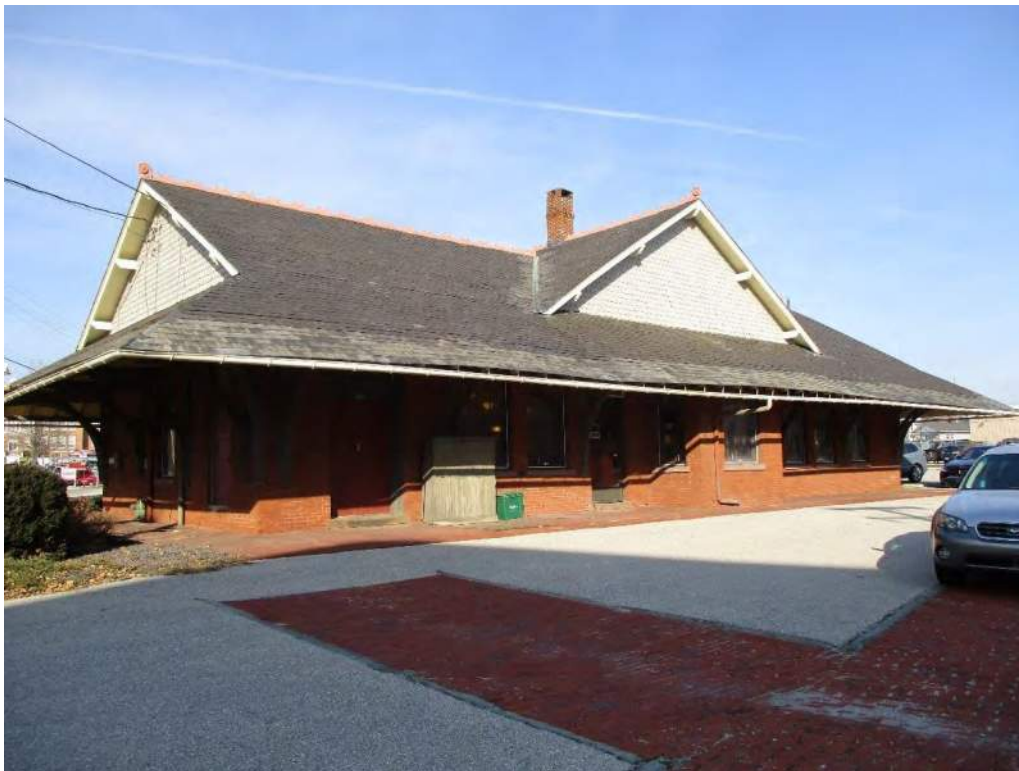
Photograph 28: View of the rear of the Hanover (Union) Passenger Station (facing the tracks of the former Gettysburg Railroad), looking south.

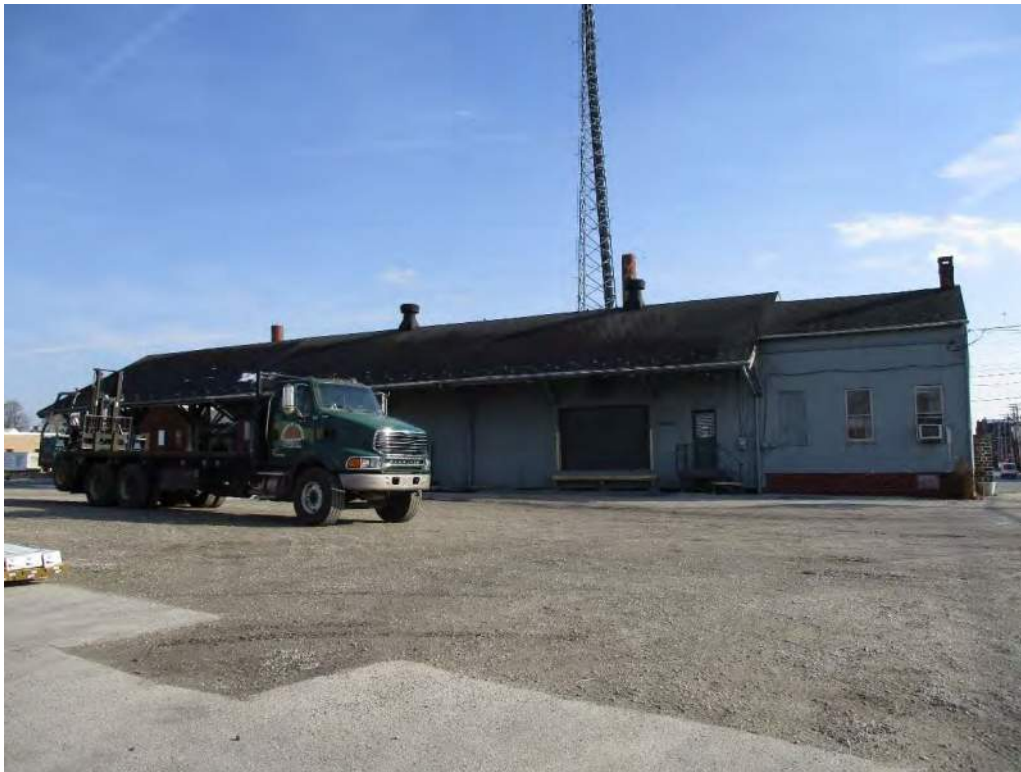
Photograph 29: View of the Western Maryland Freight Depot (Key No. 073592), looking southeast.

The single-story freight depot rests on a brick foundation, is clad in corrugated metal, and has a side gabled roof sheathed in asphalt shingles with the gable end facing the main road and the eaves ends parallel to the rail spur. The depot consists of a small office adjacent to North Railroad Street and a larger freight shed extending eastward from the office. The office is fenestrated on the south elevation by a pair of nine-over-nine, original double-hung, wood windows behind aluminum storm windows located to the west of a modern, nine-light, steel entry door. The north elevation is fenestrated by three evenly spaced windows of the same type, the easternmost of which has been sealed with plywood. The

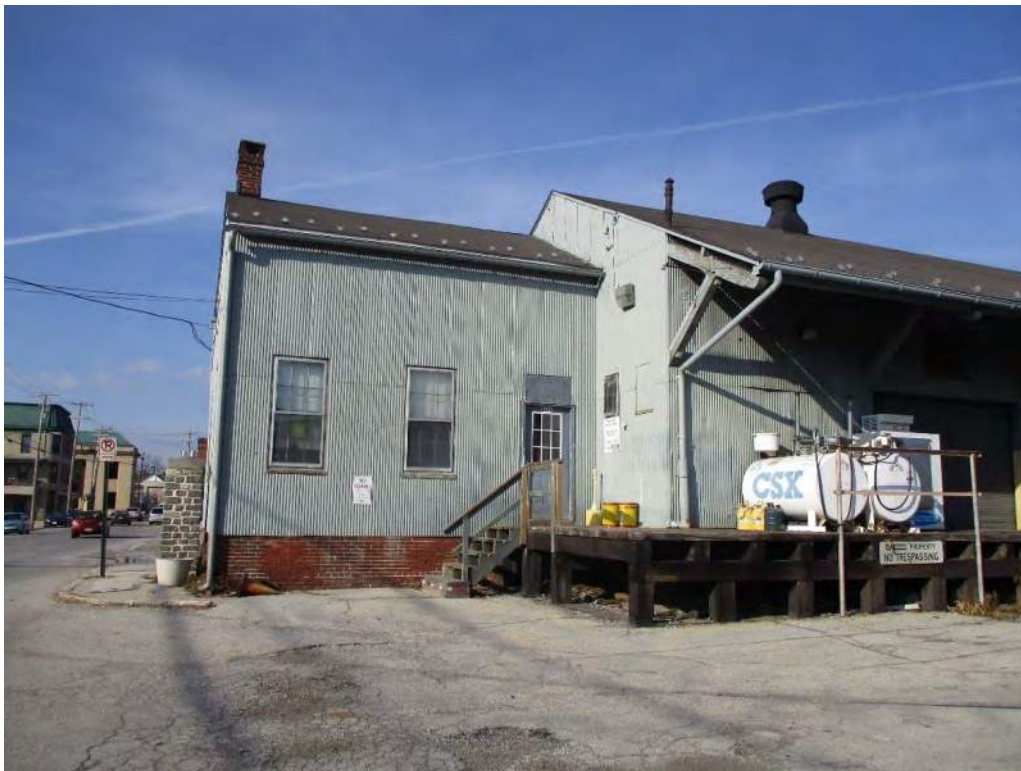
Photograph 30: View of the Western Maryland Freight Depot (Key No. 073592), looking north.

The south elevation of the freight shed has no windows, but features a pair of large, mid-to-late 20<sup>th</sup> century overhead doors, evenly spaced on the façade. The arrangement of overhead doors is repeated on the north elevation, and a replacement wood entry door with a single light over three panels is located on the western end of the elevation, accessed by a wooden staircase. A heavy timber platform runs the length of the freight shed on the south elevation and extends beyond the building to the east for several feet. The building features large, deeply overhanging eaves, which shelters the platform on the south elevation. The eaves are supported by timber brackets along the sides of the freight shed. The roof extends past the east wall of the building and is supported by wood posts with brackets at the eastern end. Two metal vents are located at the ridgeline on the freight shed portion of the building.

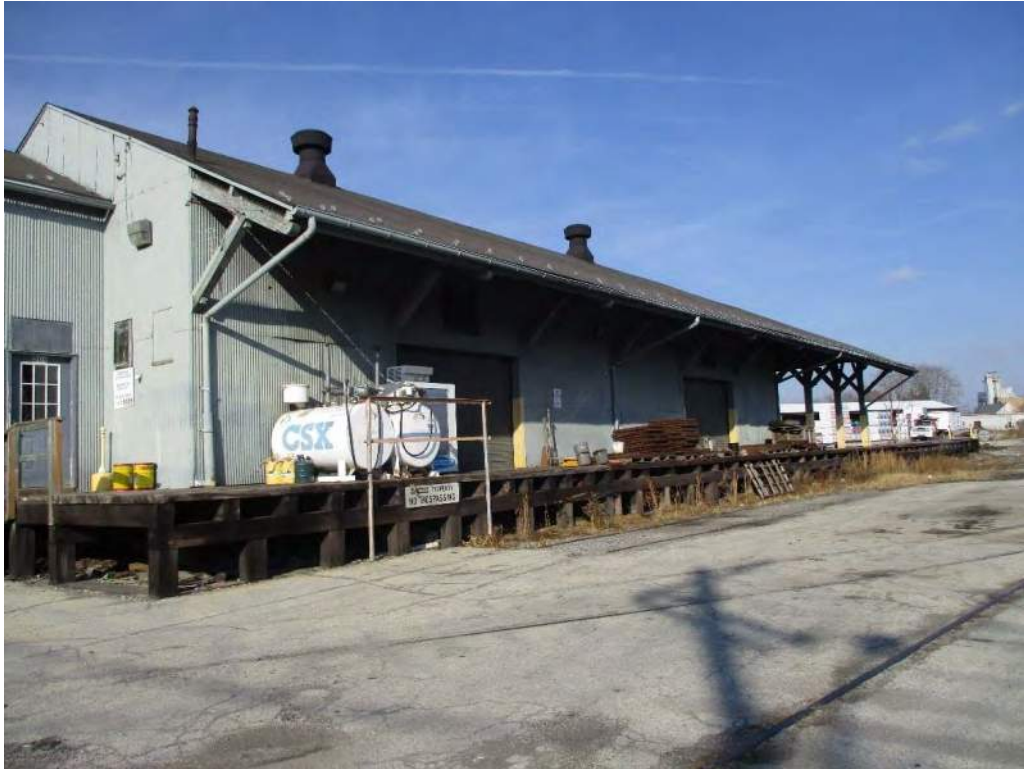
Photograph 31: View of the Western Maryland Freight Depot (Key No. 073592), looking north.

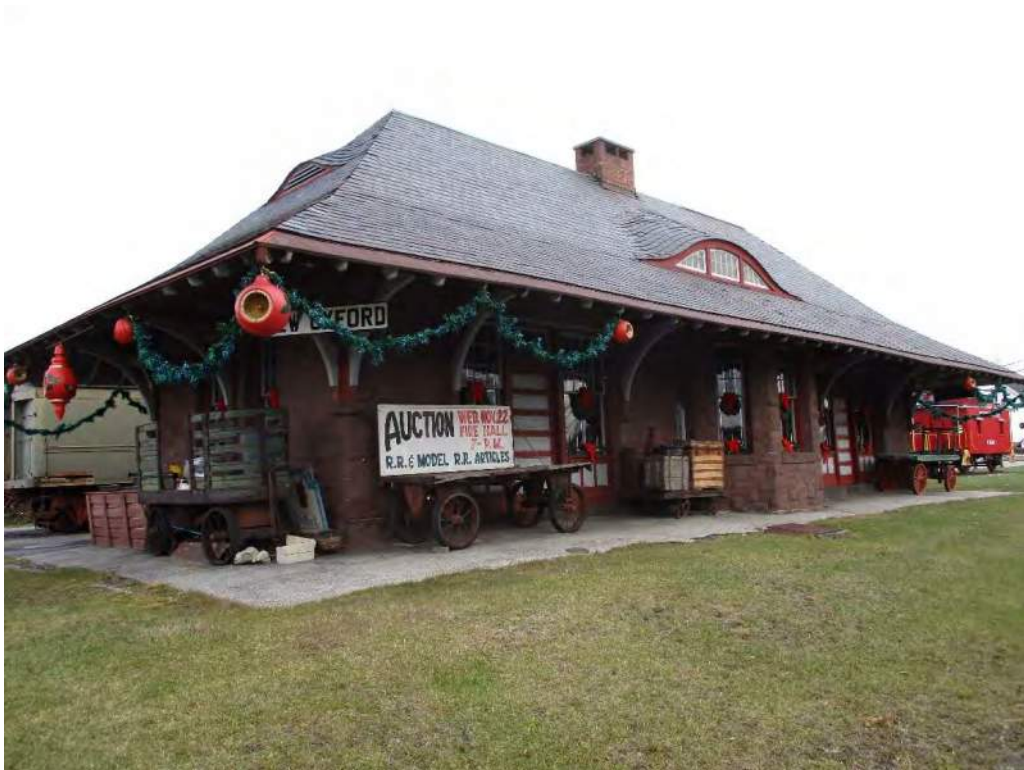
Photograph 32: View of the New Oxford Passenger Station, looking north.

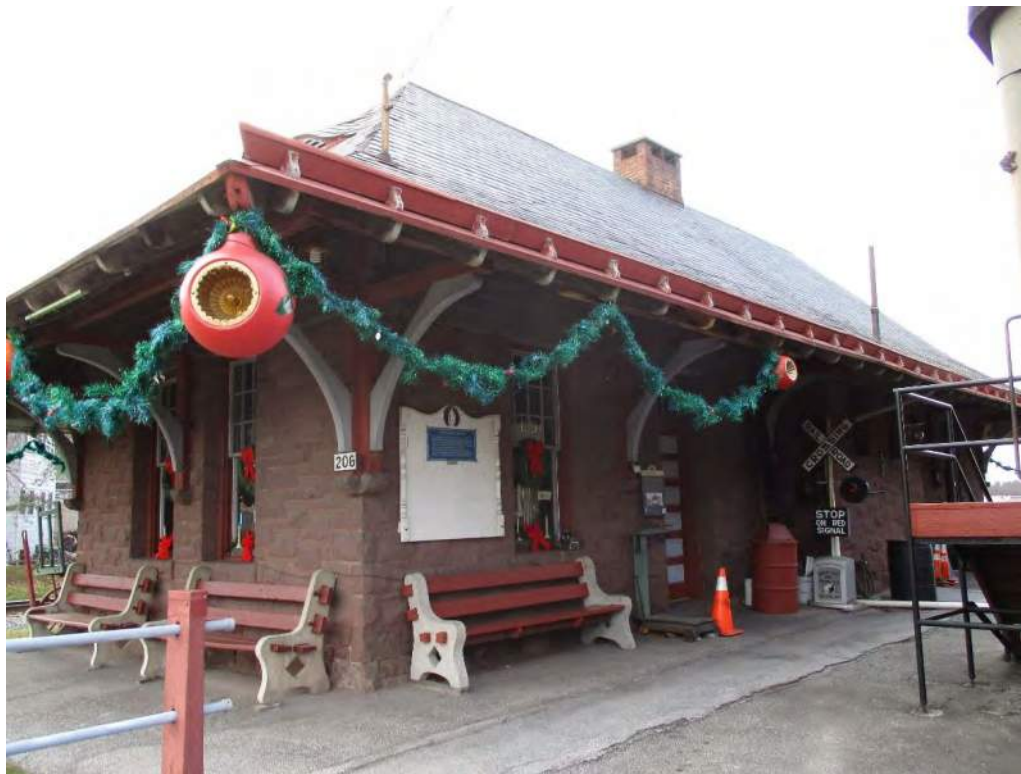
Photograph 33: View of the New Oxford Passenger Station, looking west.

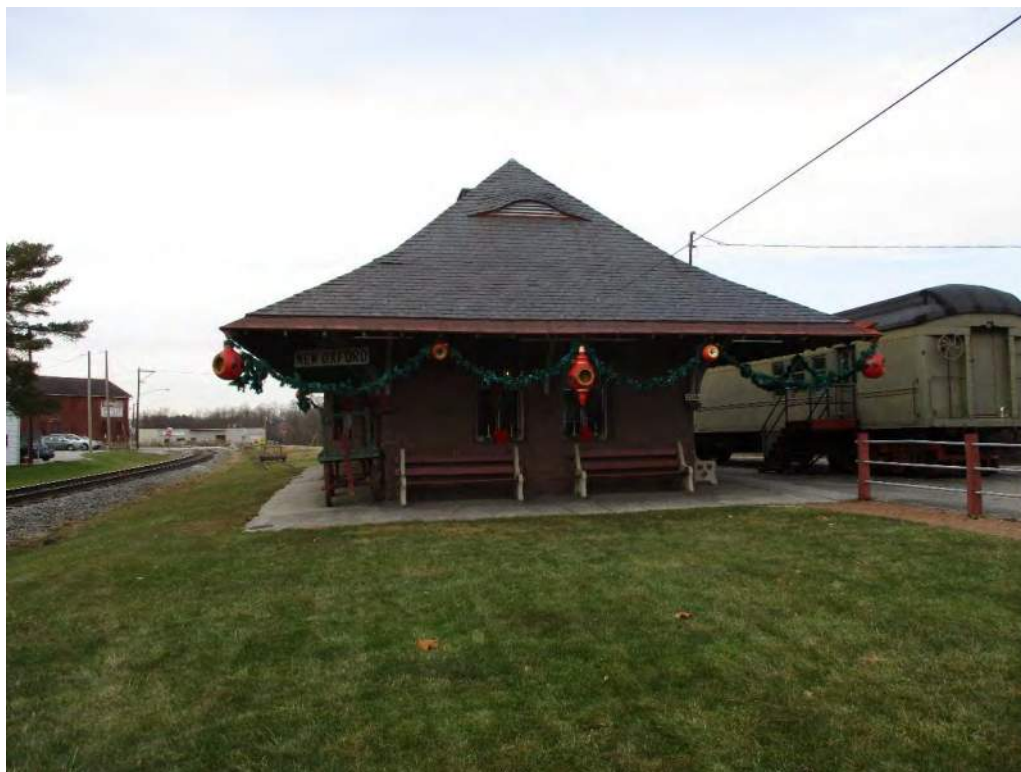
Photograph 34: View of the New Oxford Passenger Station, looking northwest.

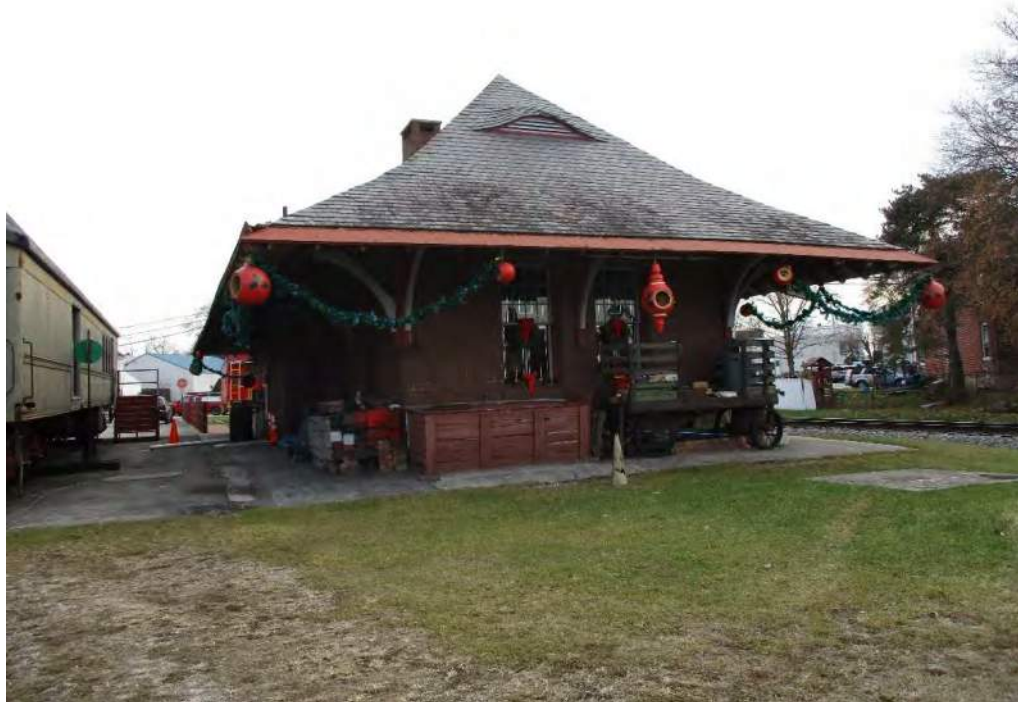
Photograph 35: View of the New Oxford Passenger Station, looking southeast.

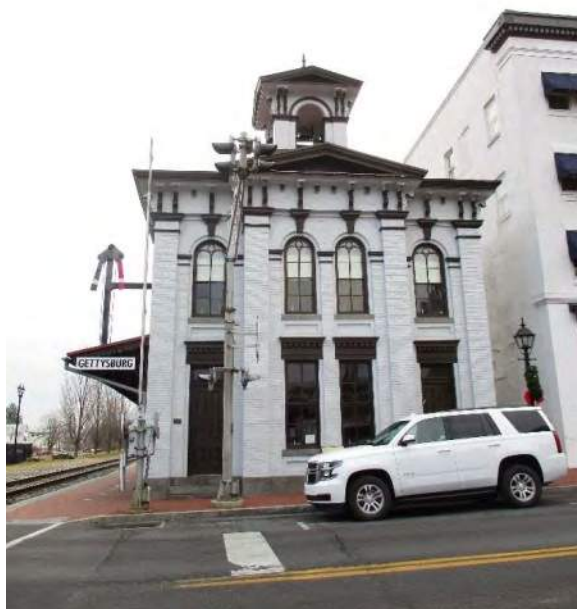
Photograph 36: View of Gettysburg Passenger Station, looking east.

The main body of the station fronts Carlisle Street, is two stories tall, constructed in brick, and rests on a stone foundation. The building is constructed in the Italianate style. It is four bays wide and features a belfry in the form of a cupola at the center of the hipped roof of the main body of the building, which features a bracketed cornice. The central two bays are surmounted by a pediment and flanked by engaged pilasters. The first story is fenestrated by double-hung, four-over-four wood windows located to the west of a four-paneled door with two-light transom, all with flat hoods ornamented with dentil molding. The second story is fenestrated by four-over-four, double-hung, rounded-arch windows which appear to be original.

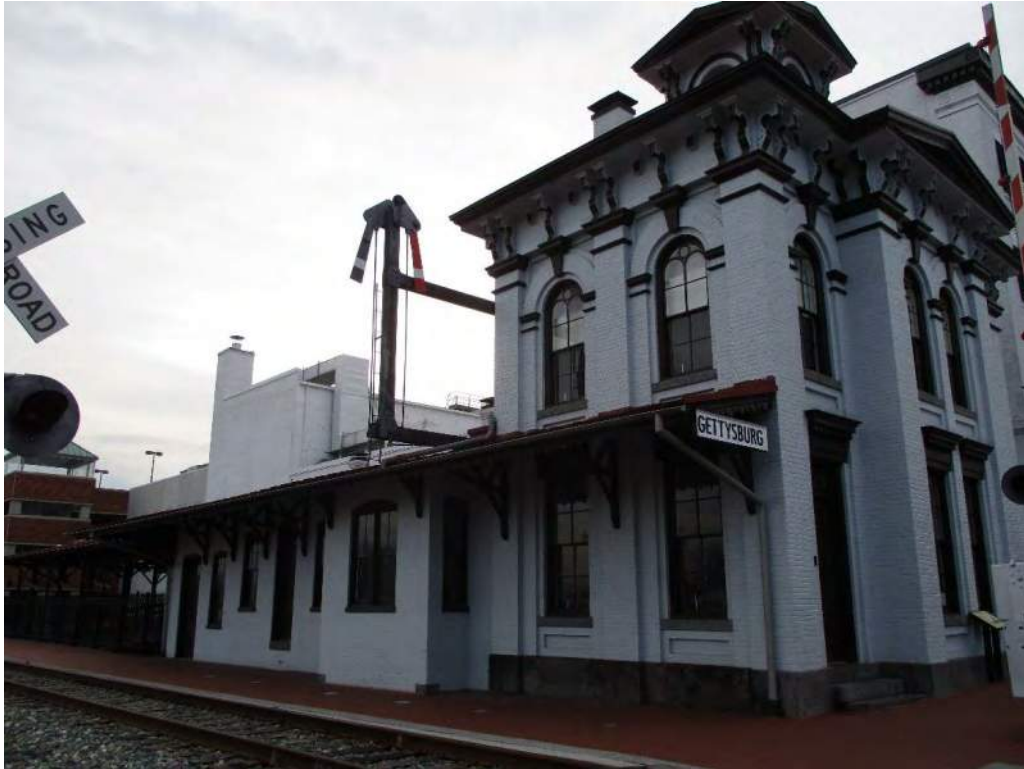
Photograph 37: View of Gettysburg Passenger Station, looking southeast.

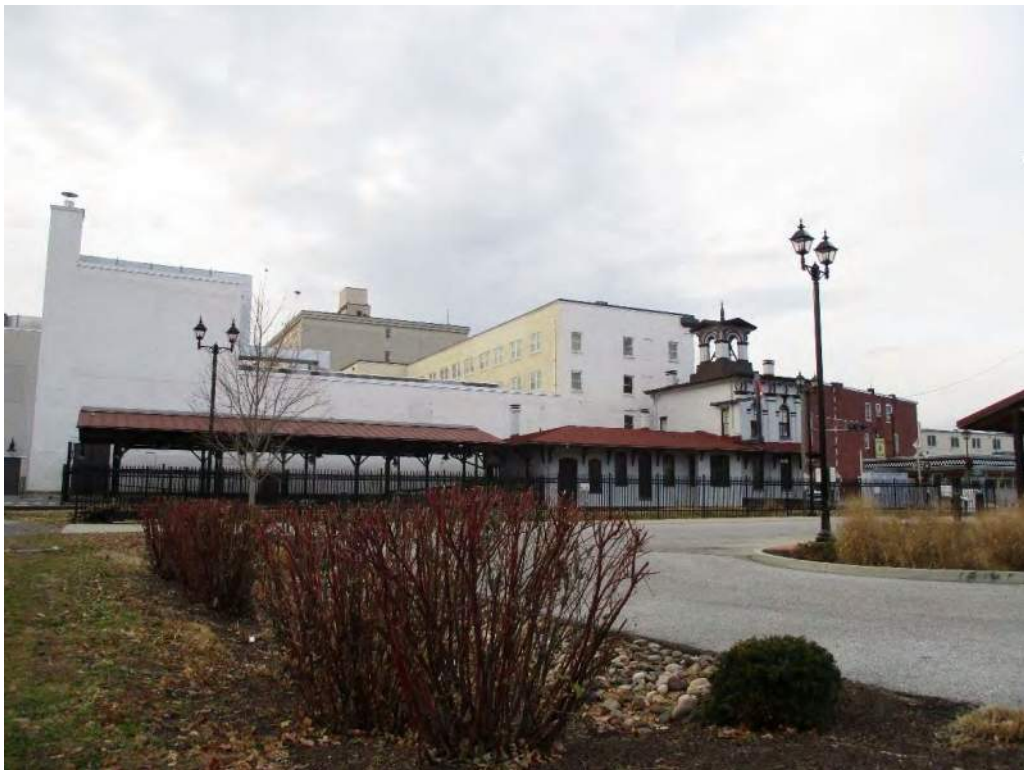
Photograph 38: View of Gettysburg Passenger Station, looking southwest.

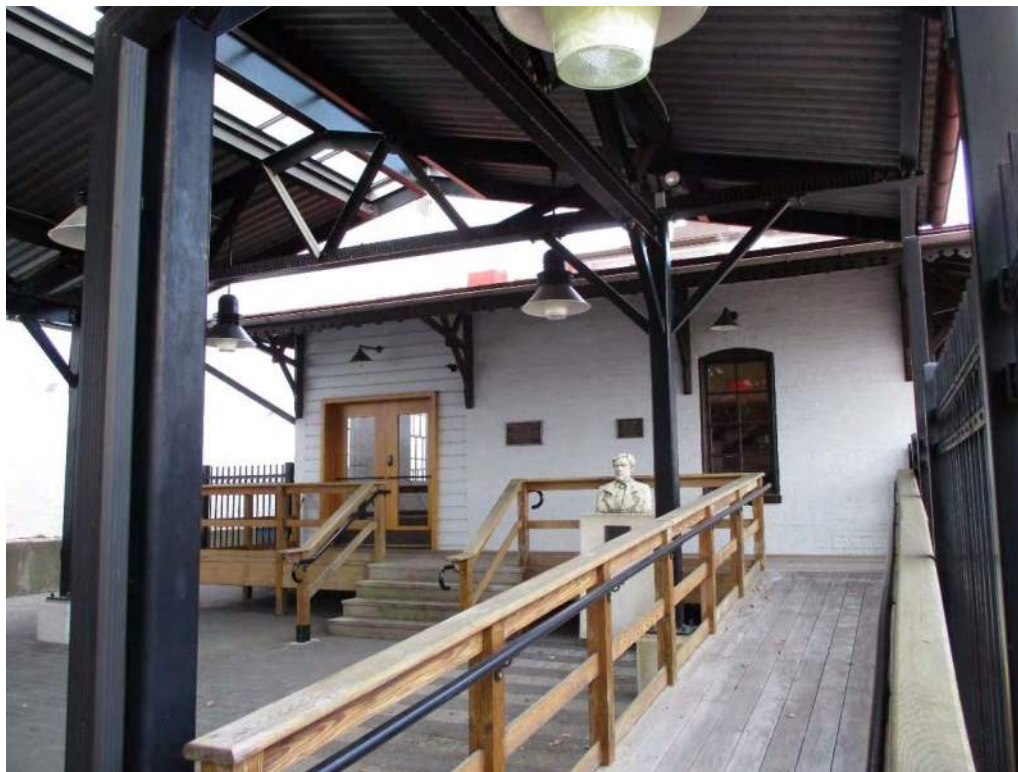
Photograph 39: View of Gettysburg Passenger Station, looking west.

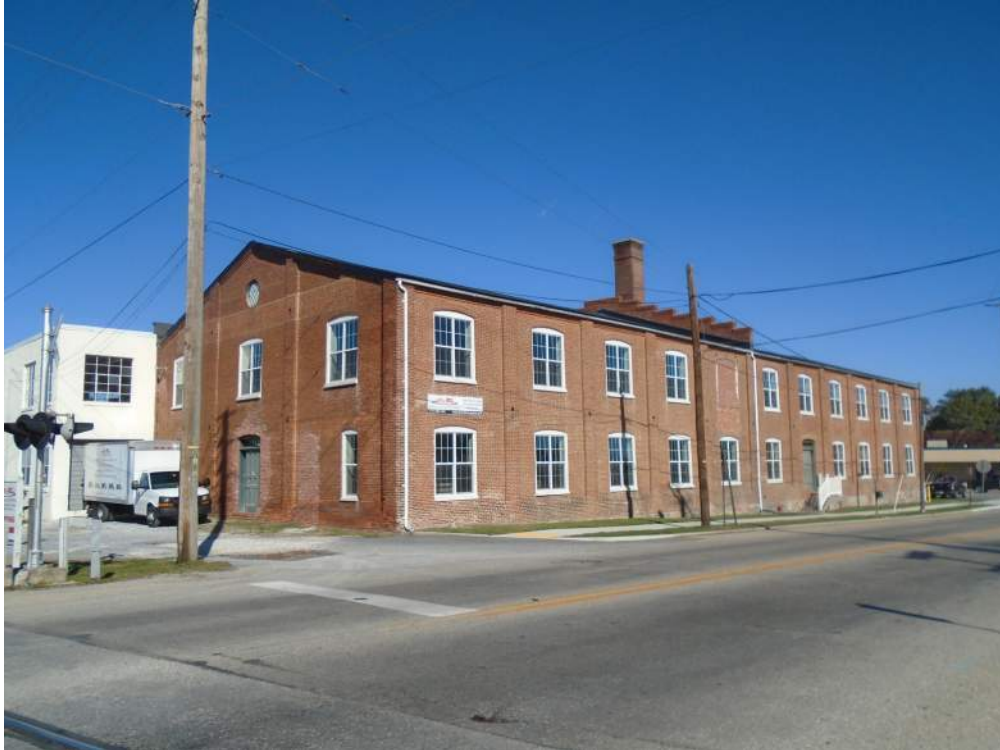
**Photograph 1:** Overview of the factory complex at 549 W. Elm Avenue, showing the mid-twentieth century addition and east elevation and facade of the c. 1904 main building (left to right). Looking northeast.

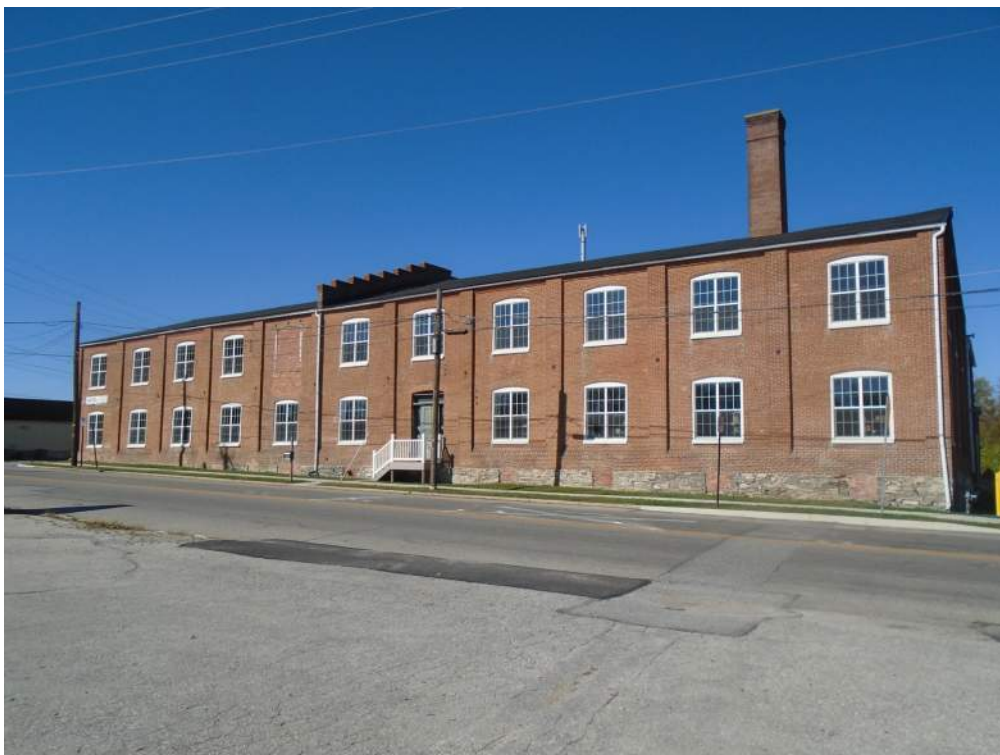
**Photograph 2:** The c. 1904 factory, showing the facade (south). Looking northwest.

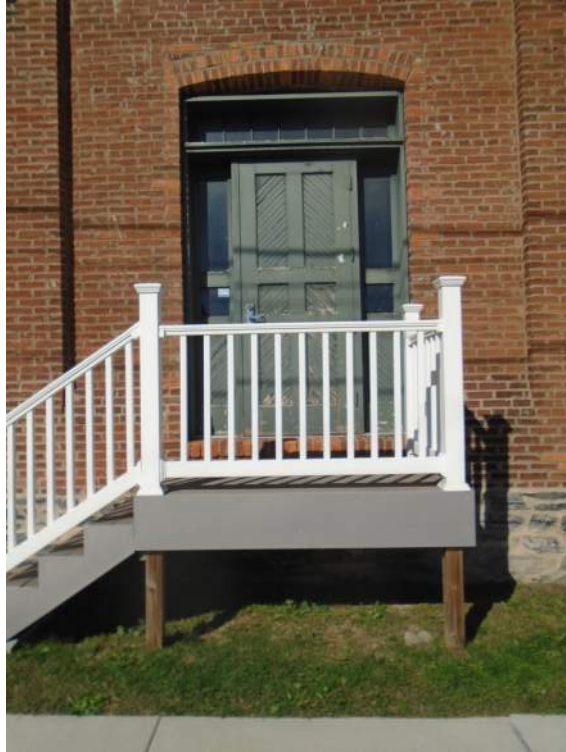
**Photograph 3:** Detail view of the c. 1904 factory facade, showing the historic, wood door and replacement steps and balusters. Looking north.

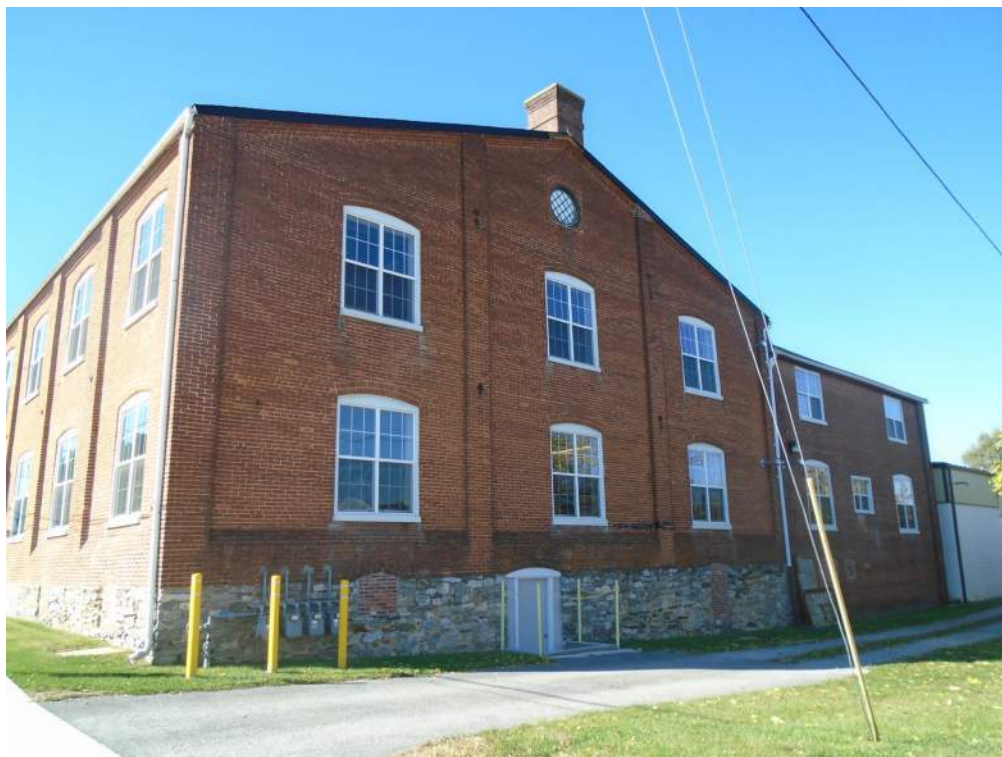
**Photograph 4:** The c. 1904 factory, showing the east elevation. The c. 1930s brick ell and post-1971 additions may be seen to the right. Looking northwest.

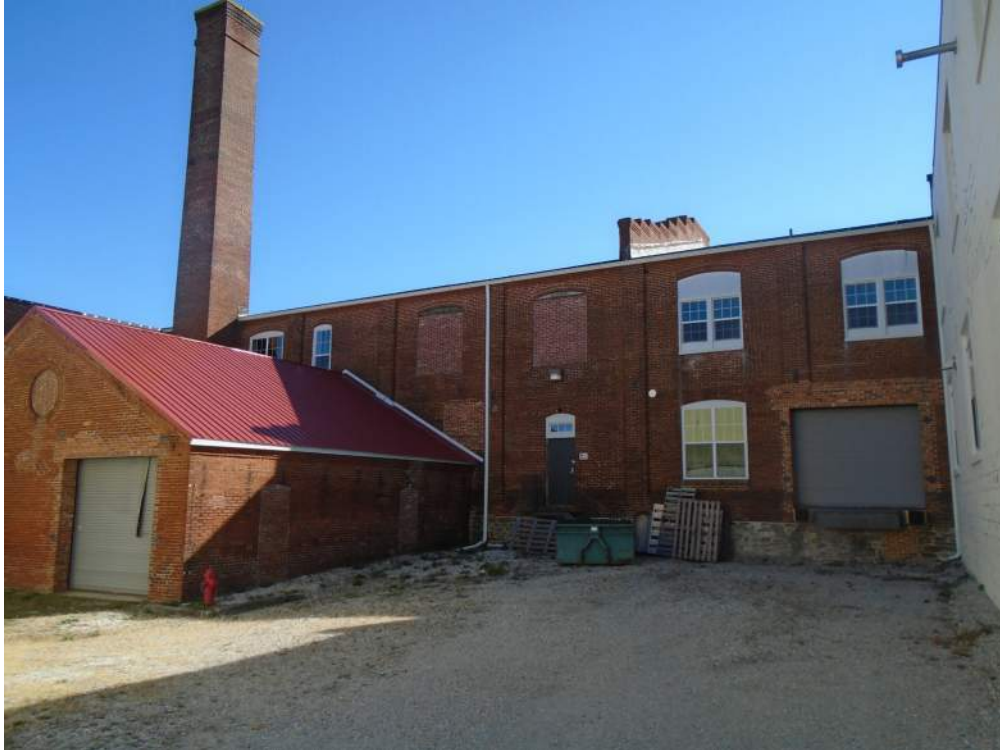
**Photograph 5:** The c. 1904 factory, showing the north elevation as well as the engine room ell and chimney. Looking southeast.

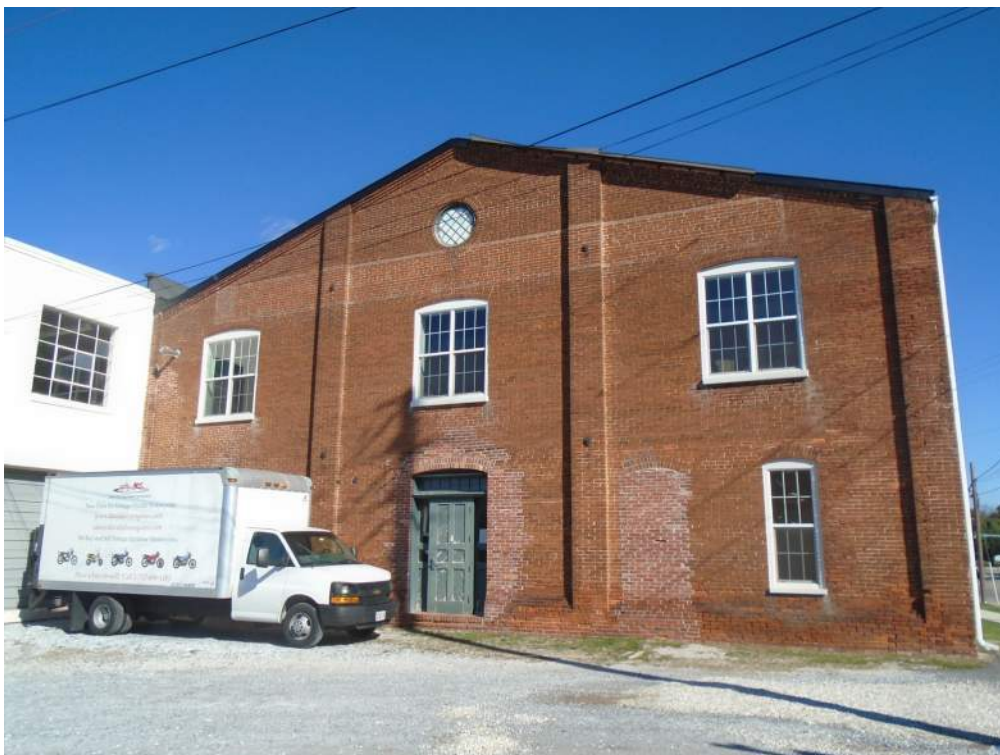
**Photograph 6:** The c. 1904 factory, showing the west elevation as well as the mid-twentieth century addition to the north. Looking east.

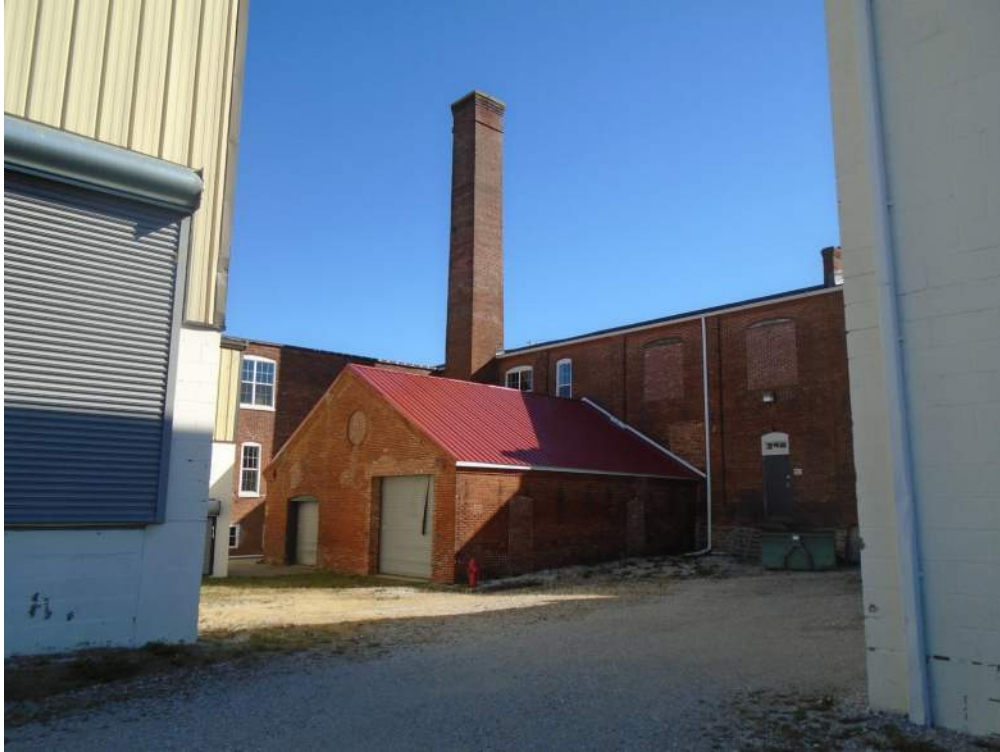
**Photograph 7:** The engine room ell, showing the north and west elevations. Looking southeast.

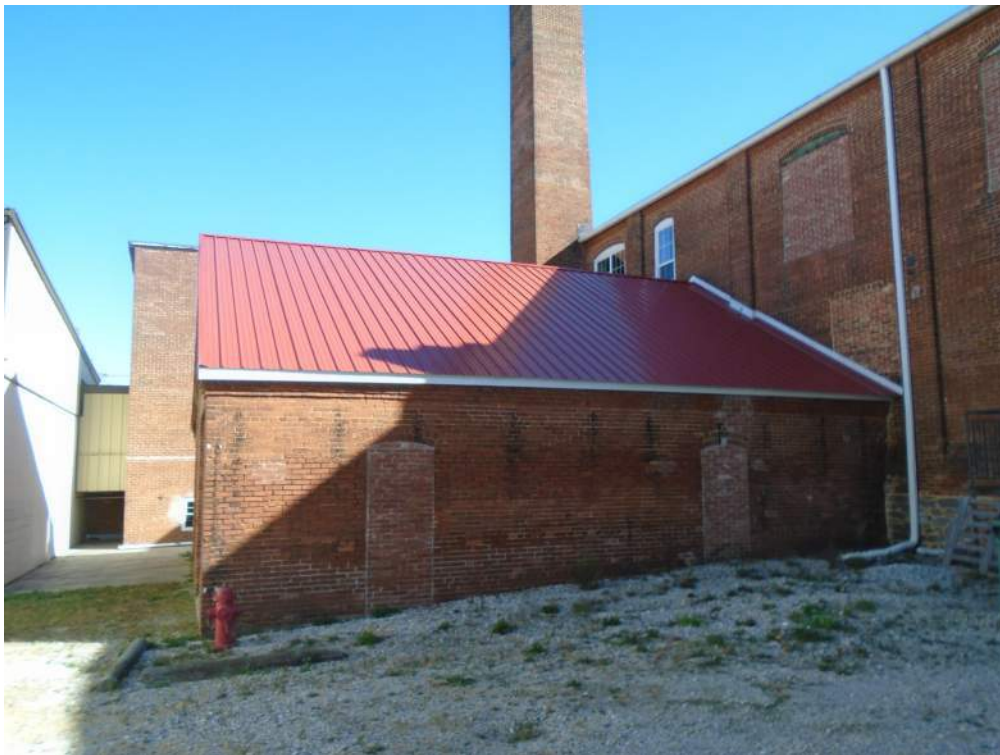
**Photograph 8:** The engine room ell, showing the west elevation. Looking east.
