# Historic Resource Survey Form

PENNSYLVANIA HISTORICAL AND MUSEUM COMMISSION  
Bureau for Historic Preservation

Key # \_\_001901, 001920, 001930\_\_\_\_\_  
 ER # \_\_2016-8477-001\_\_\_\_\_

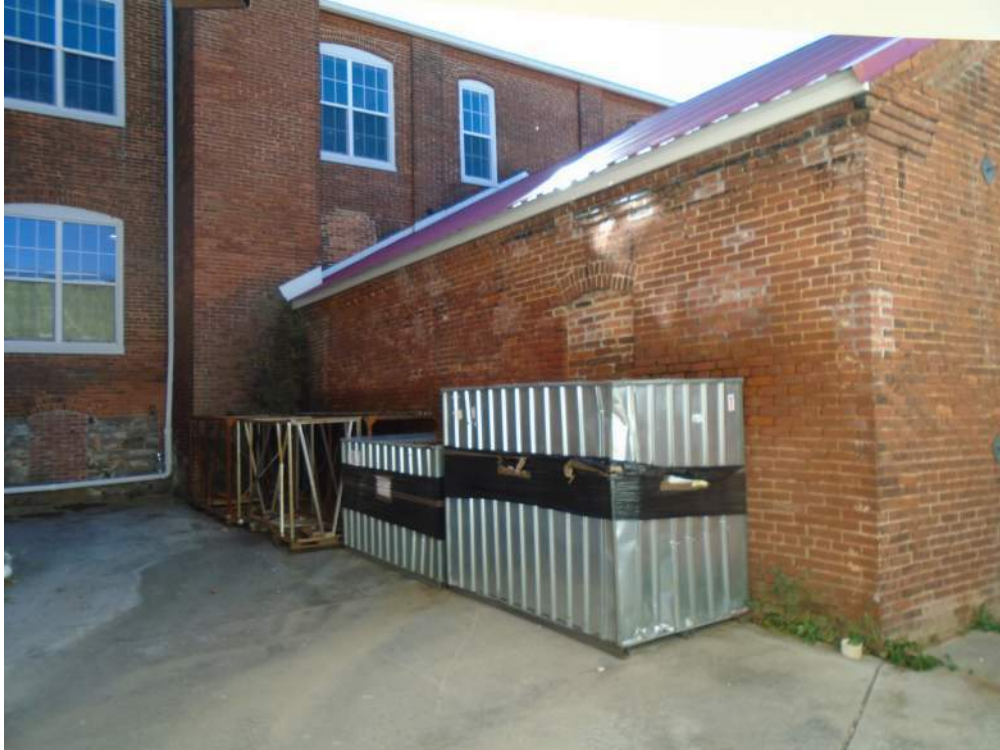
**Photograph 9:** The engine room ell, showing the east elevation and the first bay of the main building's south elevation at left. Looking southwest.

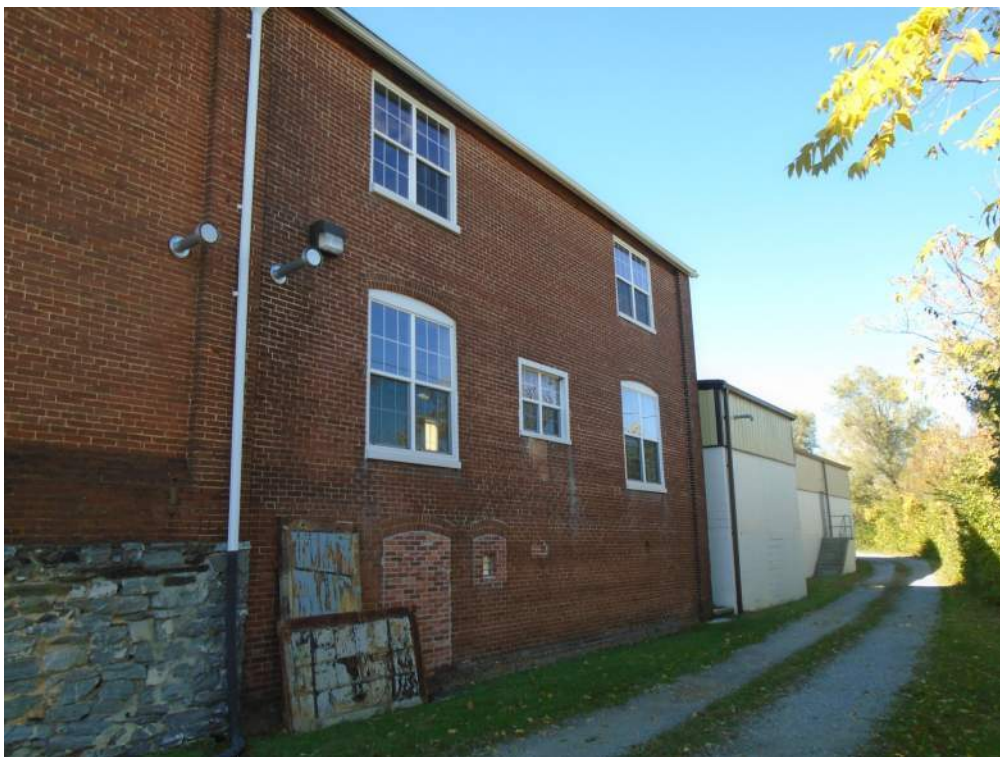
**Photograph 10:** The c. 1930s ell, showing the east elevation. Looking north.

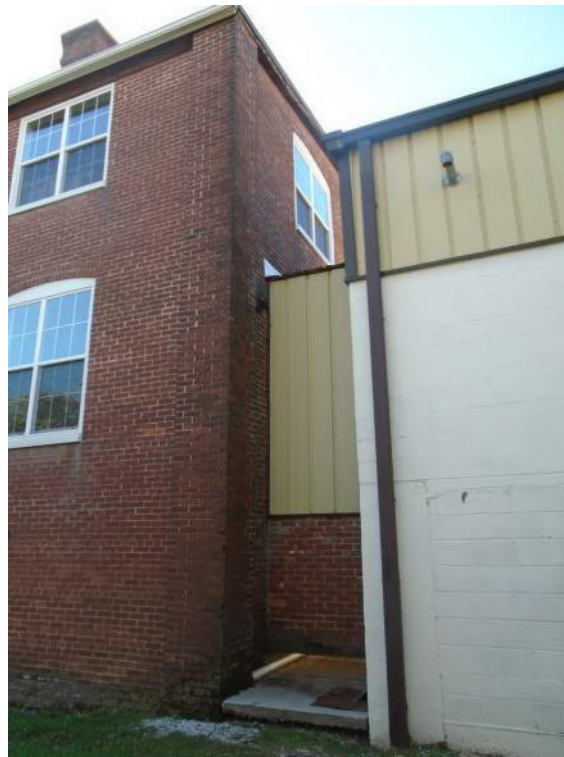
**Photograph 11:** The c. 1930s ell, showing the north elevation and connection to the post-1971 additions at right. Looking southwest.

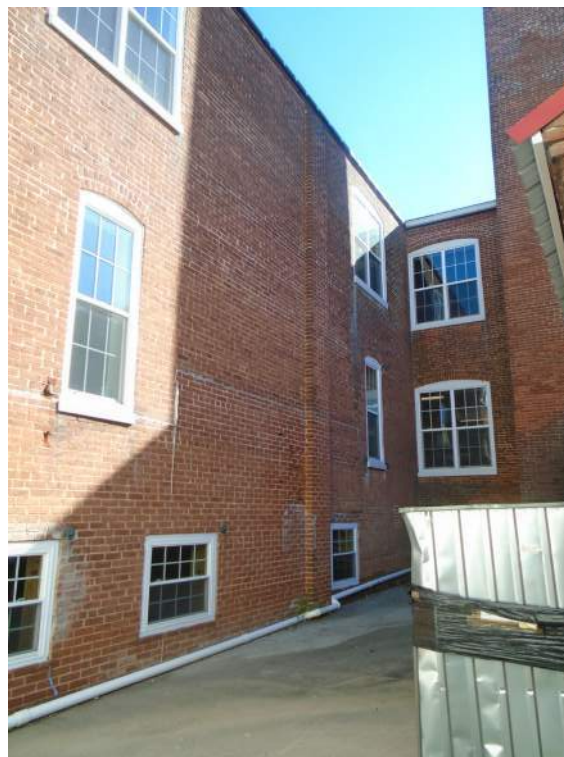
**Photograph 12:** The c. 1930s ell, showing the west elevation as well as the south elevation of the c. 1904 main building to the right. Looking south.

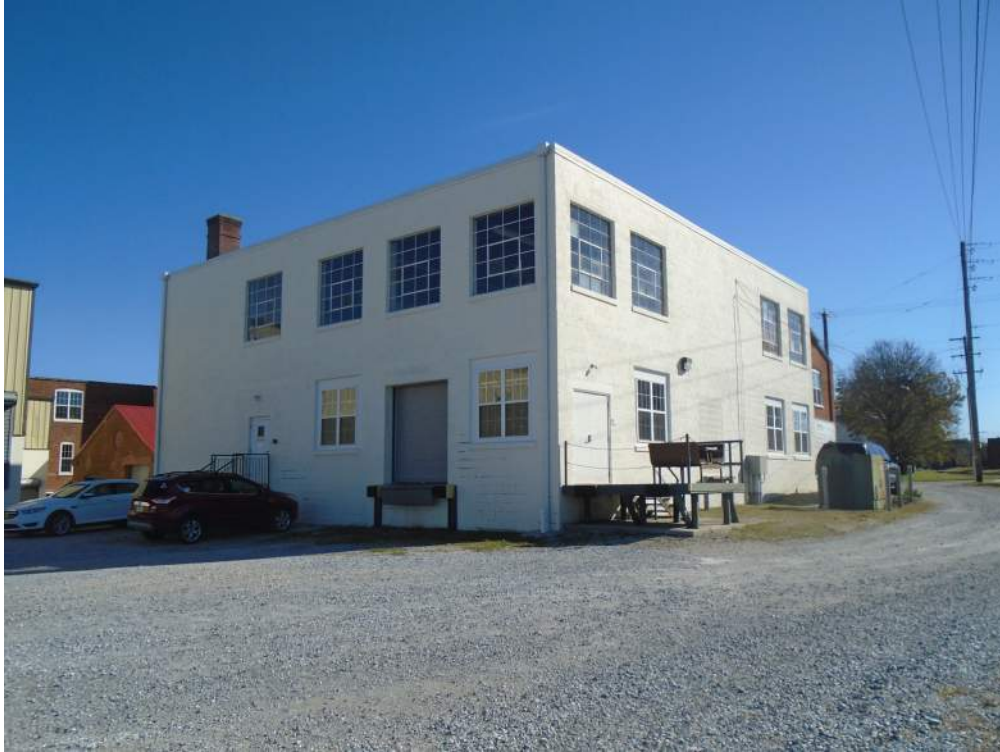
**Photograph 13:** The mid-twentieth century, CMU addition, showing the north and west elevations. Looking southeast.

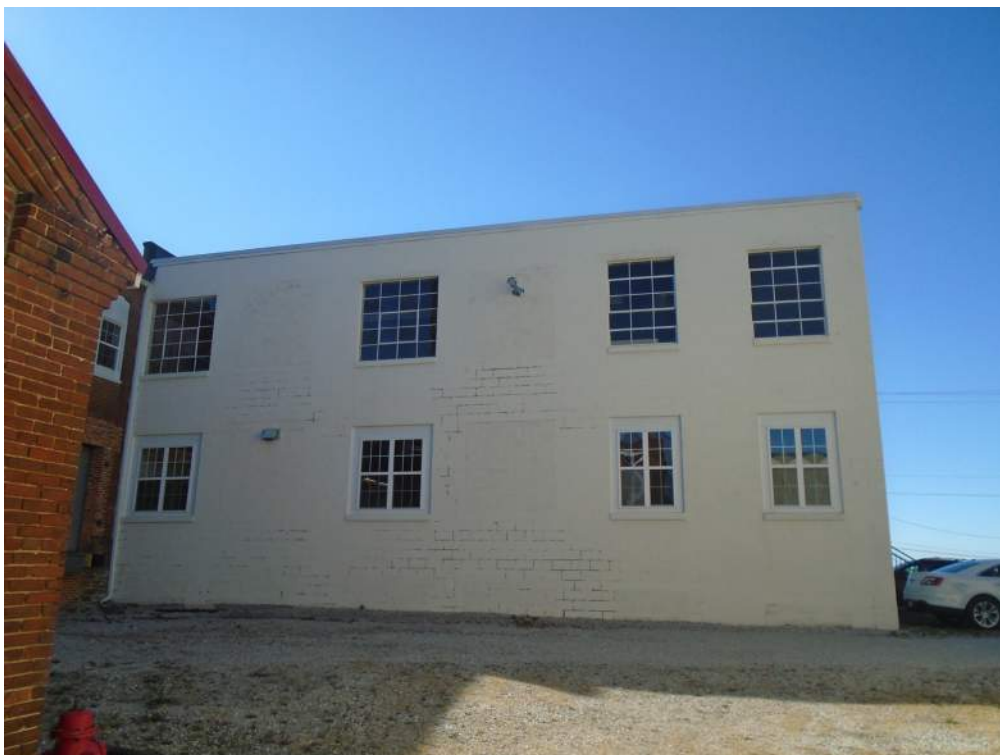
**Photograph 14:** The mid-twentieth century, CMU addition, showing the east elevations. Looking west.

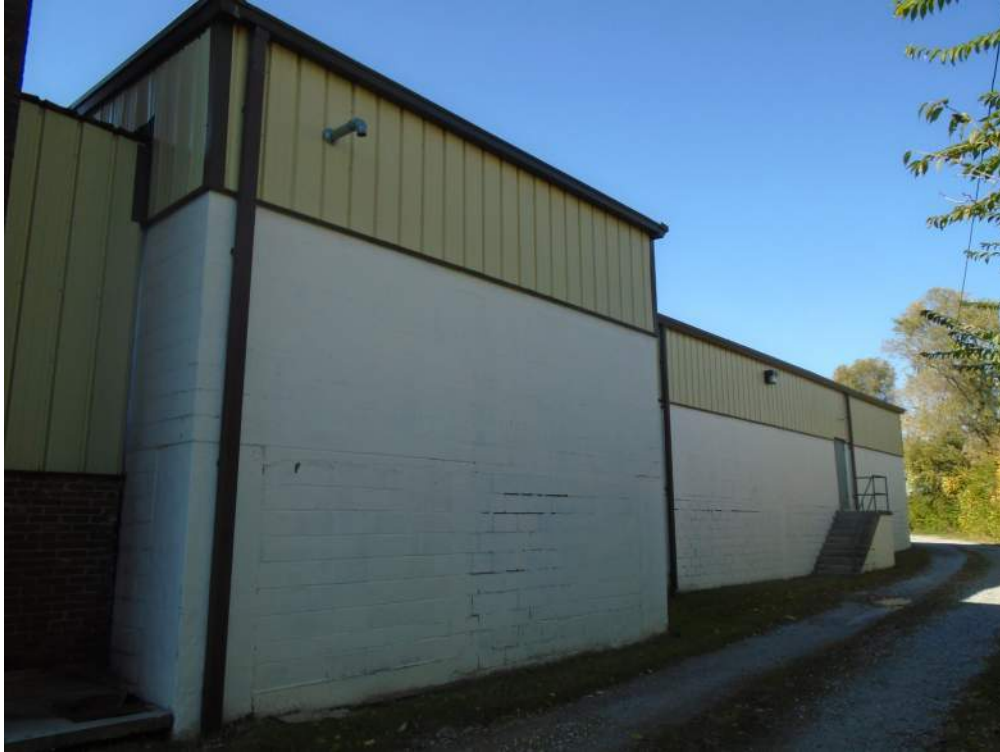
**Photograph 15:** The post-1971, storage addition, showing the east elevation of the southernmost section and central wing. Looking north.

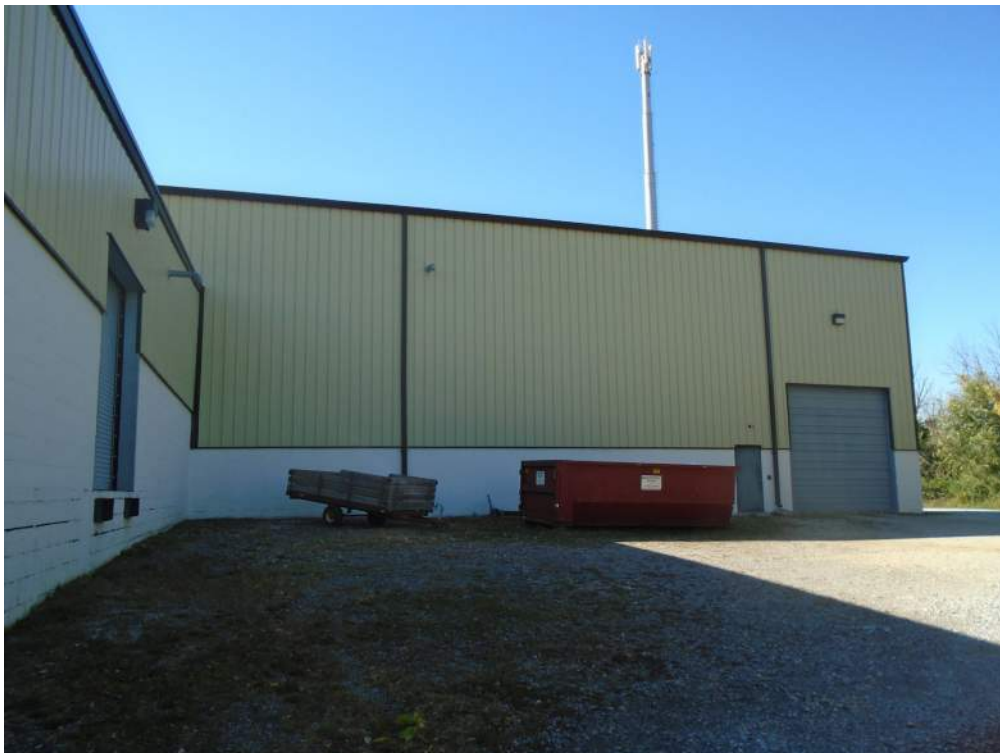
**Photograph 16:** The post-1971, storage addition, showing the east elevation of the western-most section. Looking west.

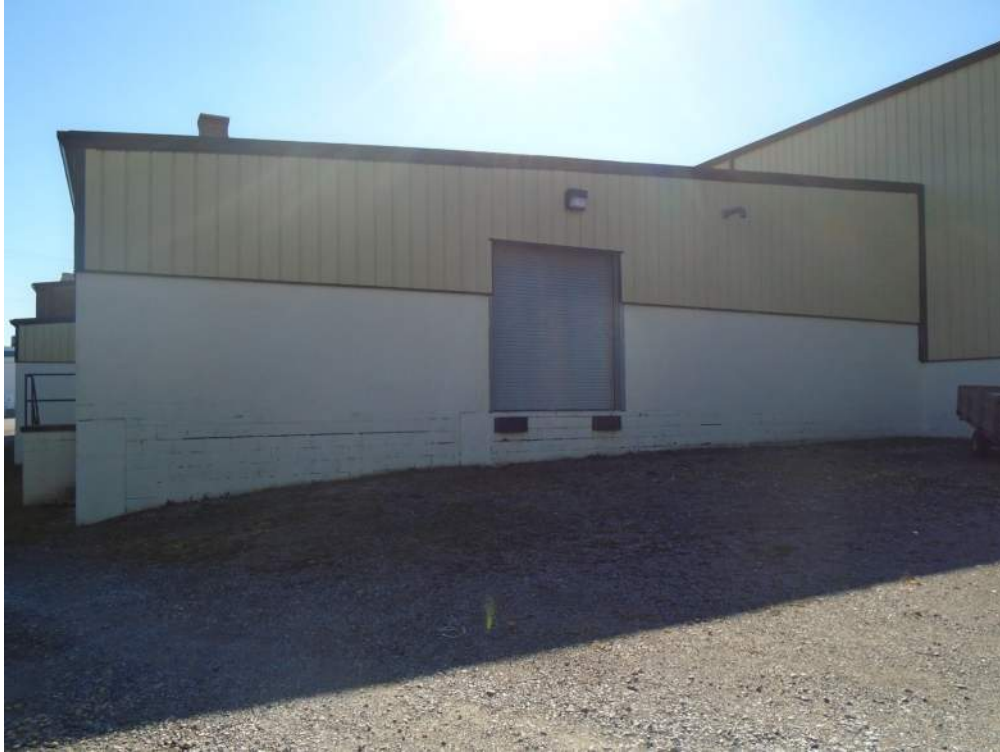
**Photograph 17:** The post-1971, storage addition, showing the north elevation of the central section. Looking south.

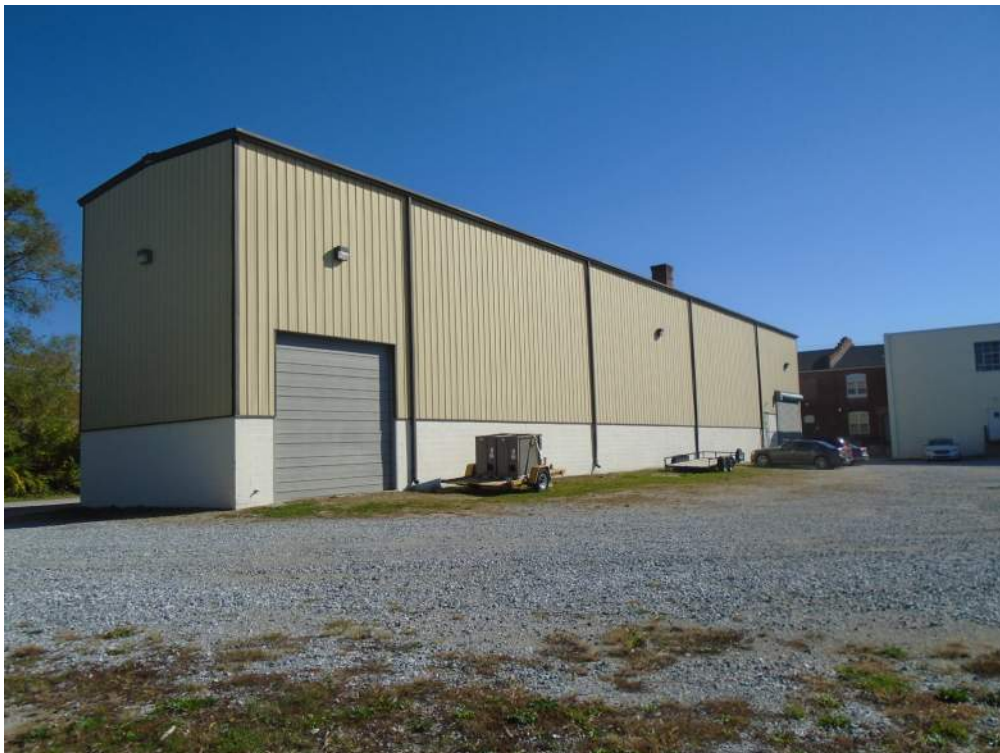
**Photograph 18:** The post-1971, storage addition, showing the north and west elevations of the westernmost section. Looking southeast.

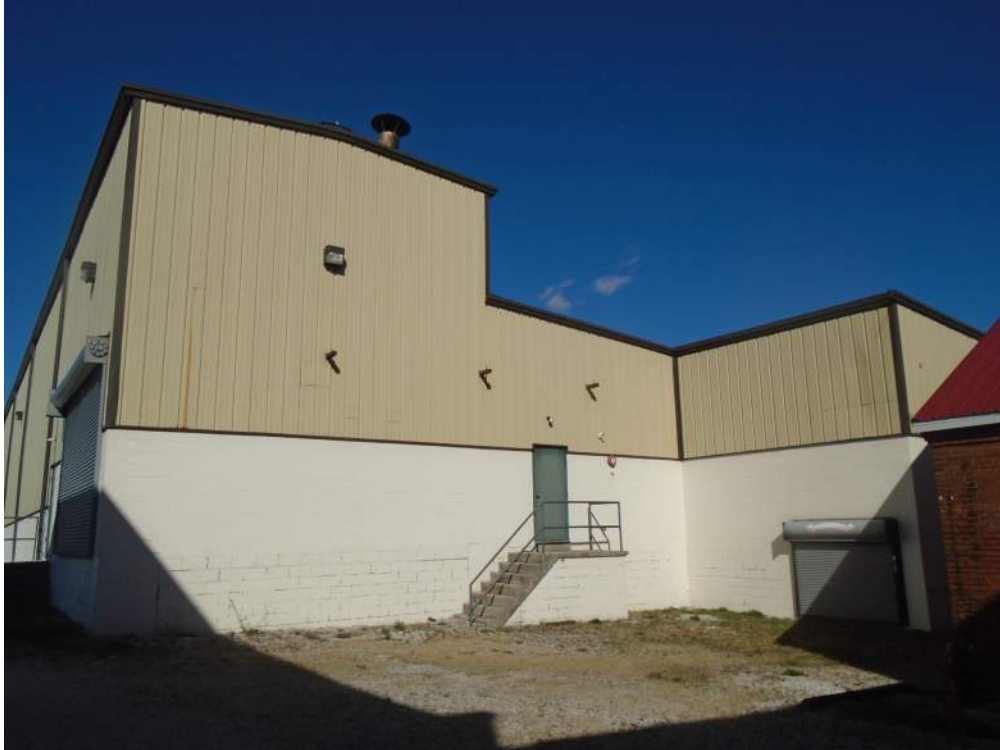
**Photograph 19:** The post-1971, storage addition, showing the south elevation of the west section, central wing and east or southernmost section. Looking northeast.

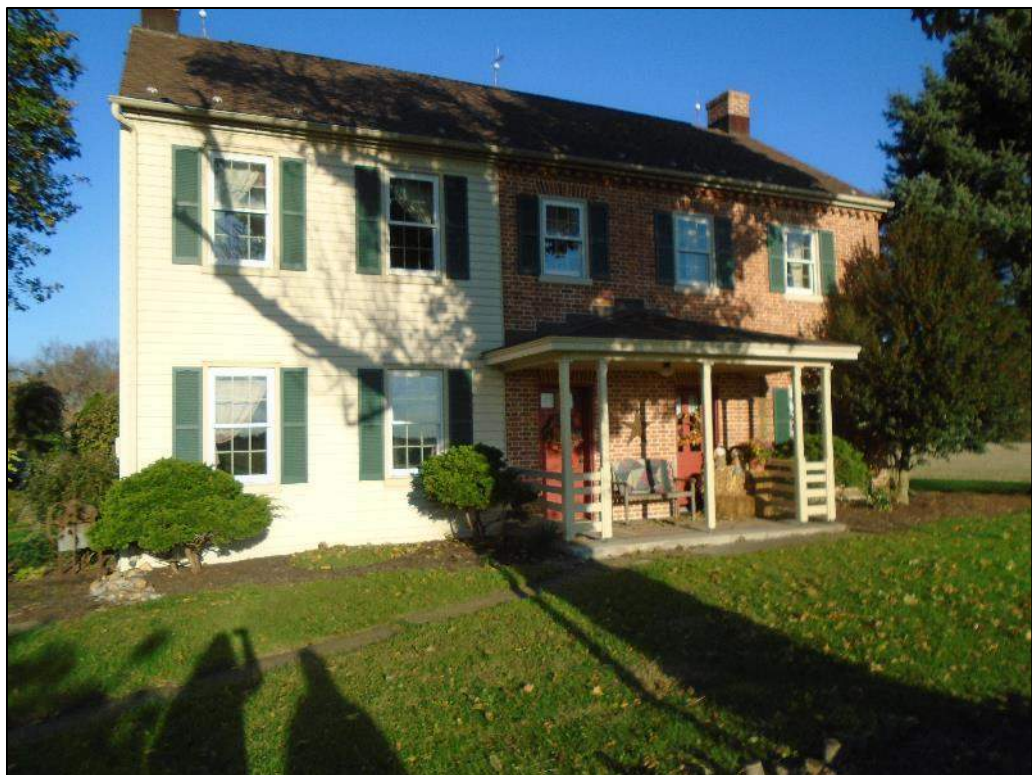
Photograph 1 – Façade (east elevation) of the dwelling; looking northwest.

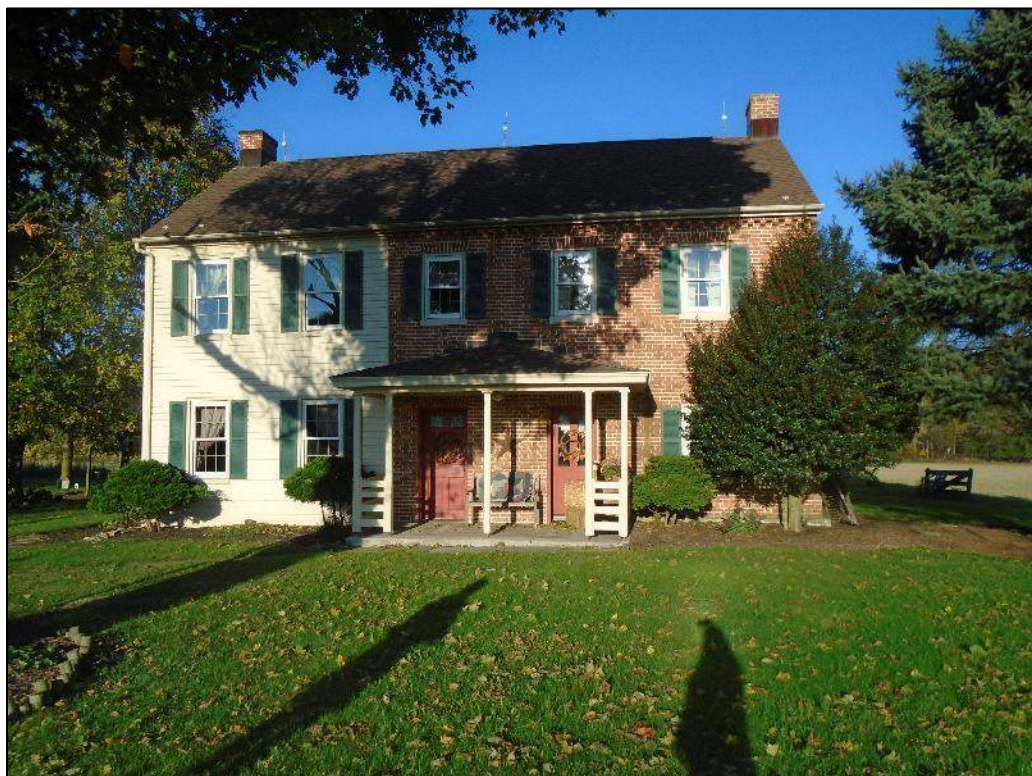
Photograph 2 – Façade (east elevation) of the dwelling; looking west.

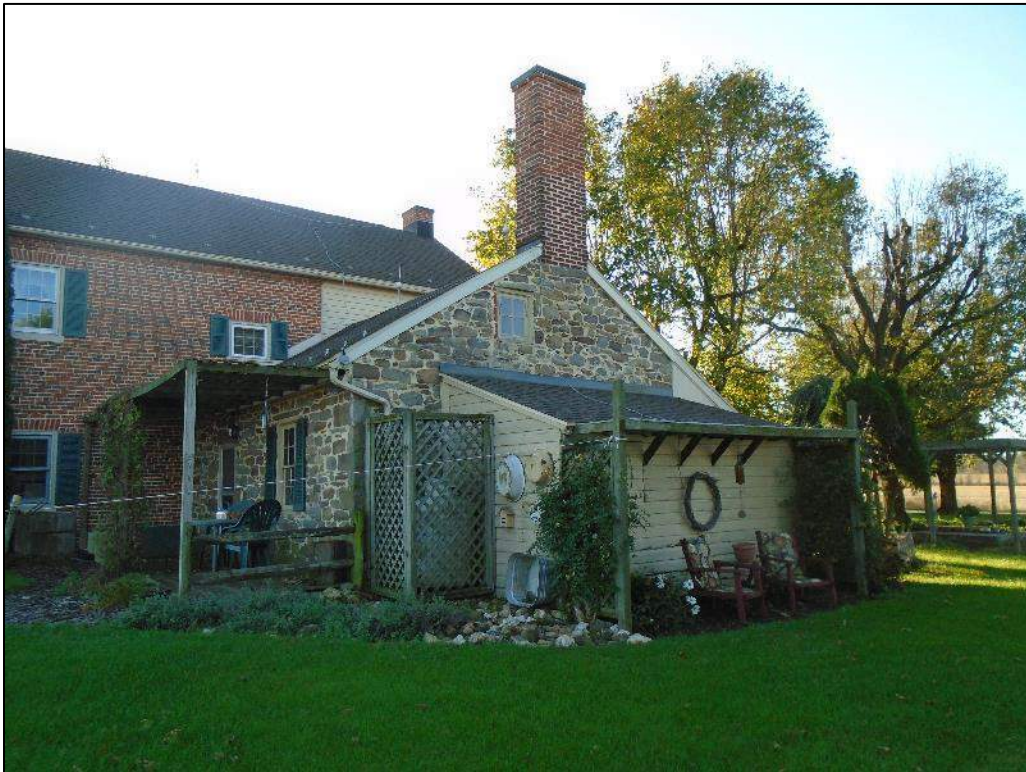
Photograph 3 – Side (north elevation) of the dwelling; looking south.

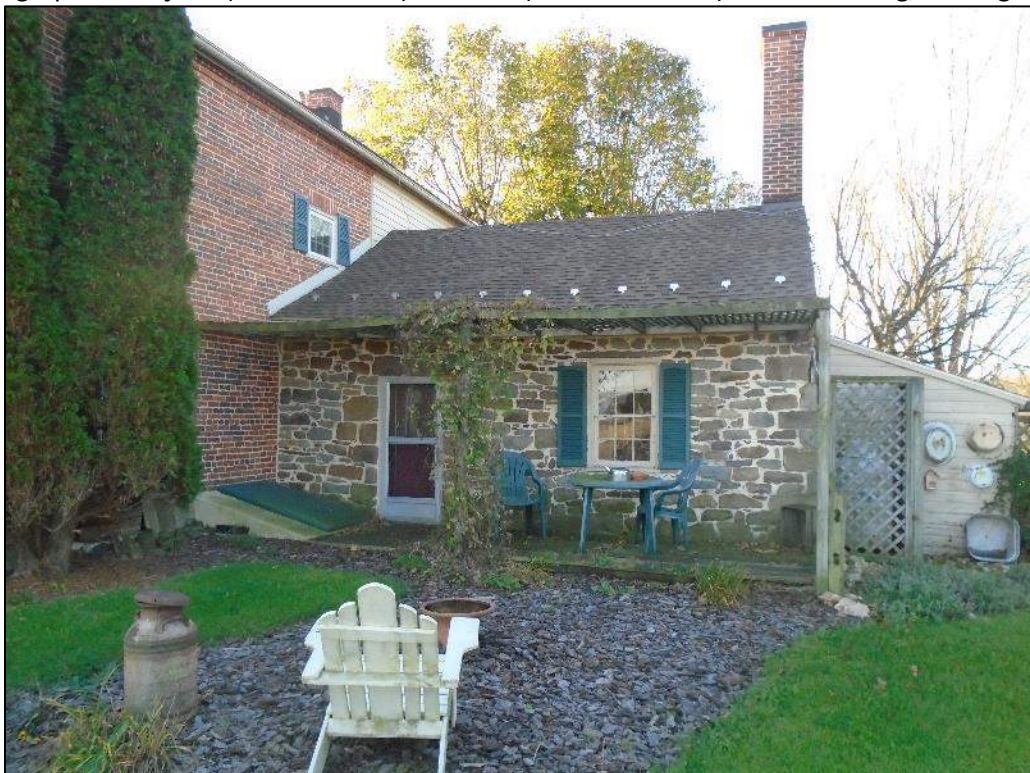
Photograph 5 – Façade (east elevation) and side (south elevation) of the dwelling; looking north.

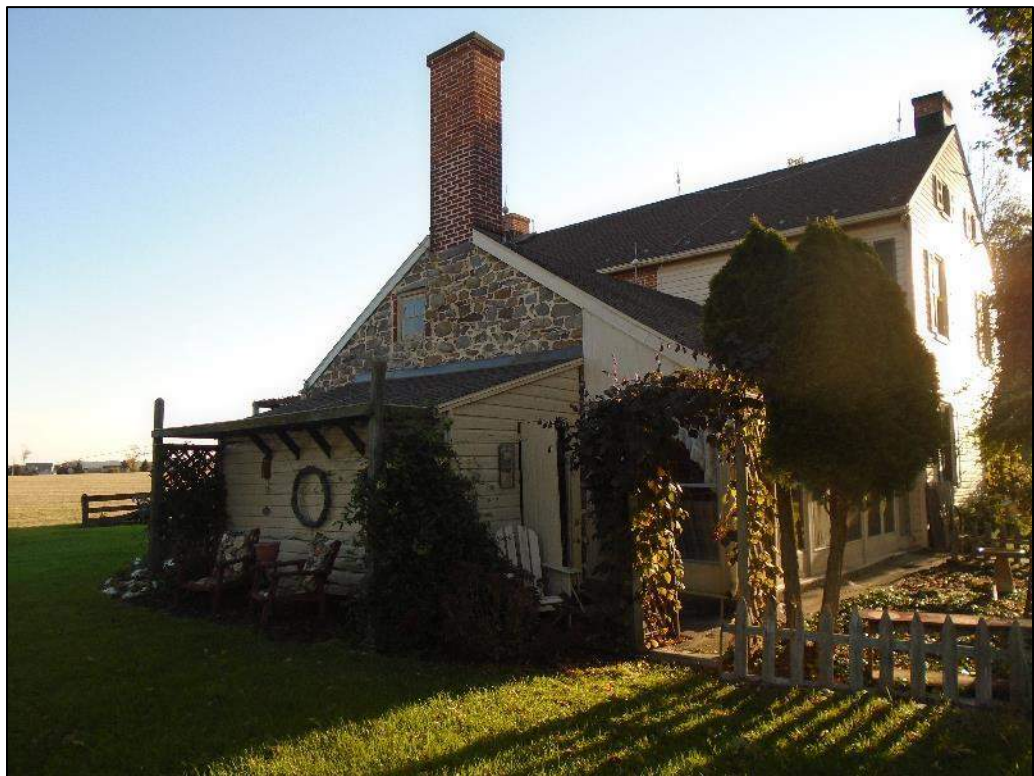
Photograph 6 – Side (north elevation) of the summer kitchen and rear (west elevation) of the dwelling; looking south.

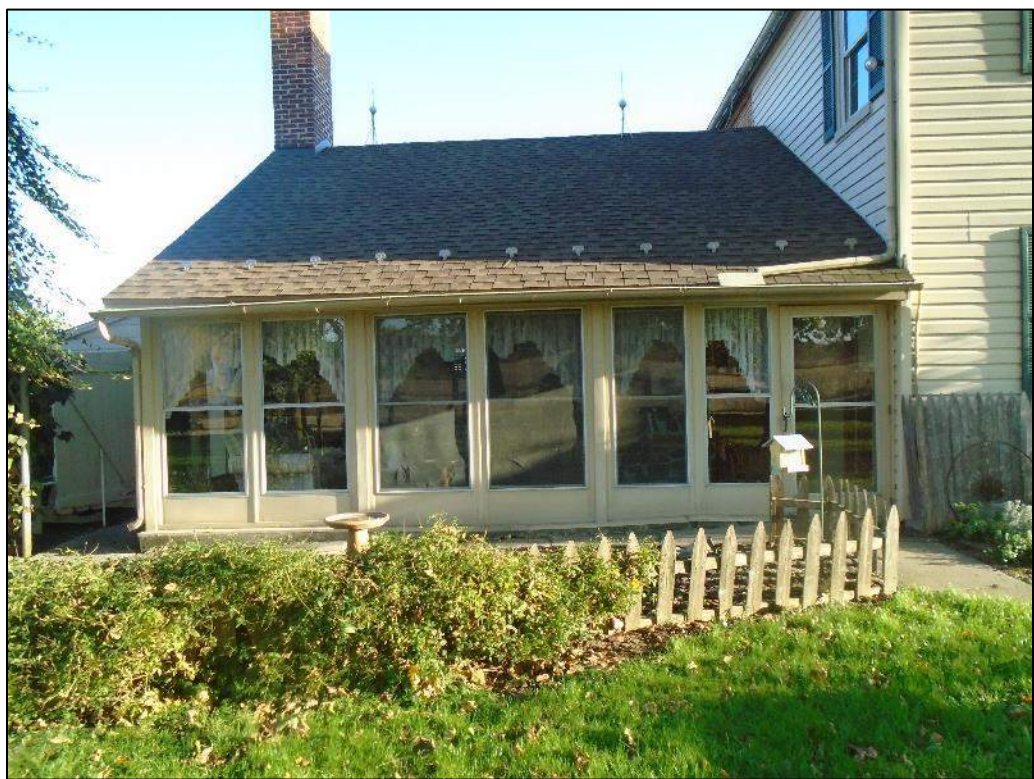
Photograph 7 – Rear (west elevation) of the summer kitchen; looking east.

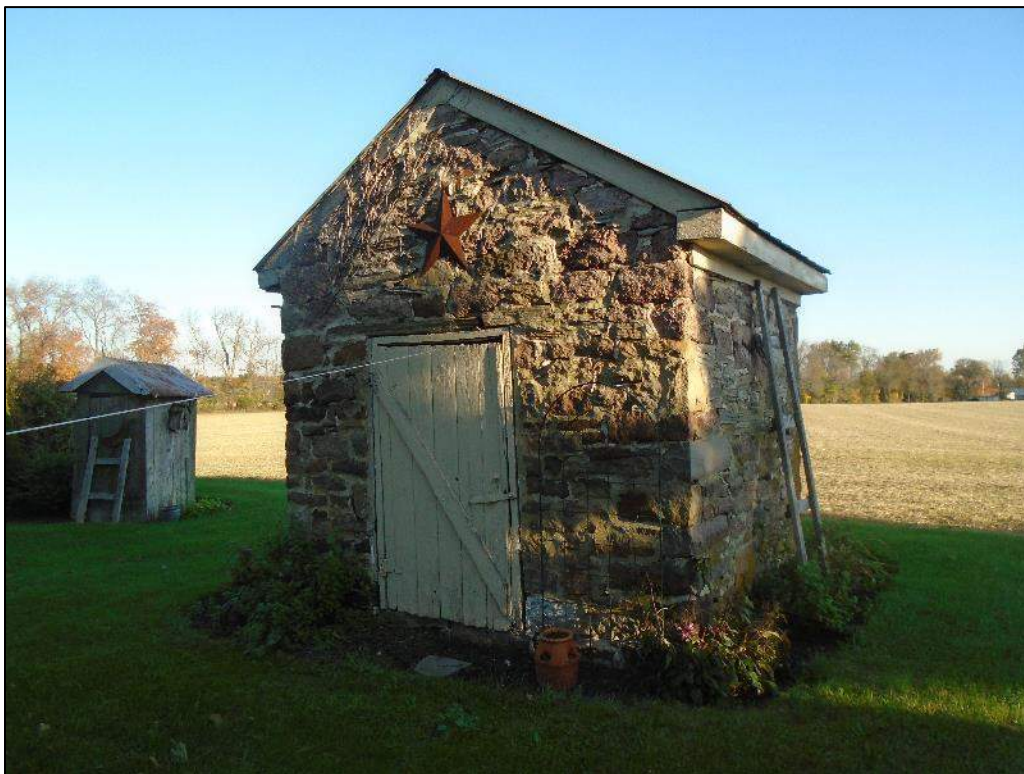
Photograph 8 – Side (south elevation) of the summer kitchen; looking north.

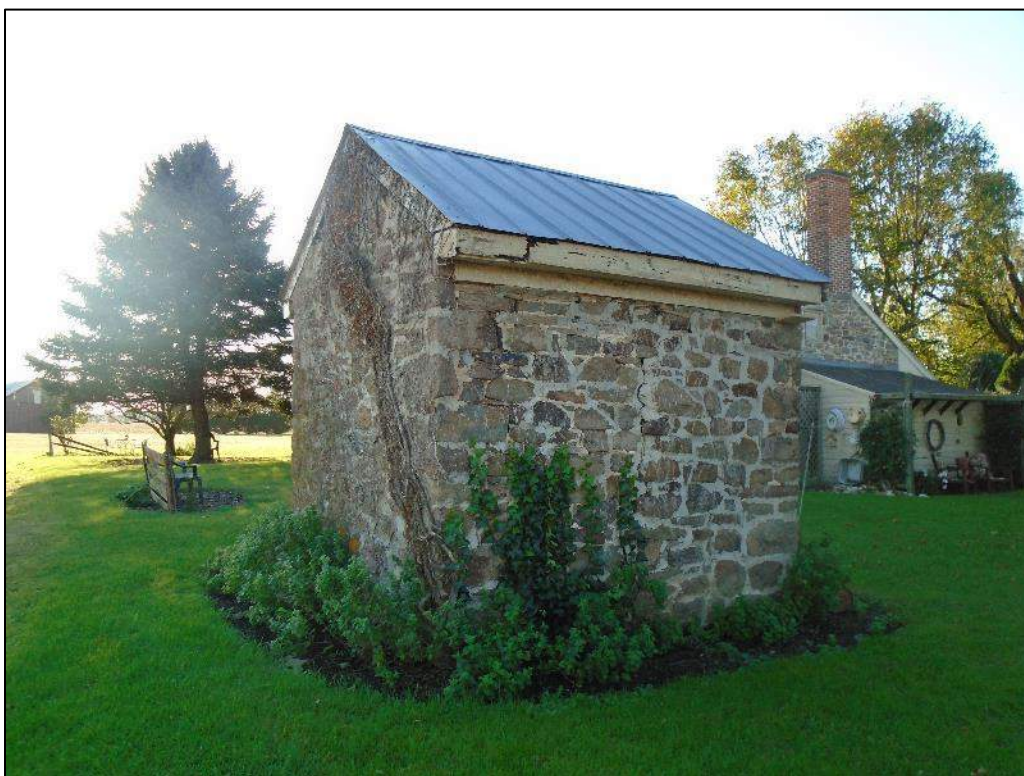
Photograph 9 – Front (south elevation) and side (east elevation) of the smokehouse; looking north.

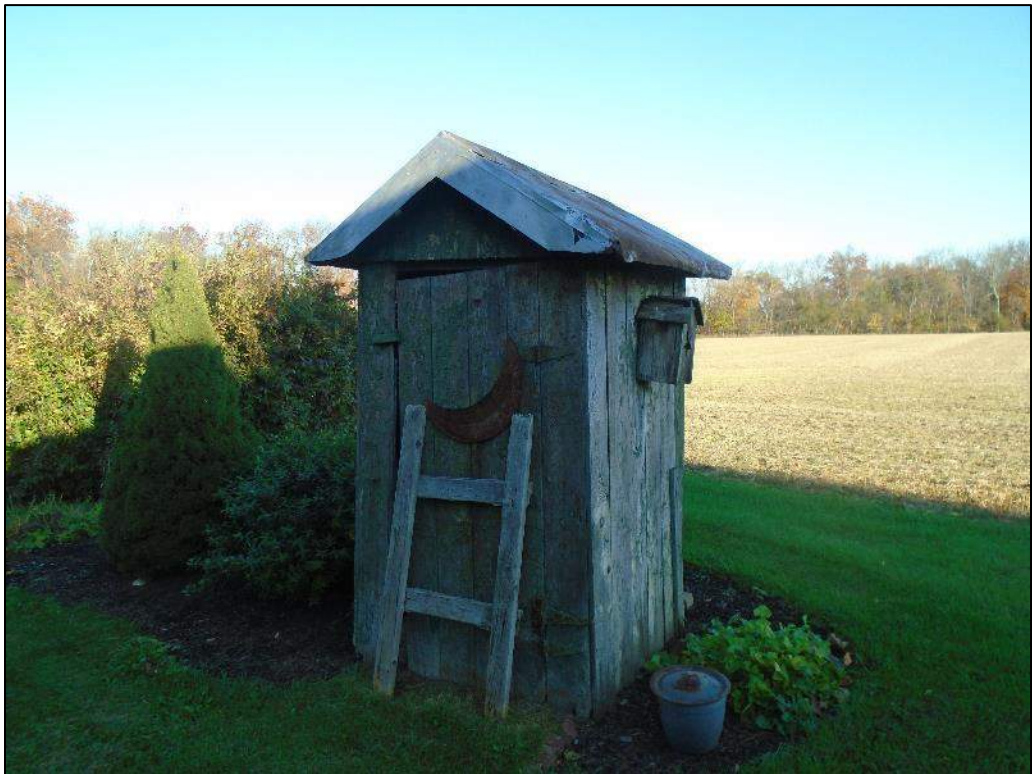
Photograph 12 – Rear (north elevation) of the privy; looking south.

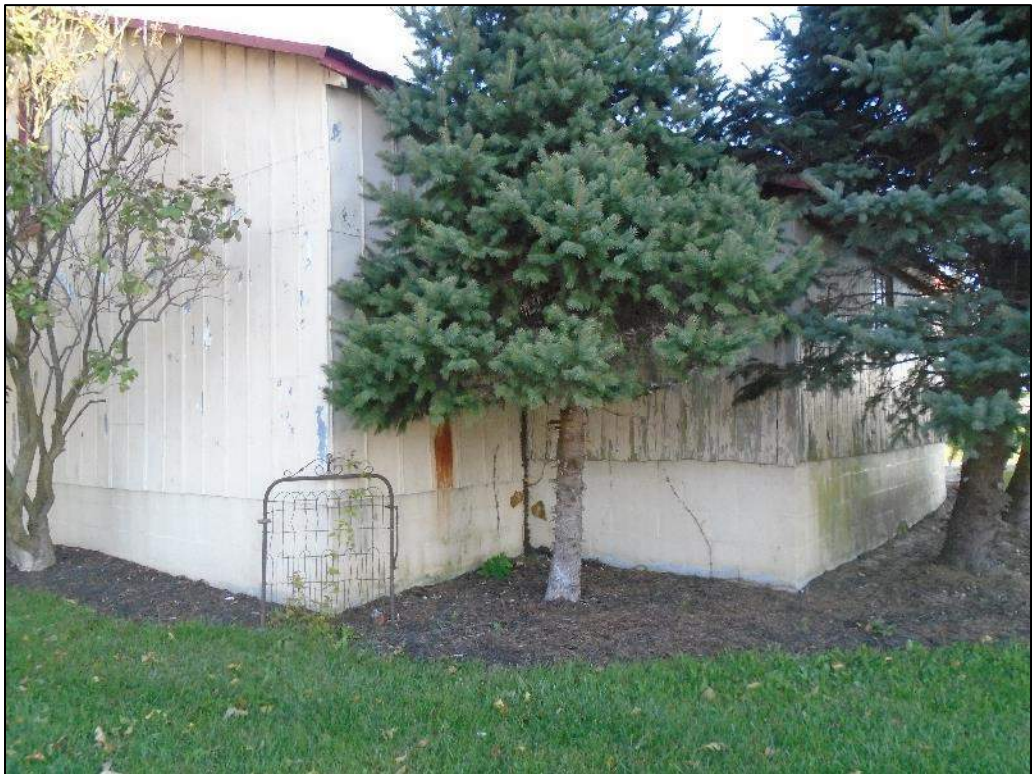
Photograph 14 – Façade (northeast elevation) of the machine shed; looking southwest.

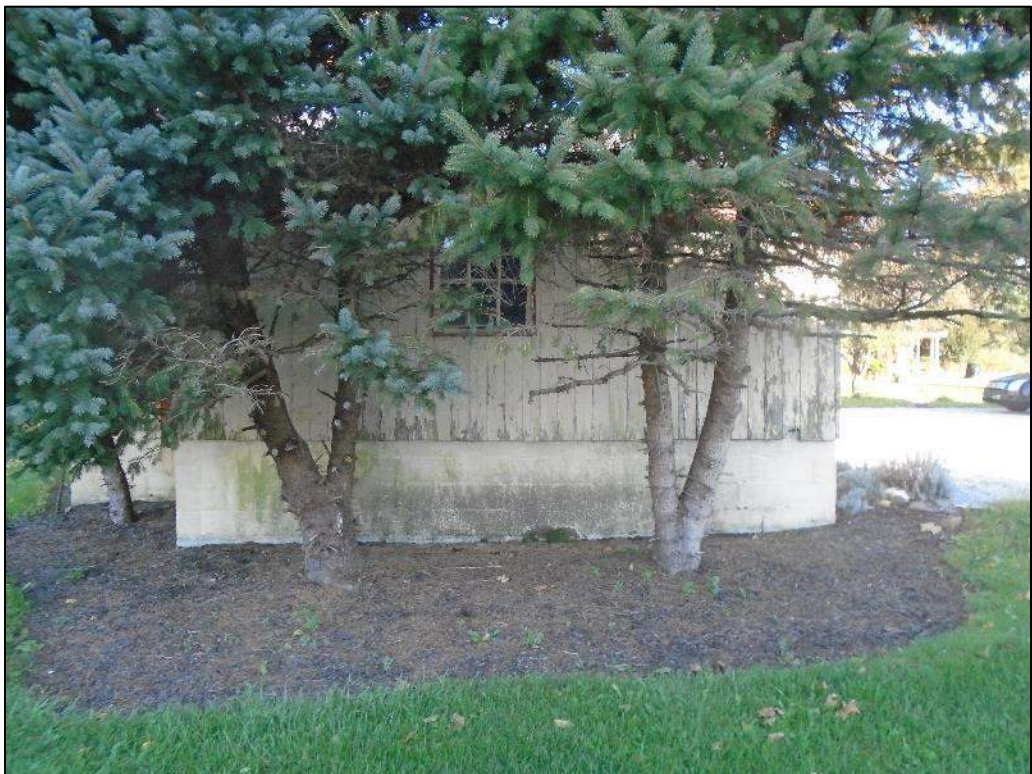
Photograph 15 – Rear (southwest elevation), side (southeast elevation) and rear (southwest elevation) of the machine shed and addition; looking north.

A ca. 1950 machine shed is located approximately 70 feet south of the dwelling. It is five bays wide, two bays deep, and one-and-a-half stories tall. The walls and front gable roof are covered in standing seam metal, and the foundation is made of CMU. The main (northeast) elevation has four pairs of vehicle-sized, hinged, wood, double doors and a single wood board pedestrian door in the southern bay. The walls of this southern bay are clad in wood panel instead of metal. Centered within the gable is a small, wood panel, hinged door (Photograph 14). The northwest side elevation does not contain any fenestration. The rear (southwest) elevation has a centered, asymmetrical, two-bay extension with wood panel walls and a six-over-six, double-hung, wood window centered in the gable (Photographs 15). The southeast side elevation has a single, centered, six-pane, wood window (Photograph 16).

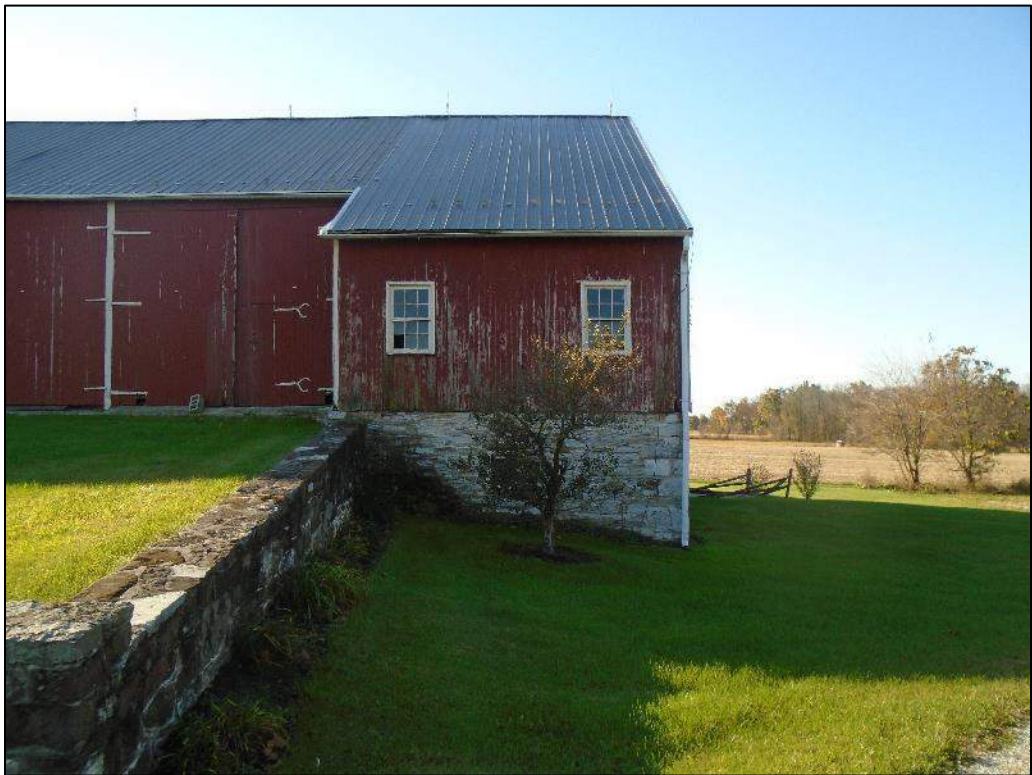
Photograph 17 – Banked (north) elevation and side (east elevation) of the barn; looking southwest.

elevation. The east and west bays of the barn, which are not recessed, each have an exposed stone foundation and two evenly spaced, six-over-six, wood windows. Stone retaining walls line the sides of the banked incline (Photograph 18).

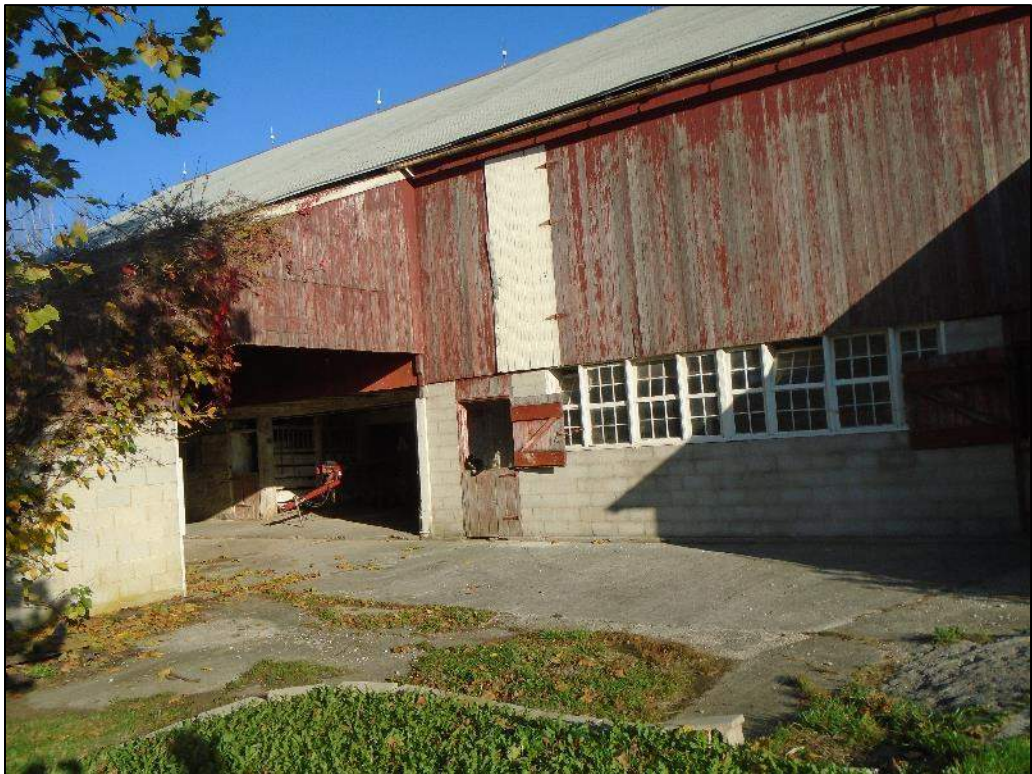
Photograph 20 – Side (west elevation) of the barn and addition and rear (south elevation) of the addition; looking east.

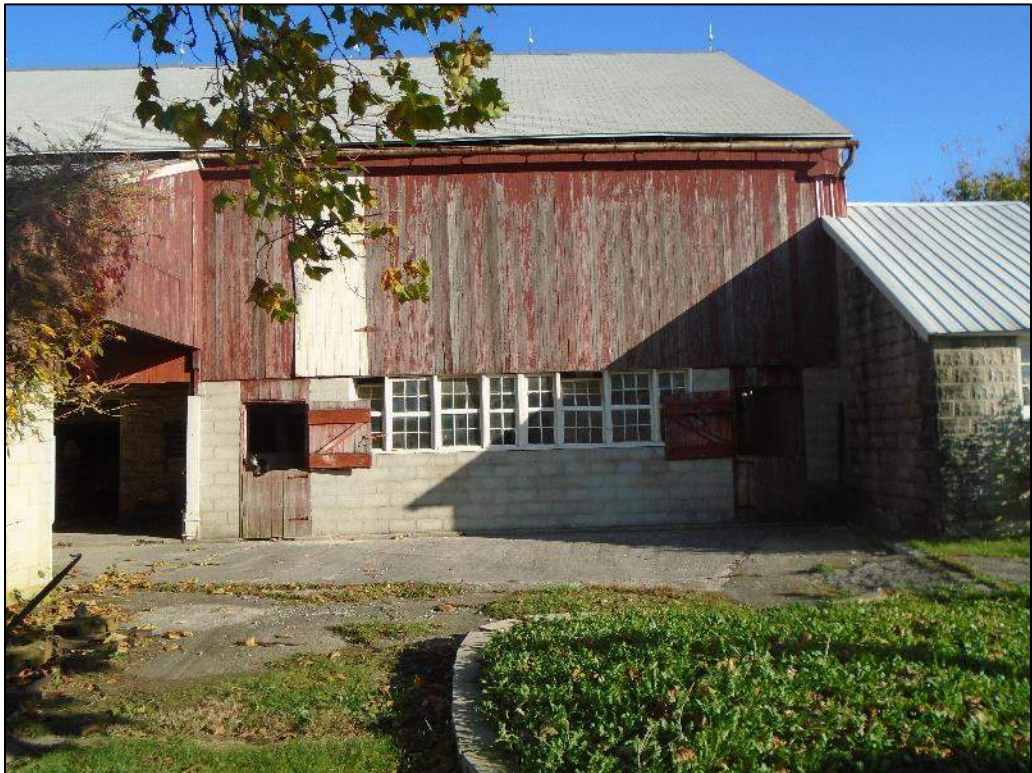
Photograph 21 – Rear (south elevation) of the barn and side (east elevation) of the addition; looking northwest.

The original forebay on the rear, south elevation has been enclosed. The five western bays have been enclosed with the addition mentioned above (Photograph 20). The south elevation of the addition has five evenly spaced, two-pane, metal windows. The east elevation has a wide, vehicle entrance directly adjacent to the barn (Photograph 21). The remainder of the forebay has been enclosed with CMU that sits flush with the original wood walls of the upper portion of the barn. A ribbon of eight, four-over-four and six-over-six, wood windows is centered on the CMU wall and flanked on both sides by a wood Dutch door (Photograph 22).

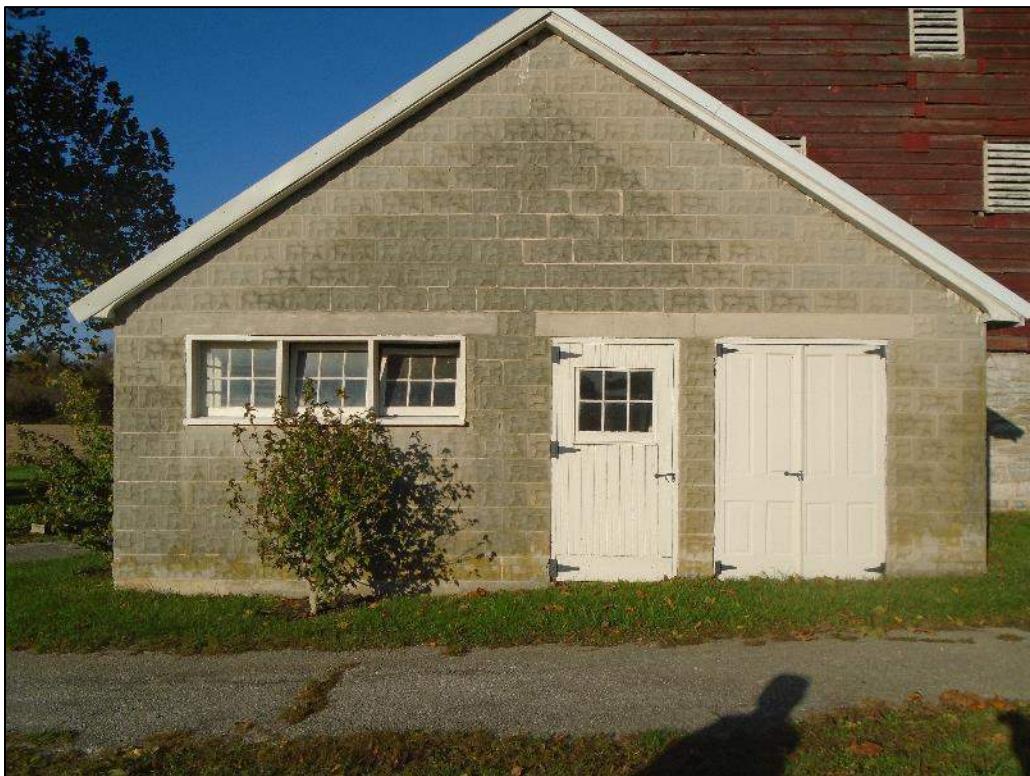
Photograph 22 – Rear (south elevation) of the barn with milk house and addition; looking north.

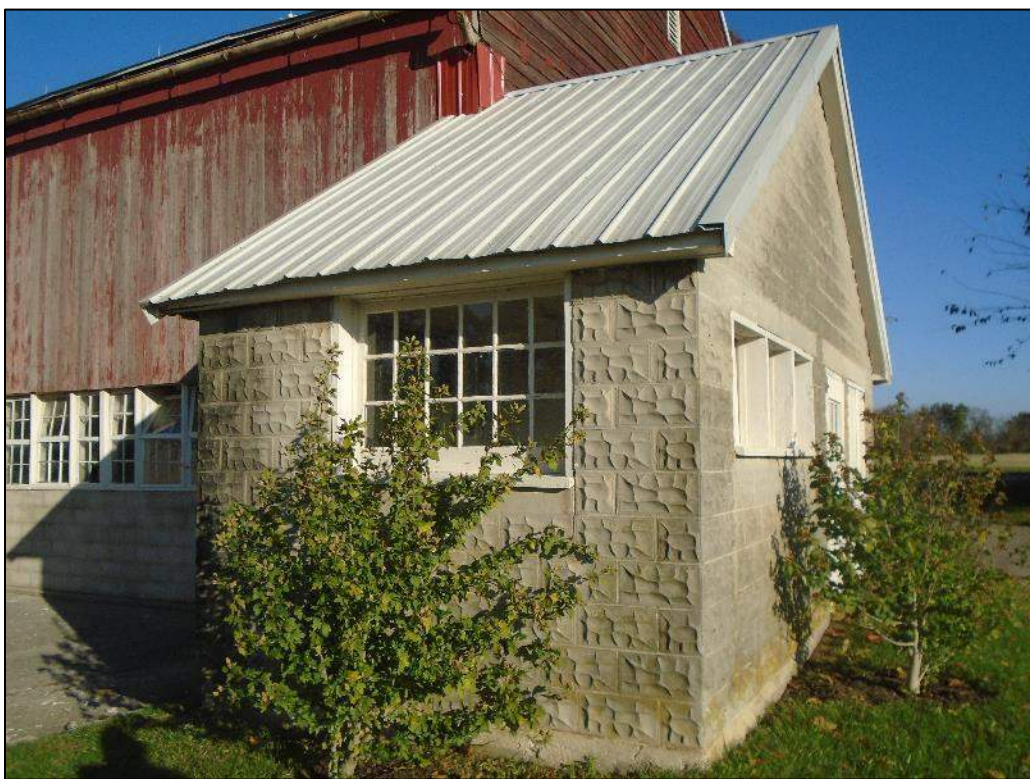
Photograph 23 – Front (east elevation) of the milk house addition; looking west.

A two-bay-wide, one-bay-deep, ca. 1950 milkhouse was added to the southeast corner of the barn. It encompasses the southern bay of the barn's west side elevation and is set forward from the rest of the elevation. It was constructed of textured CMU and has a front gable, standing seam roof. The east, front-gable elevation has a ribbon of three six-light, wood, hopper windows within the southern bay. The northern bay contains a half-light, six-pane, wood door on the southern side of the bay, and a pair of four-panel wood doors on the northern side of the bay (Photograph 23). The south side elevation of the milk house has a fifteen-light, wood, hopper window. The north side elevation has a pair of six-light, wood, hopper windows (Photograph 24).

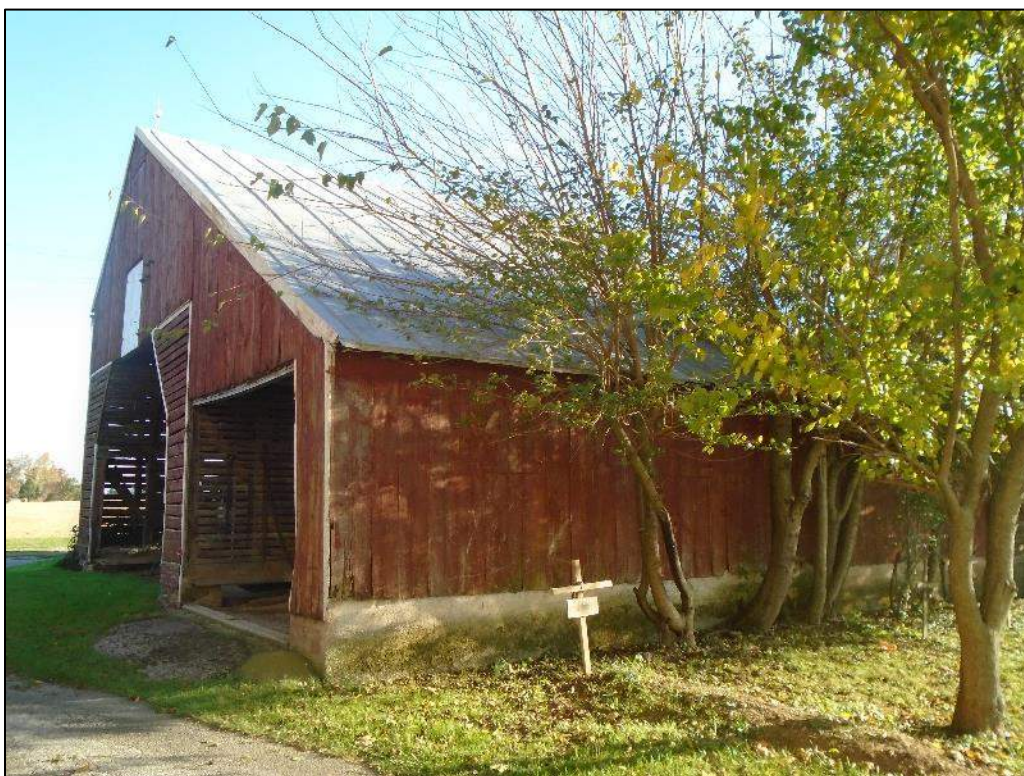
Photograph 26 – Front (west elevation) and side (south elevation) of the drive thru corn crib; looking northeast.
