# Historic Resource Survey Form

PENNSYLVANIA HISTORICAL AND MUSEUM COMMISSION  
Bureau for Historic Preservation

Key # \_\_001901, 001920, 001930\_\_\_\_\_  
 ER # \_\_2016-8477-001\_\_\_\_\_

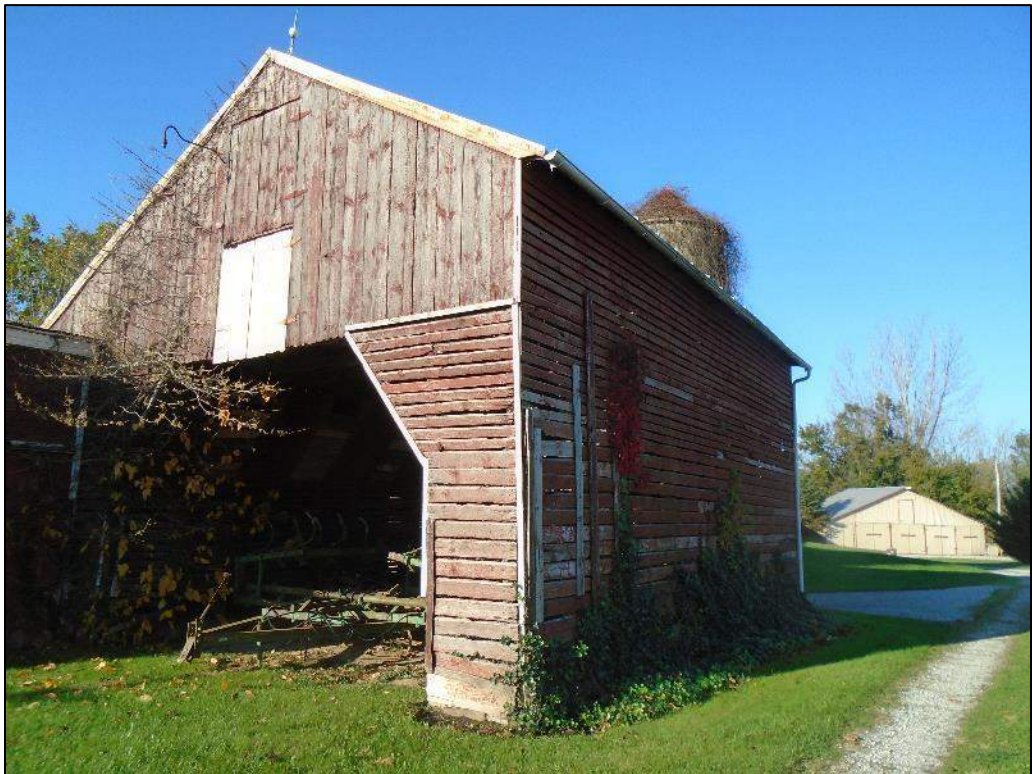
Photograph 27 – Side (north elevation) and rear (east elevation) of the drive thru corn crib; looking southwest.

The ca. 1935 drive thru corn crib building is situated approximately 15 feet east of the barn. The corn crib section is two stories tall and measures approximately 26 feet wide and 36 feet long. A one-story, 15-foot-wide, machine shed addition was constructed along the south elevation and runs the length of the corn crib section, an additional 15-foot by 15-foot shed roof storage addition was added to the east elevation. Both the corn crib and machine shed have a drive-through bay. The corn crib section has a standing seam metal, front gable roof, walls are clad in horizontal wood board, and it has a parged concrete foundation (Photograph 26). The machine shed has a standing seam metal shed roof, walls clad in vertical wood boards, and a concrete foundation. The gable ends of the corn crib have single centered, hinged, wood doors (Photographs 27 and 28). The north elevation of

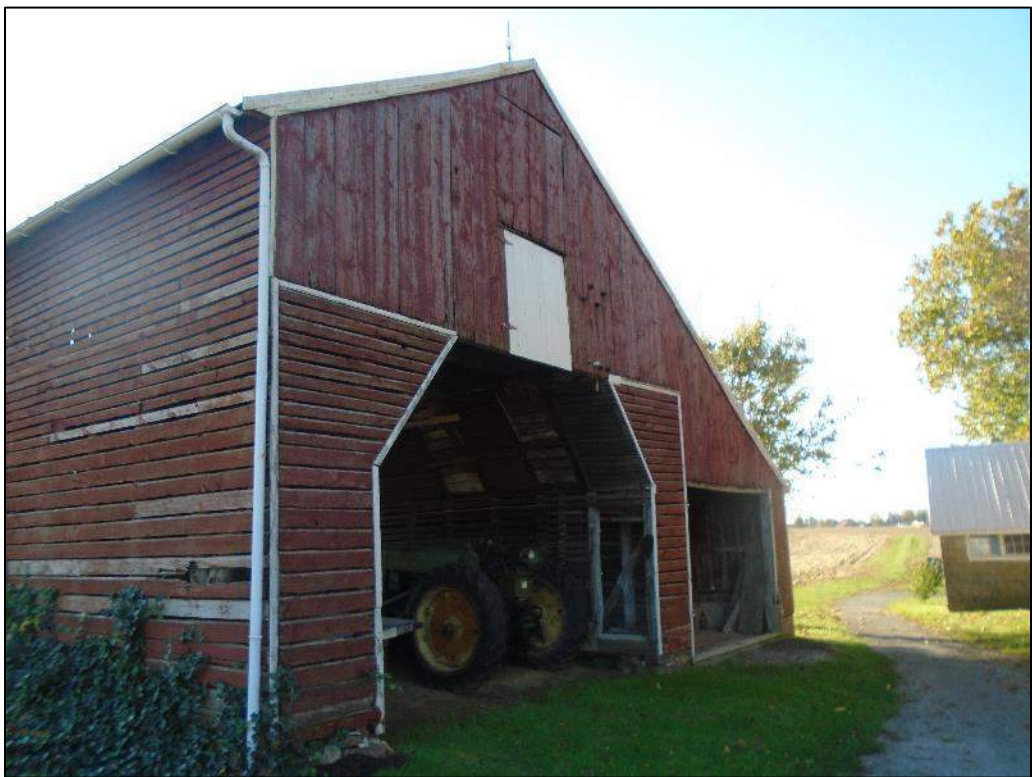
Photograph 28 – Front (west elevation) of the drive thru corn crib; looking southeast.

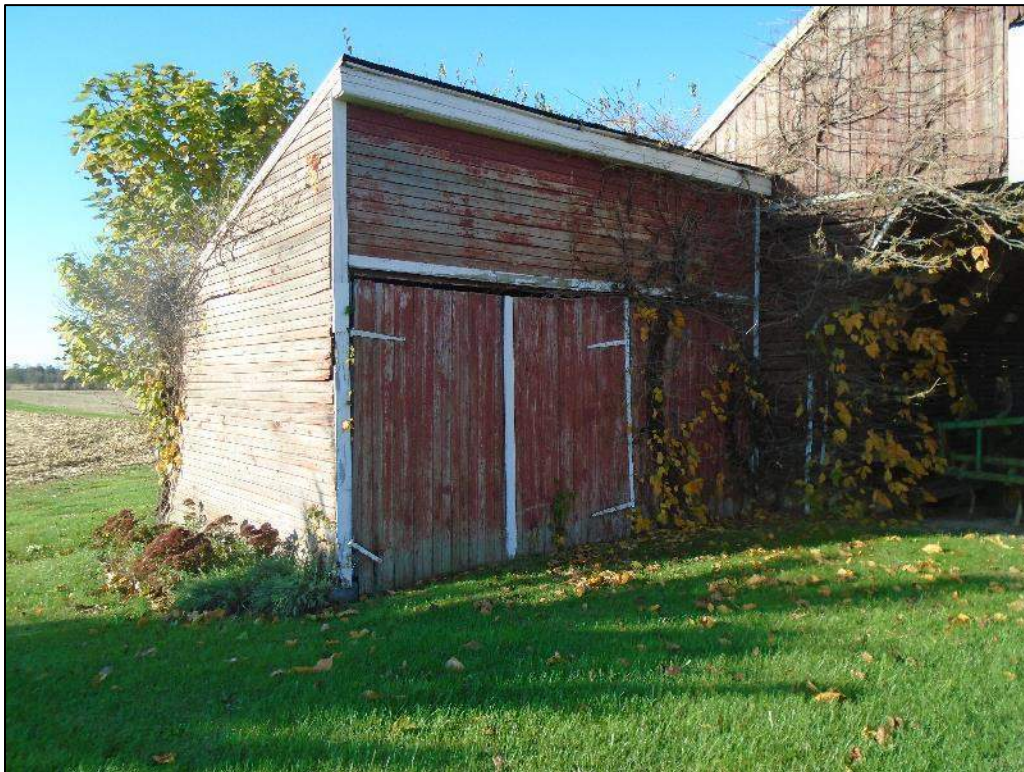
Photograph 29 –Side (north elevation) and rear (east elevation) of the drive thru corn crib addition; looking southwest.

the addition that extends beyond the length of the corn crib has a pair of hinged, wood doors to allow for vehicle access (Photograph 29). The north and south elevations have no fenestration.

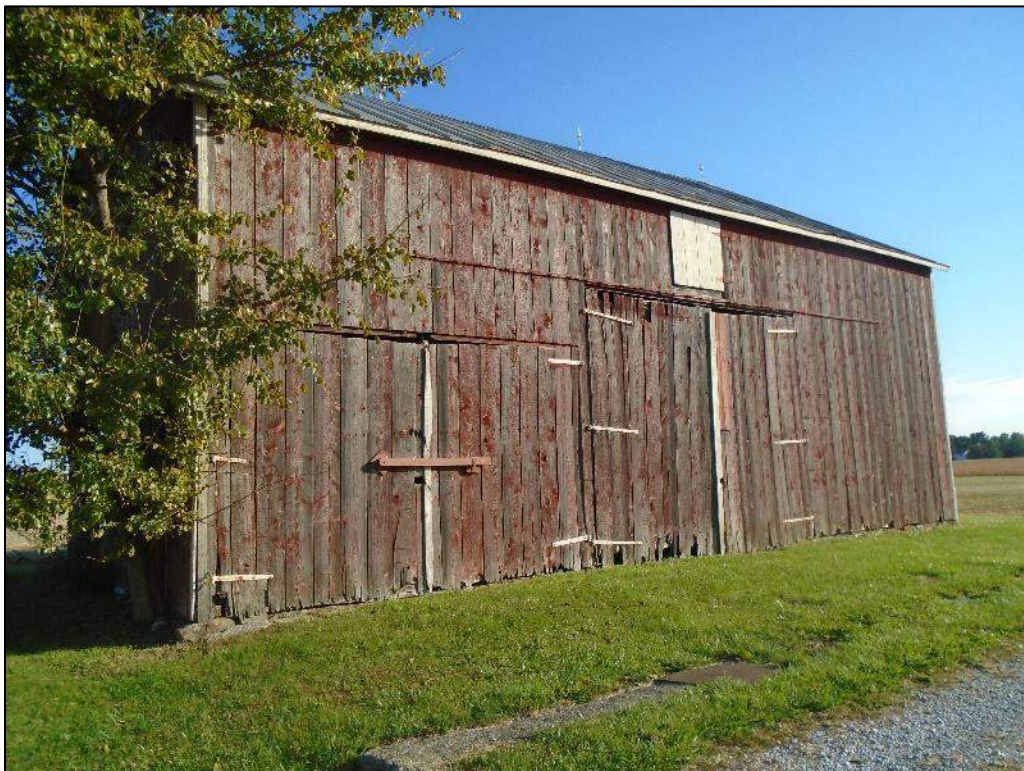
Photograph 30 – Front (south elevation) of the hay drying shed; looking northeast.

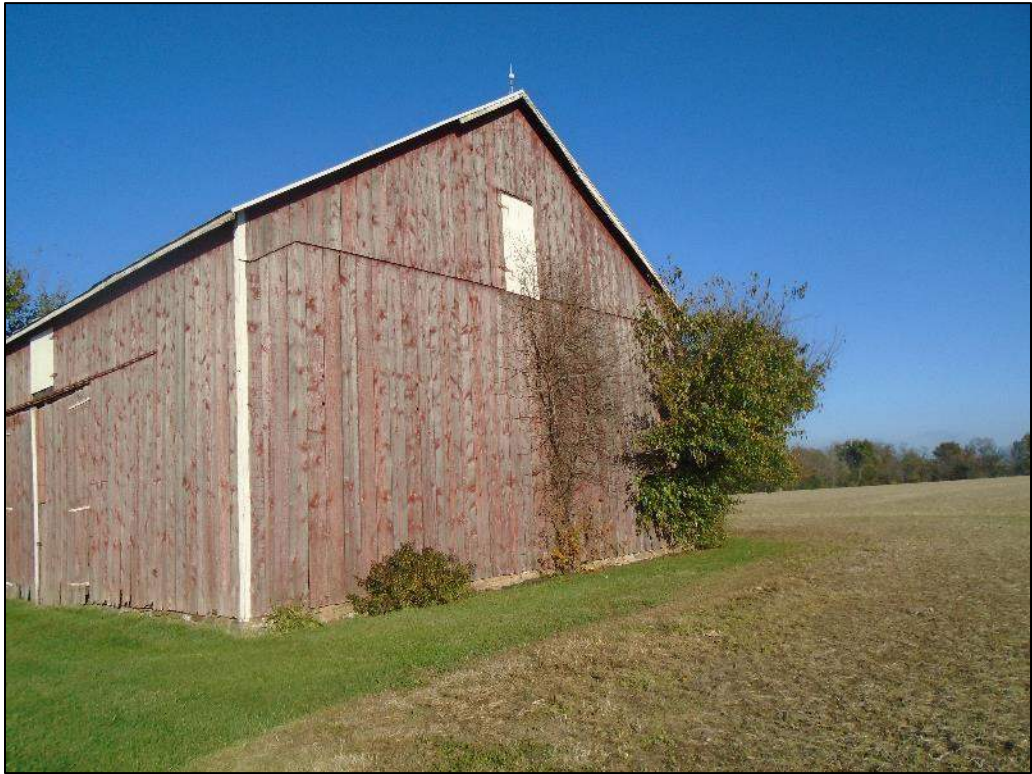
Photograph 31 – Front (south elevation) and side (east elevation) of the hay drying shed; looking northwest.

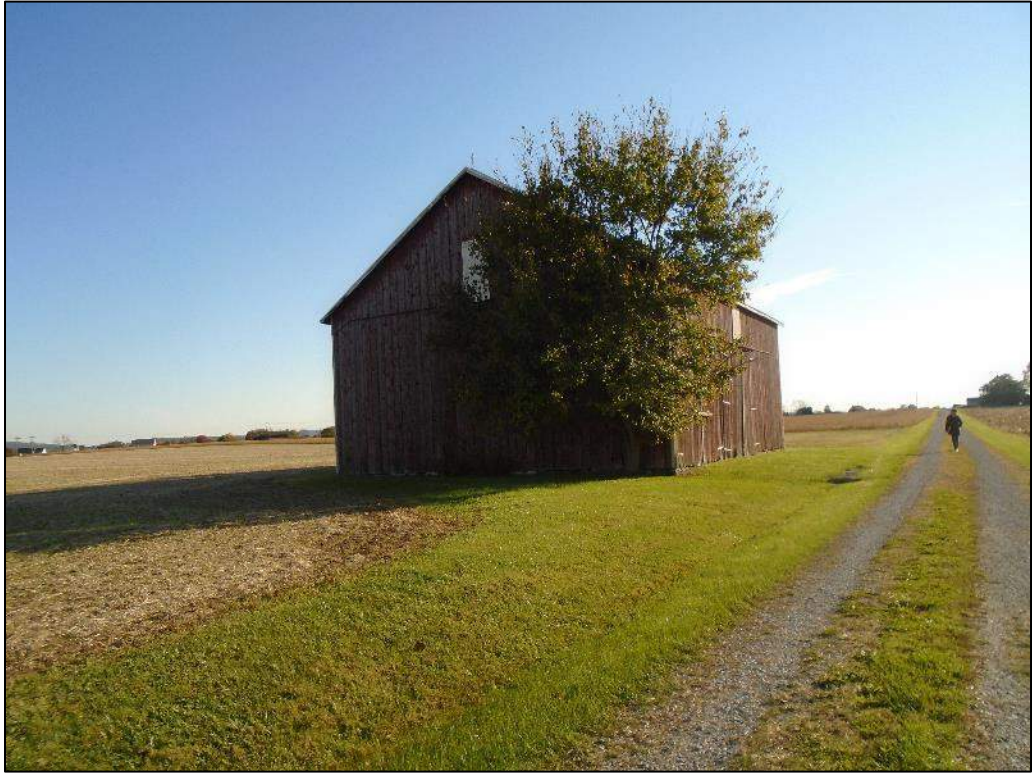
Photograph 32 – Side (west elevation) and front (south elevation) of the hay drying shed; looking east.

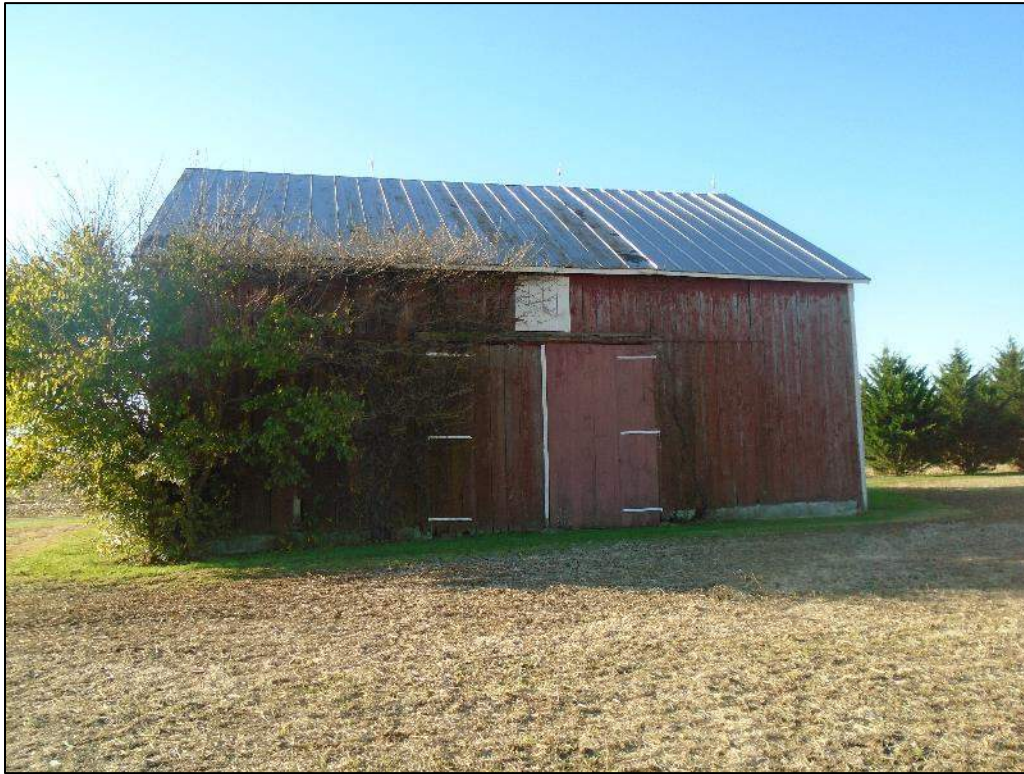
Photograph 33 – Rear (north elevation) of the hay drying shed; looking south.

A ca. 1935 hay drying shed sits further away from the barn (approximately 260 feet east), closer to the crop fields. It is three bays wide, two bays deep, and one-and-a-half stories tall. It has a stone foundation, vertical wood walls, and a side gable, standing seam metal roof. The main (south) elevation has a centered pair of large, hinged, wood doors. To the west, there is a smaller pair of hinged, wood doors. Centered on the upper level is a small, hinged, wood, hatch door (Photograph 30). The east and west side elevations have a single, centered, hinged, wood door within the gables (Photograph 31 and 32). The rear, north elevation has another pair of large, hinged, wood doors, which are surmounted by a small, hinged, wood, hatch door (Photograph 33).

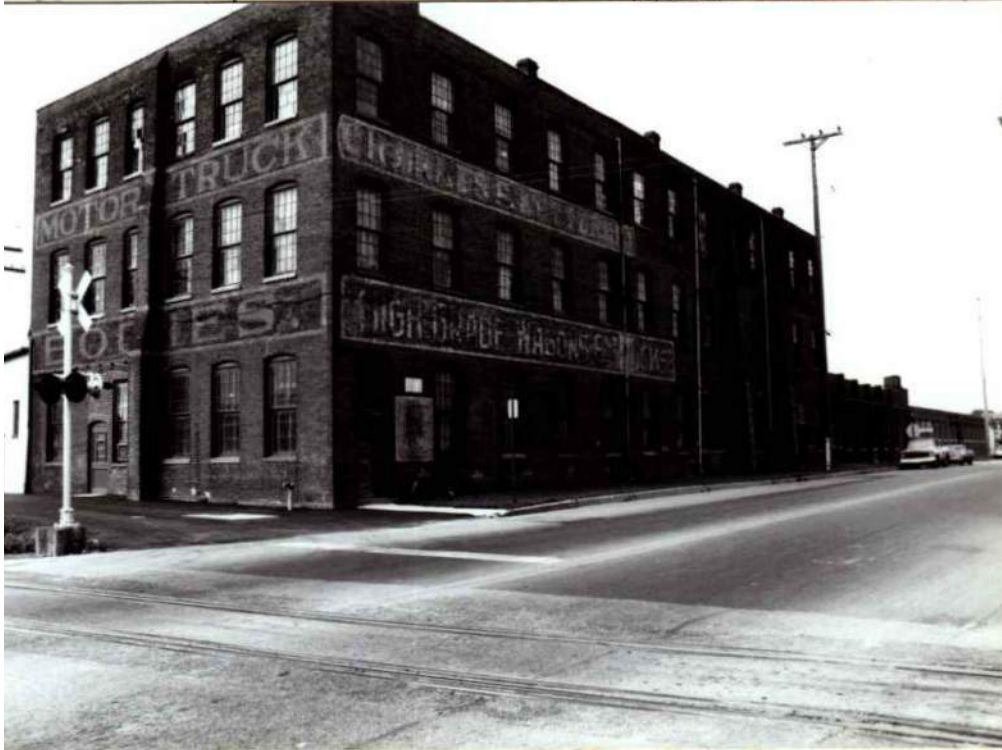
**Photograph 1:** The 1892 factory, showing the east and north elevations (1984). Looking southwest.

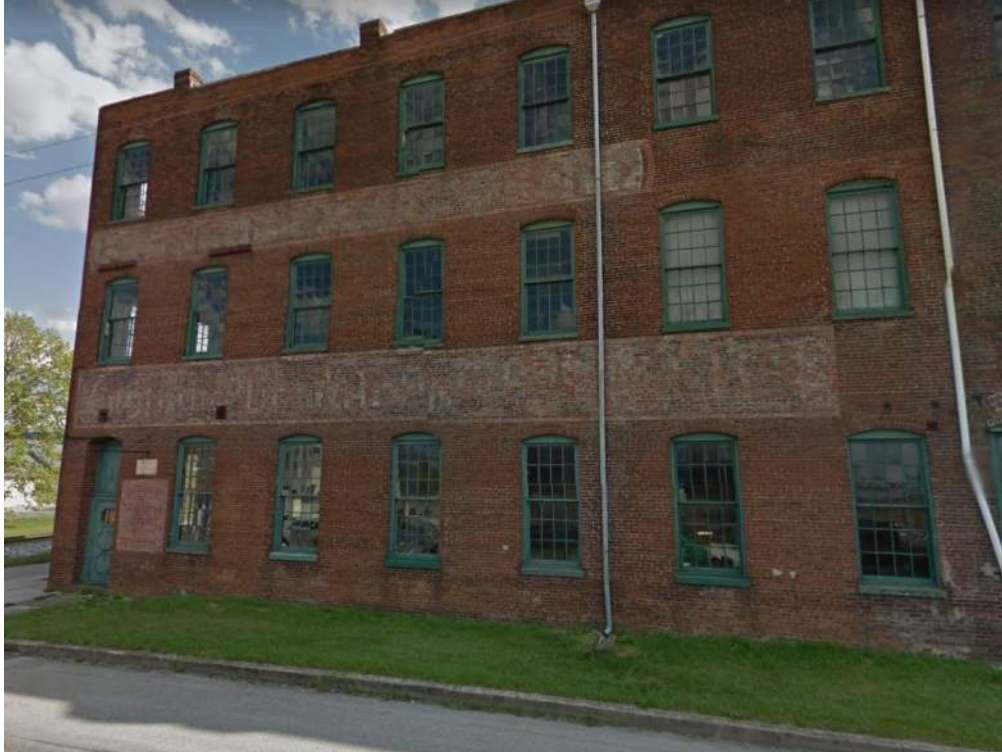
**Photograph 5:** Facade (north) of the 1892 factory, showing the historic, twelve-over-twelve, wood windows still in place, c. 2012 (Google Streetview). Looking southeast.

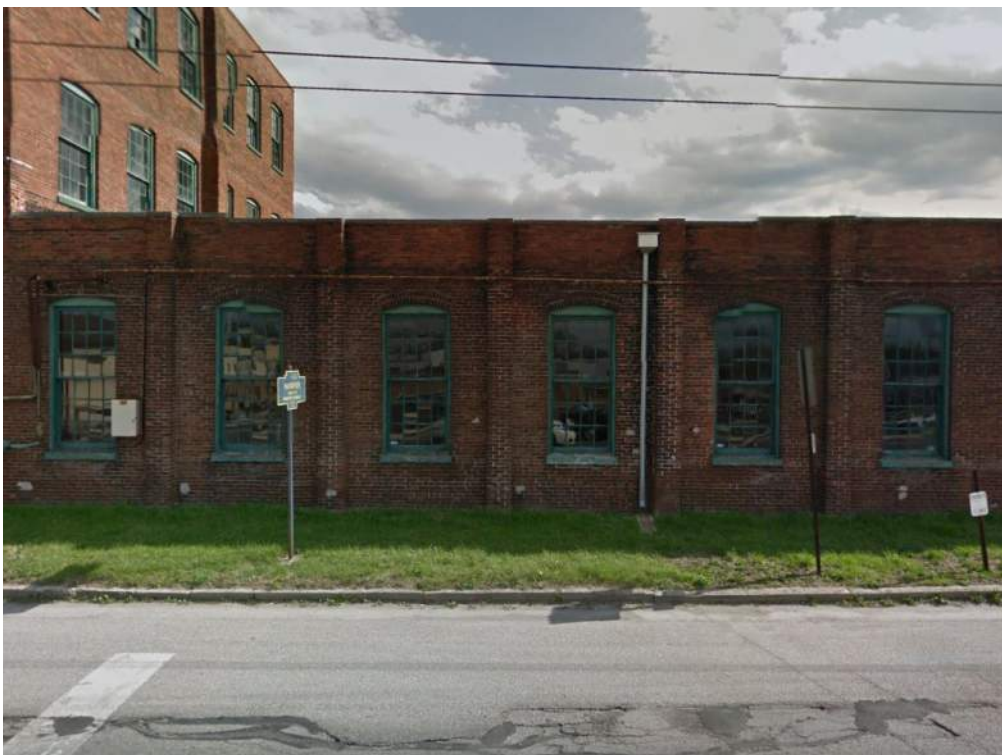
**Photograph 6:** Facade (north) of the c. 1910 addition, showing the historic, twelve-over-twelve, wood windows still in place, c. 2012 (Google Streetview). Looking south.

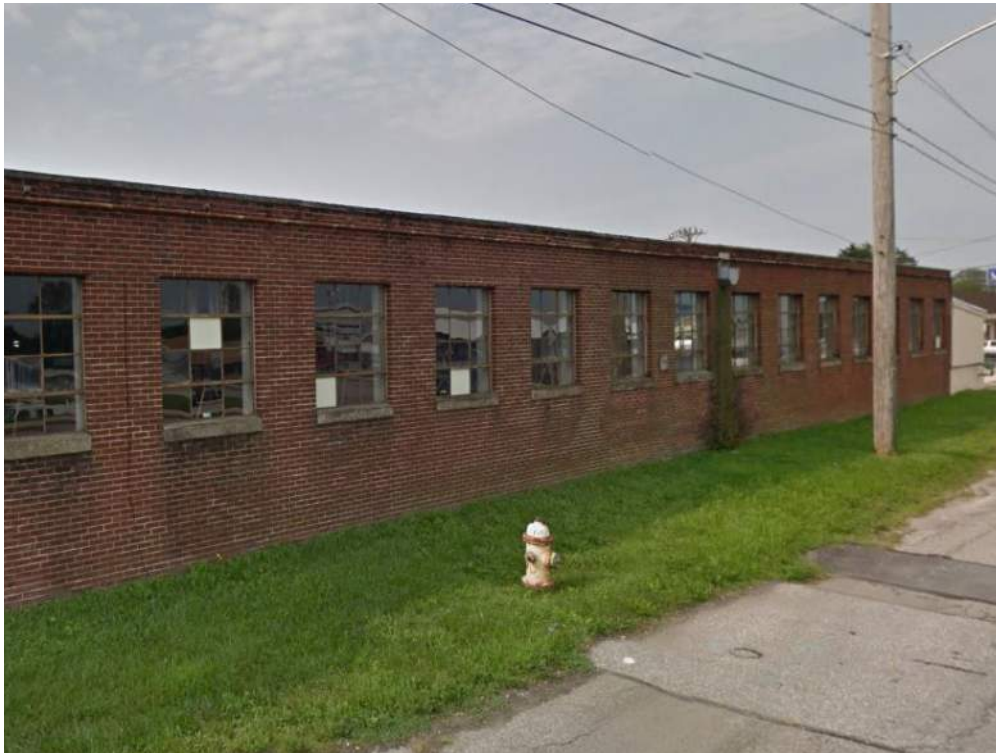
**Photograph 8:** North elevation of c. 1935 addition "G," showing the historic three-over-six-over-three windows still in place, c. 2012 (Google Streetview). Looking west.

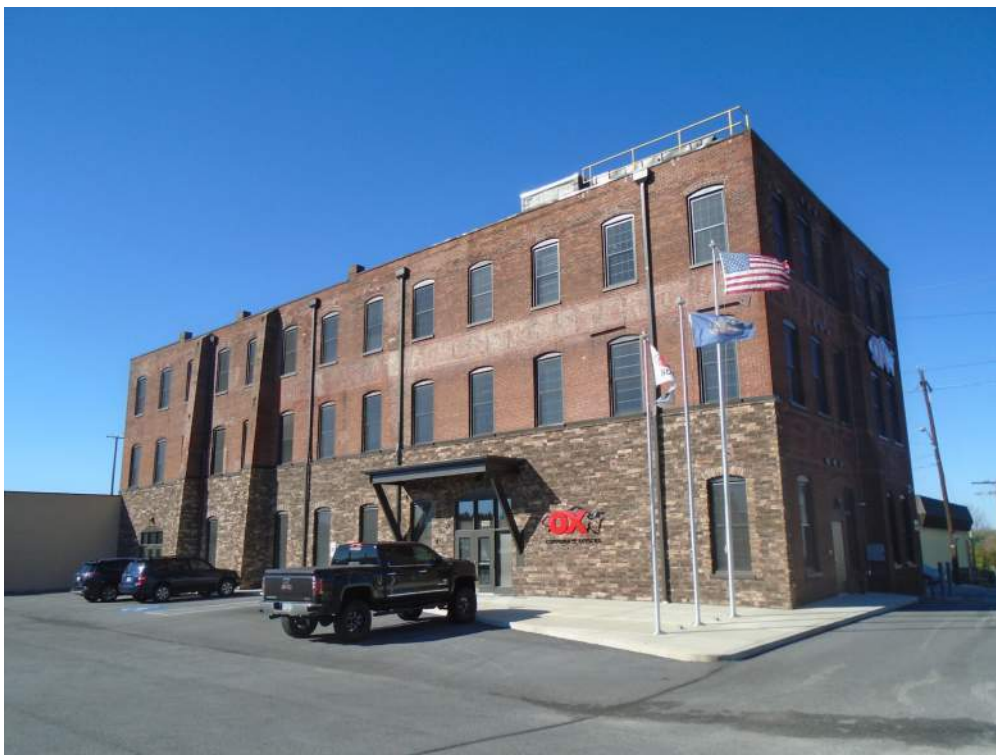
**Photograph 7:** The south elevation of the 1892 factory, showing the replacement windows and new stone veneer at the ground floor (2017). Looking northwest.

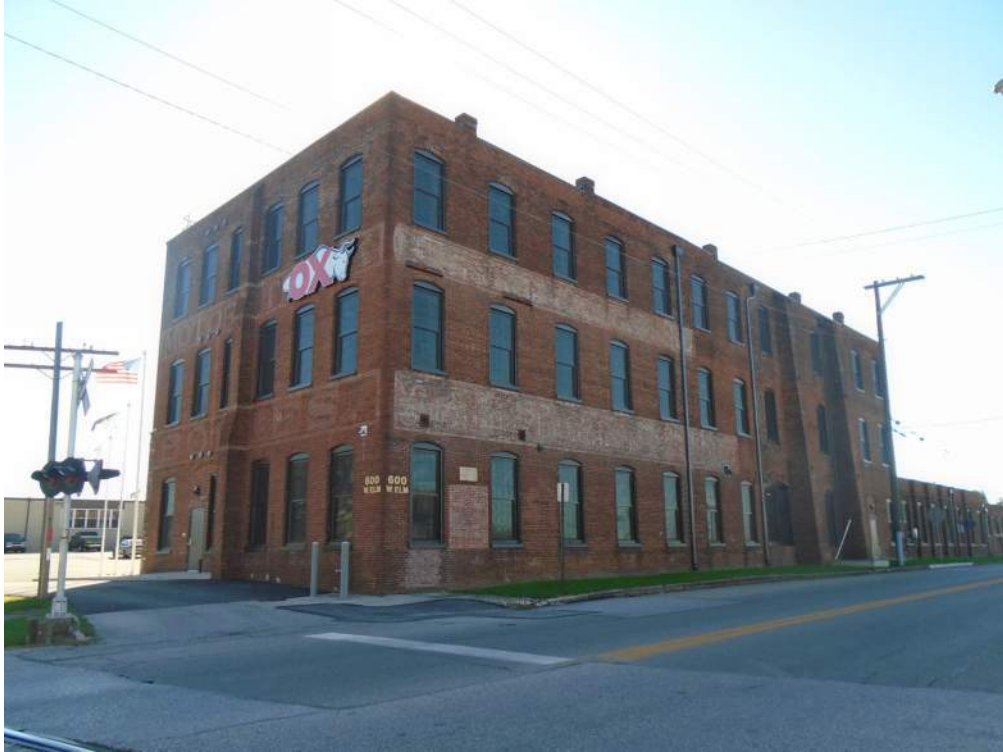
**Photograph 9:** Facade (north) and east elevation of the 1892 factory, as well as the c. 1910 addition to the far right (2017). Looking southwest.

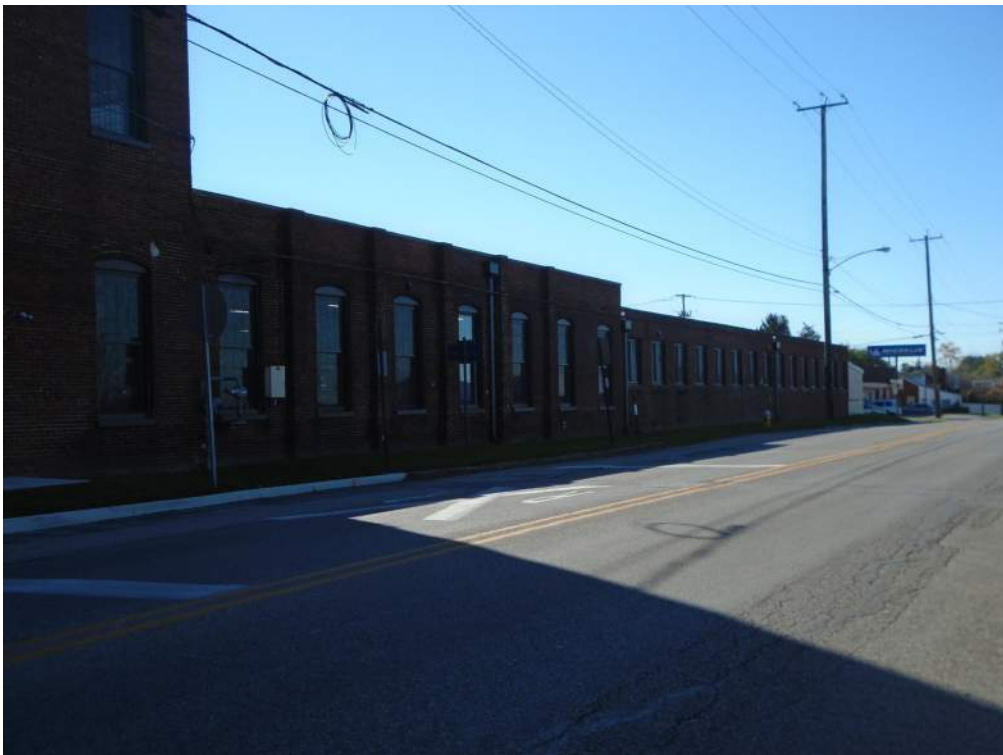
**Photograph 10:** North elevation of the c. 1910 and c. 1935 additions (left to right, 2017). Looking southwest.

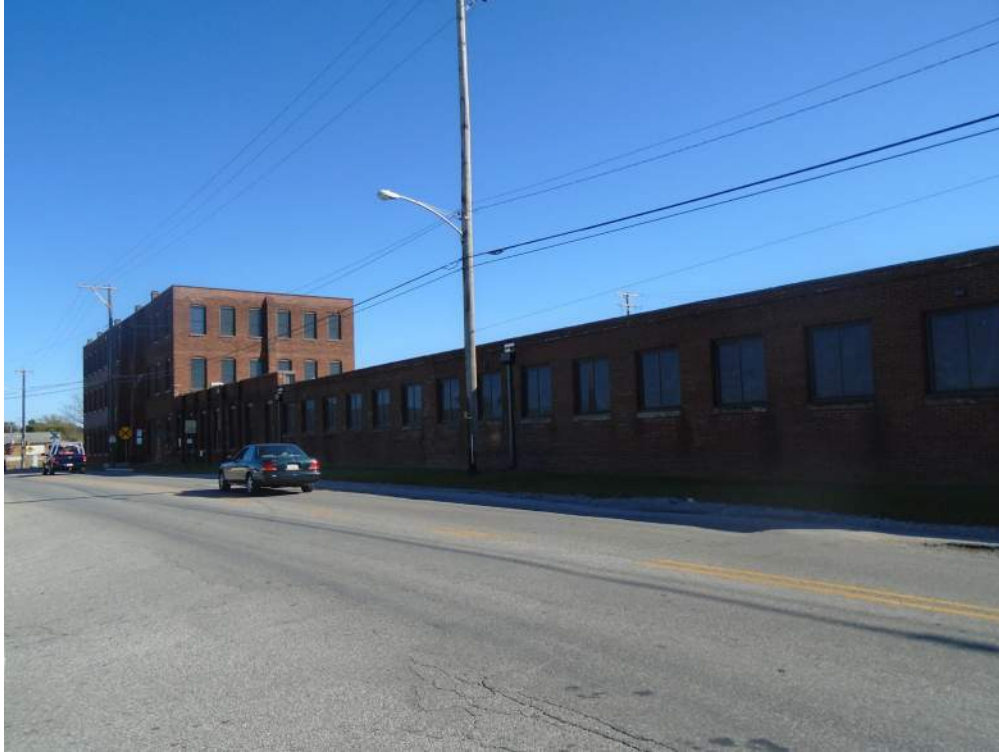
**Photograph 11:** North elevation of the 1892 factory, c. 1910 addition, and c. 1935 addition (left to right, 2017). Looking southeast.

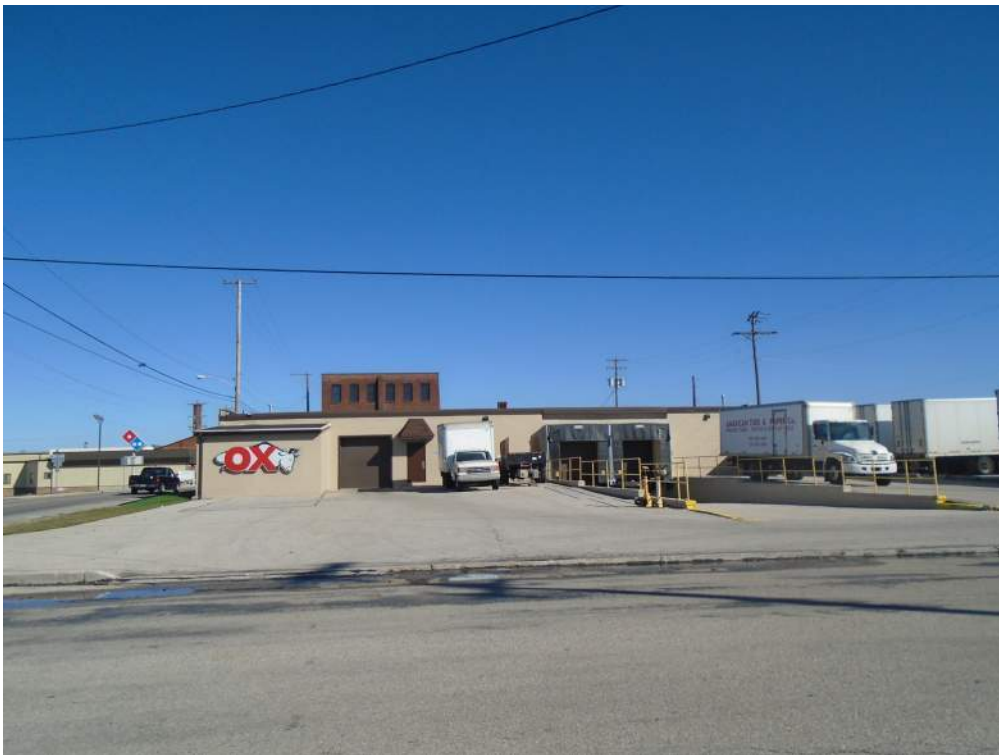
**Photograph 12:** West elevation of the c. 1935 addition. Looking east.

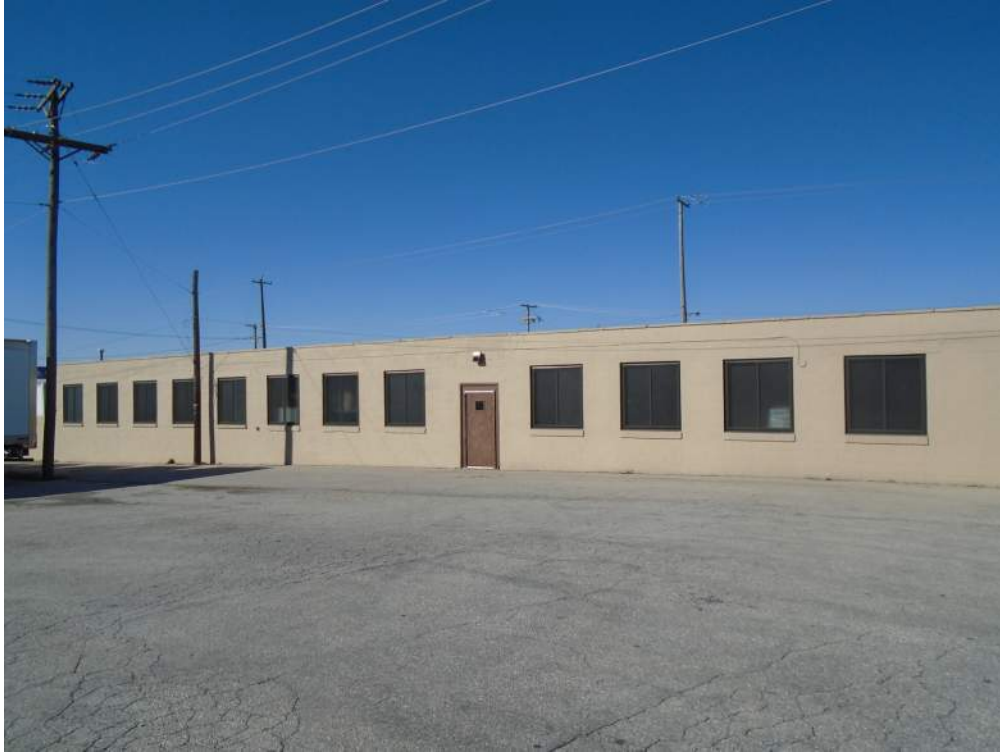
**Photograph 13:** South elevation of the c. 1935 addition. Looking northwest.

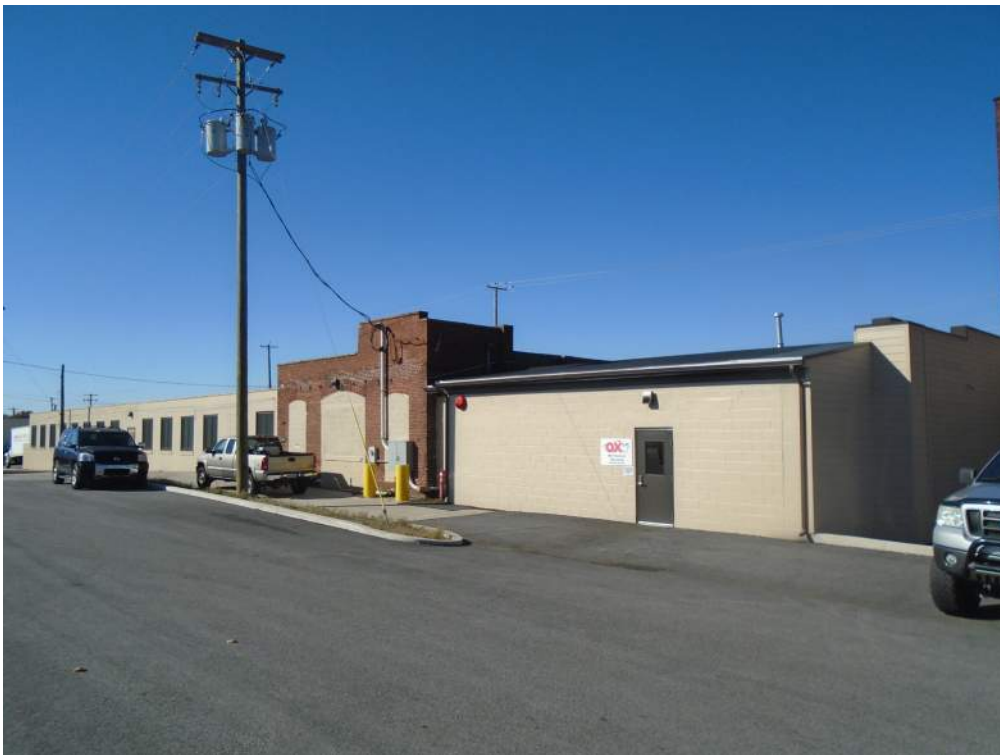
**Photograph 14:** South elevation of buildings "E" and "G" (c. 1935, CMU addition), which is on either side of building "E" (2017). Looking northwest.

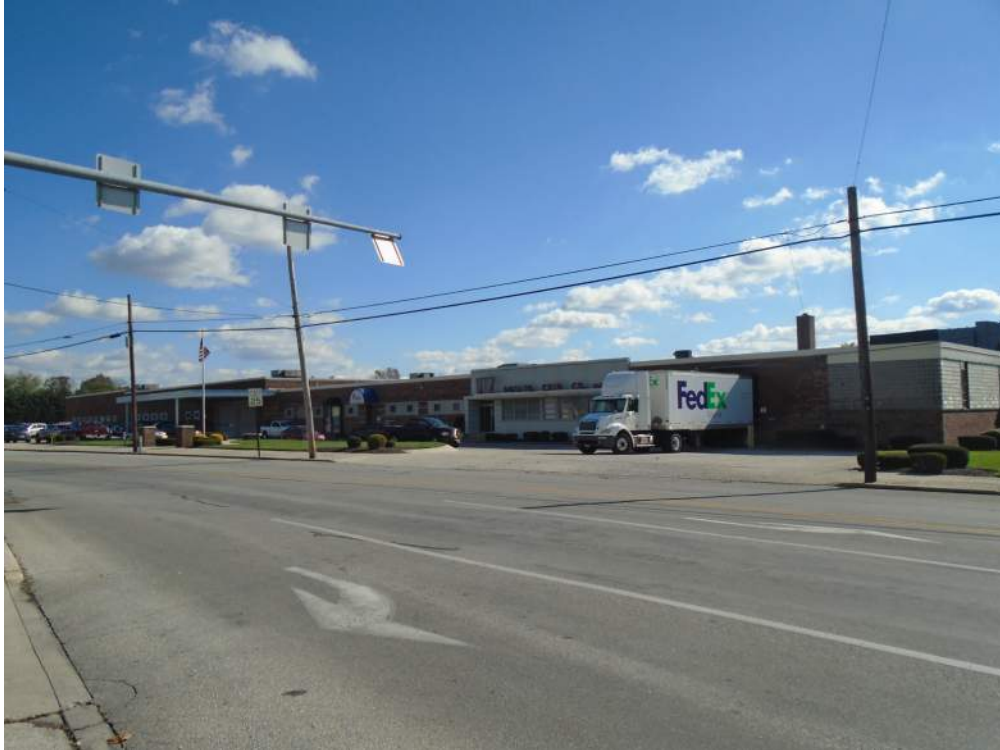
**Photograph 1:** Overview of the Utz Potato Chip Co. Factory Outlet Store showing the c. 1949 building, 1958 addition, and 1967 addition (from right to left). Looking southeast.

The 1967, 1958, and c. 1949 sections (east to west) compose the north façade and are distinguished by vertical expansion joints and stepped rooflines (*Photograph 1*). Unless otherwise noted, all sections of the façade feature original glass block openings surrounding a central, single-light, operable window. A continuous concrete header, sill, and central band span the width of the building sections and connect the glass block openings, creating a clear horizontal axis.

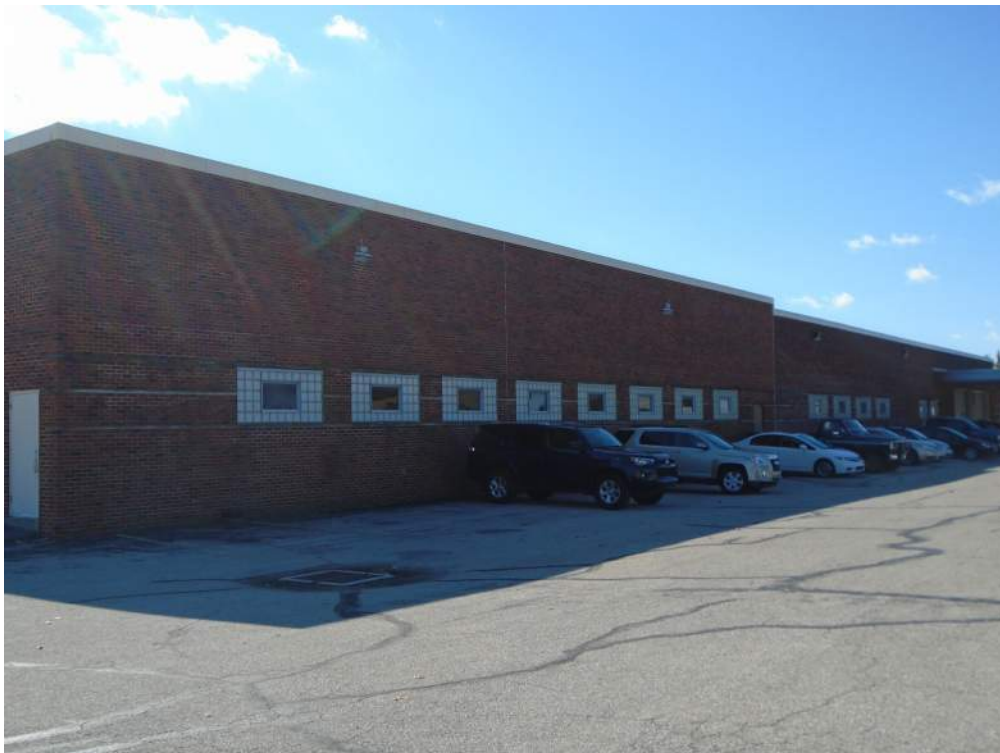
**Photograph 2:** The 1967 addition to the Utz Potato Chip Co. Factory Outlet Store. The 1958 addition is to the far right. Looking southwest.

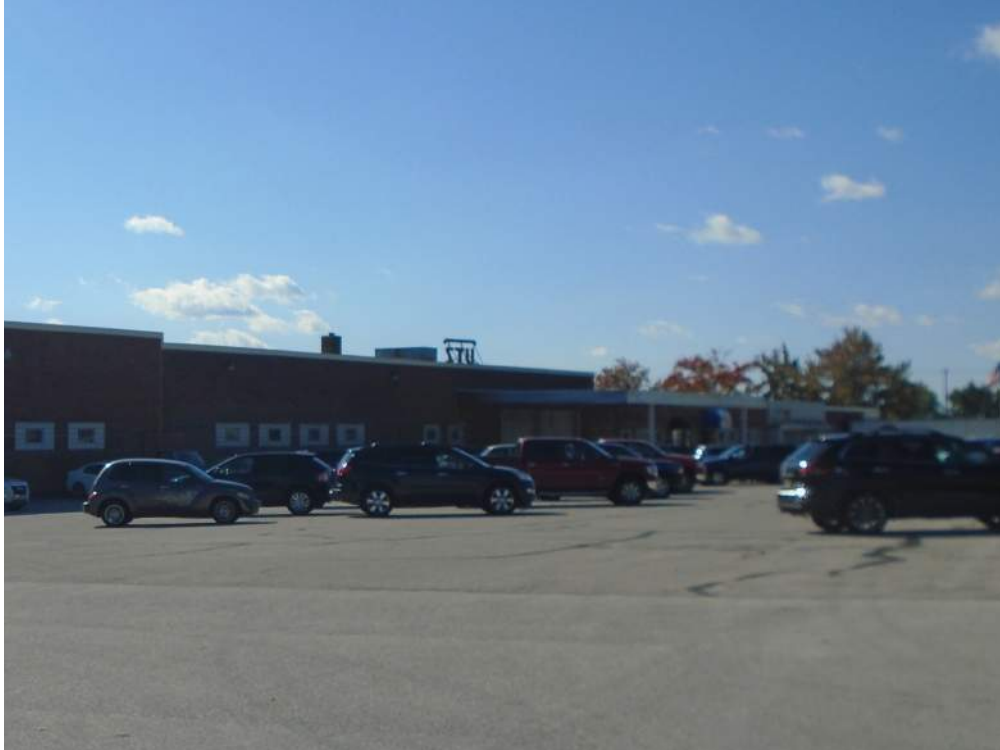
**Photograph 3:** The 1958 addition at center. Looking southwest.

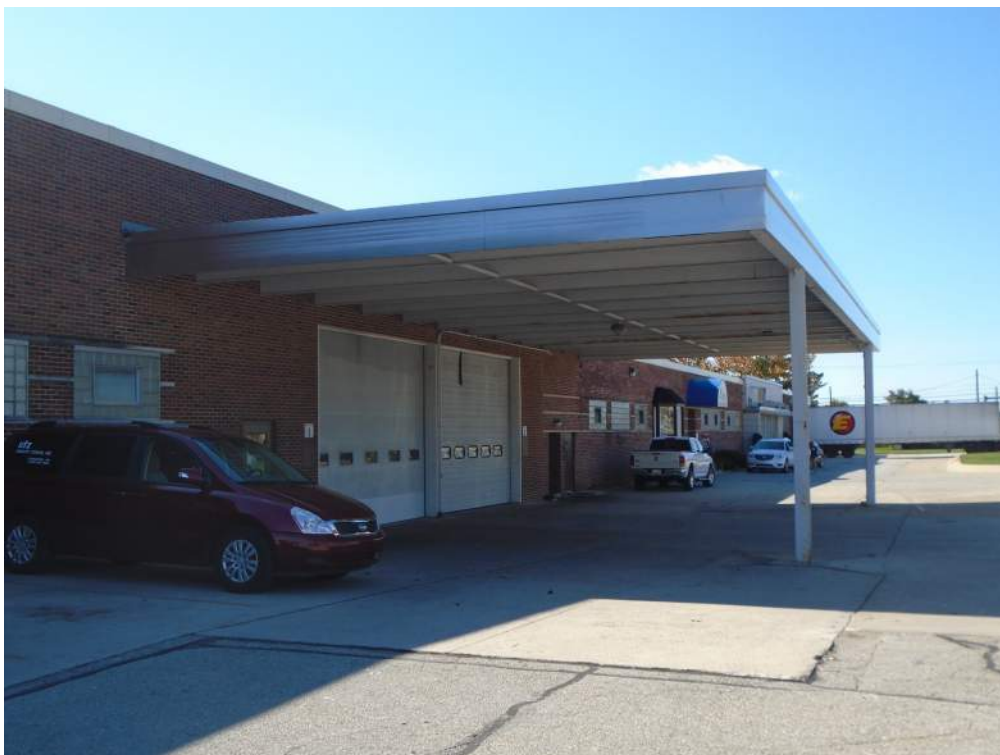
**Photograph 4:** The stylized, aluminum canopy at the 1958 addition. Looking west.

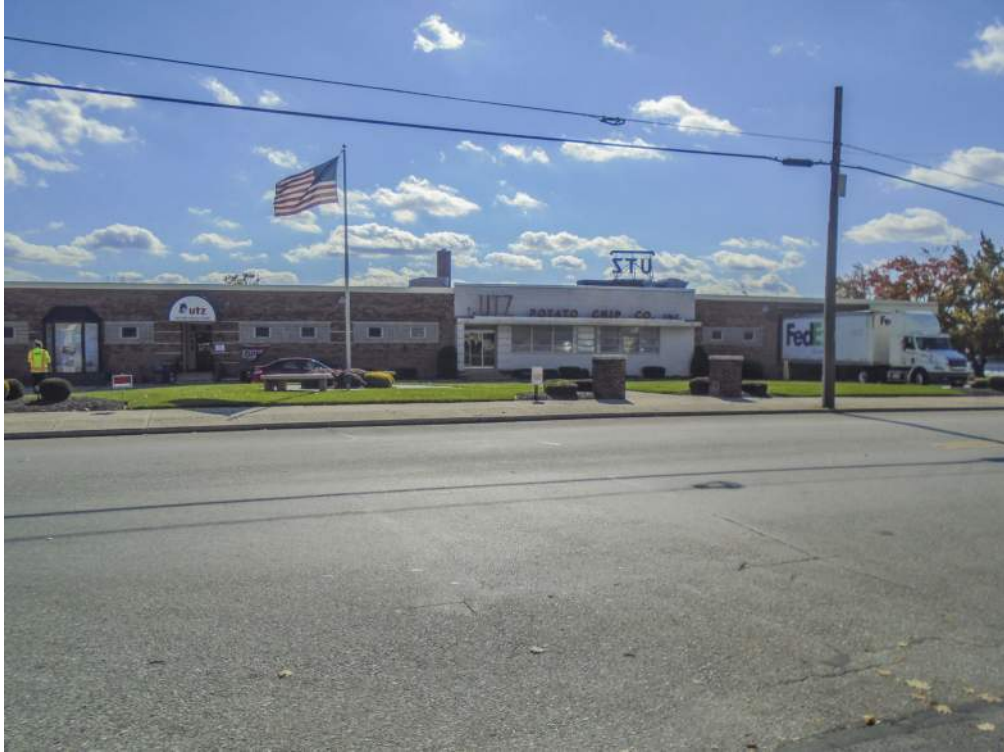
**Photograph 5:** The original, c. 1949 Utz Potato Chip Co. building, showing the entrance to the Outlet Store (at the left) and the stylized, white brick façade (at right). Looking south.

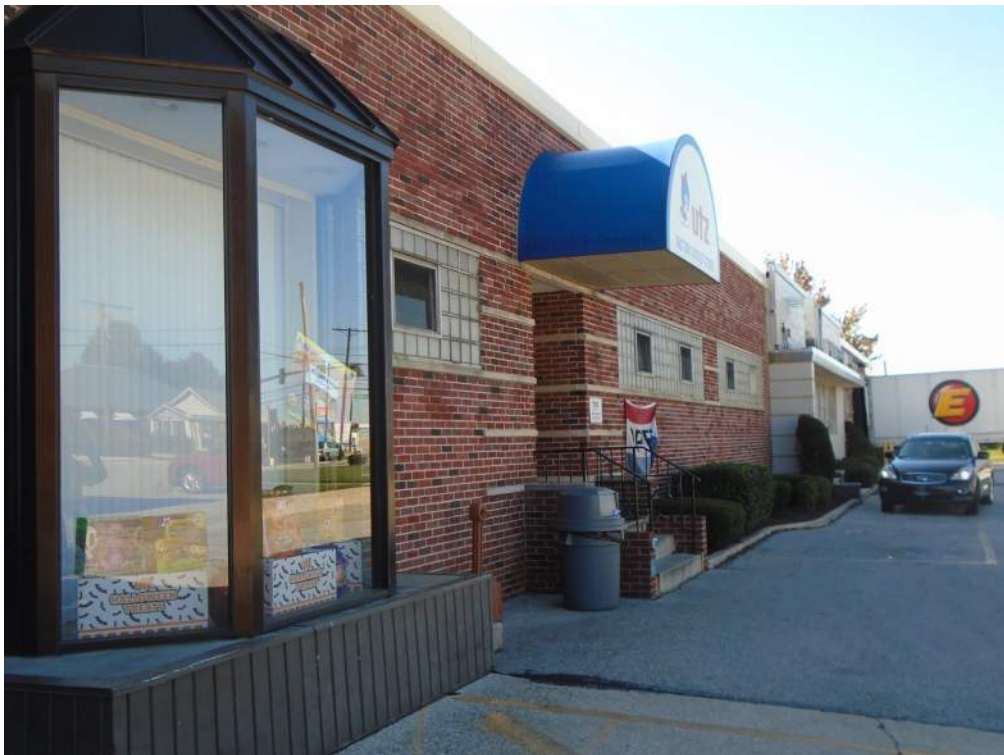
**Photograph 6:** View of the Factory Store entrance below the blue awning and display window at left. Looking west.

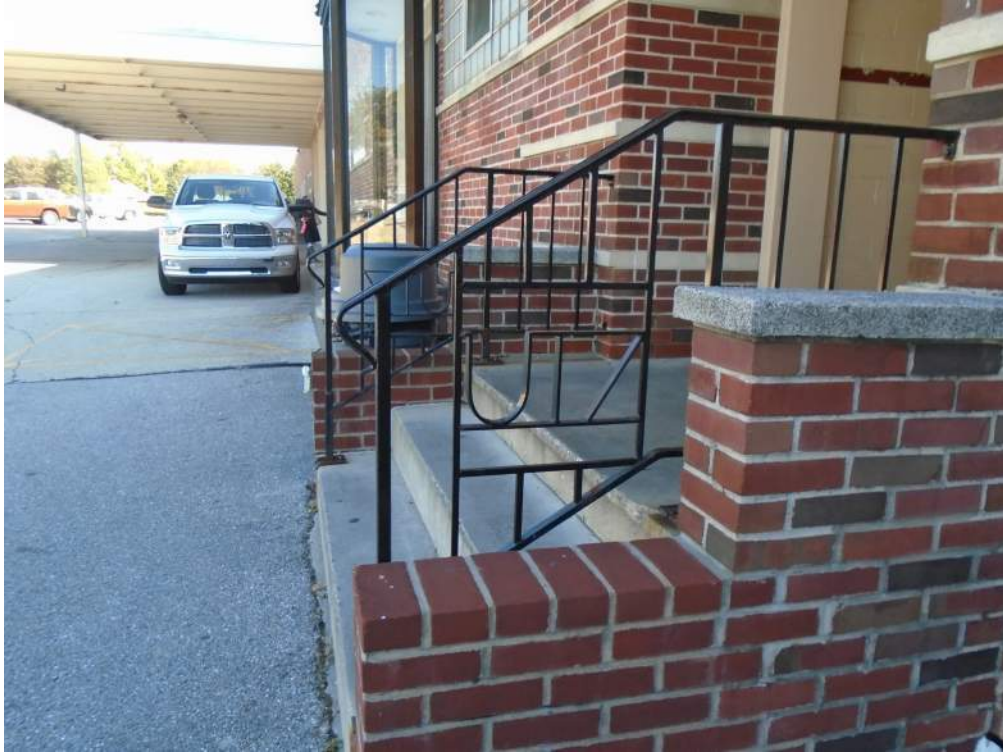
**Photograph 7:** View of the custom-made handrails containing the Utz name within the balusters. Looking east.

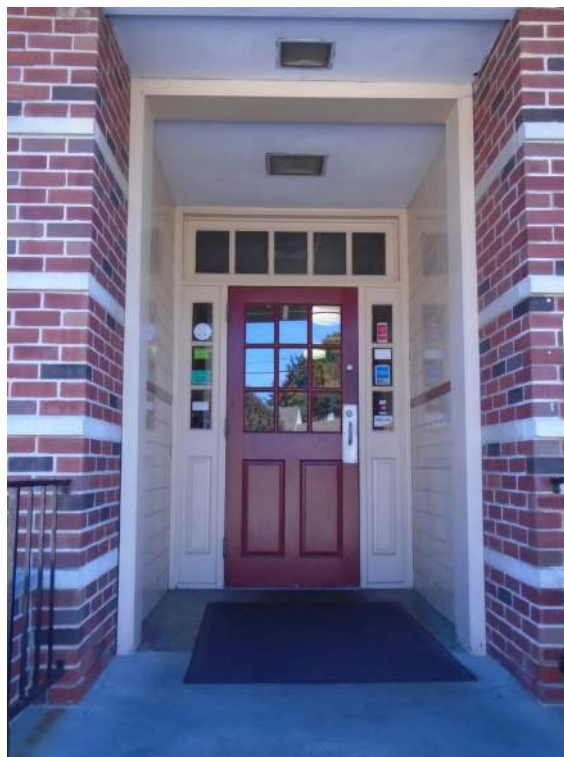
**Photograph 8:** View of the Factory Store entrance vestibule, showing the glazed brick and original wooden door system. Looking south.

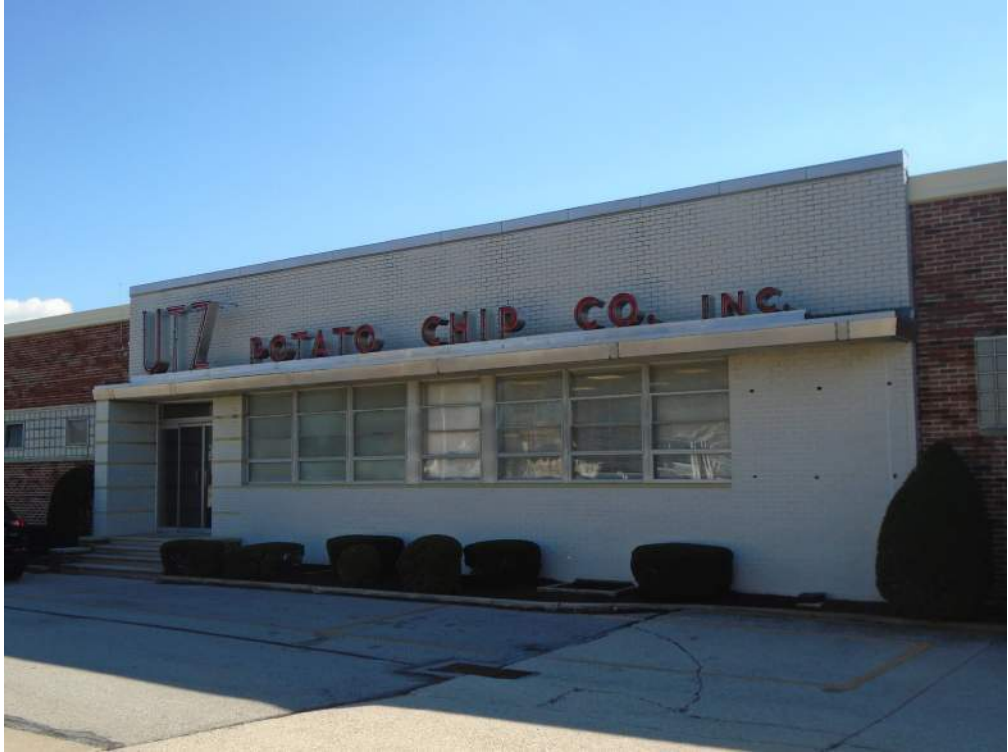
**Photograph 9:** The highly stylized, white brick façade at the original c. 1949 factory building. Looking southeast.

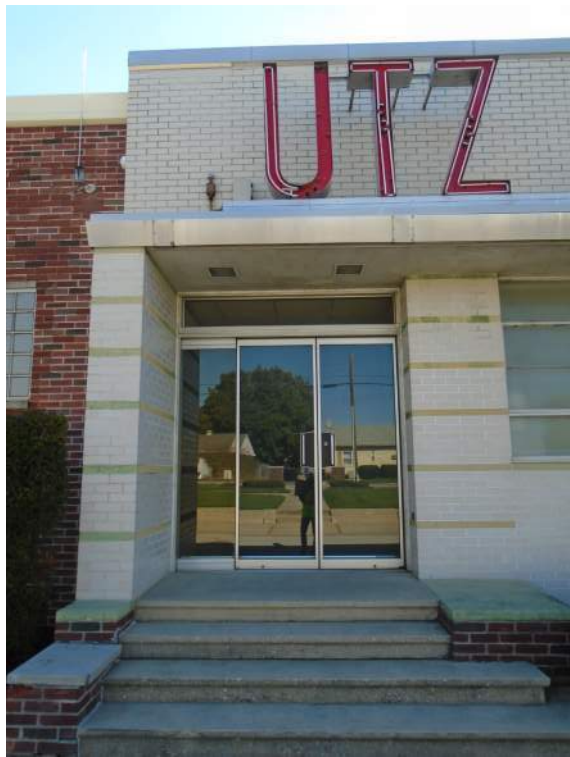
**Photograph 10:** Detail view of the entrance at the white brick façade, showing the original door system and masonry detailing. Looking south.

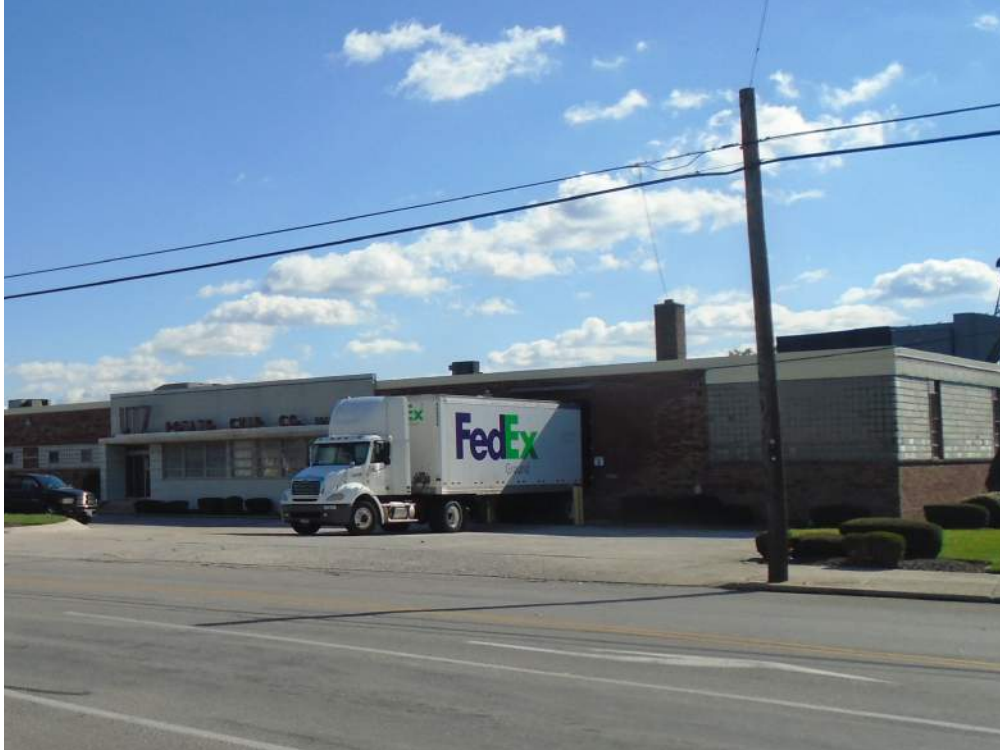
**Photograph 11:** View of the northwest corner of the Utz Potato Chip Co. factory building, showing the truck-loading door and glass block glazing.
