# Historic Resource Survey Form

PENNSYLVANIA HISTORICAL AND MUSEUM COMMISSION  
Bureau for Historic Preservation

Key # \_\_001901, 001920, 001930\_\_\_\_\_  
 ER # \_\_2016-8477-001\_\_\_\_\_

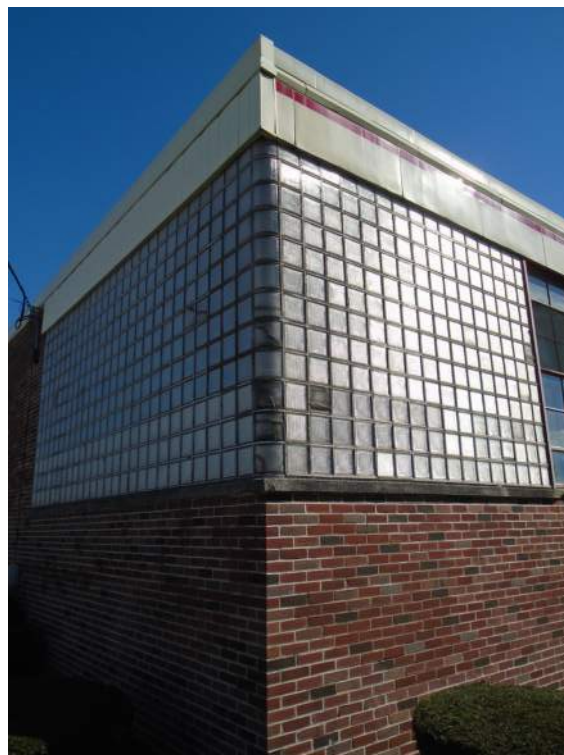
**Photograph 12:** Detail view of the curved glass block glazing and metal fascia at the northwest corner. Looking southeast.

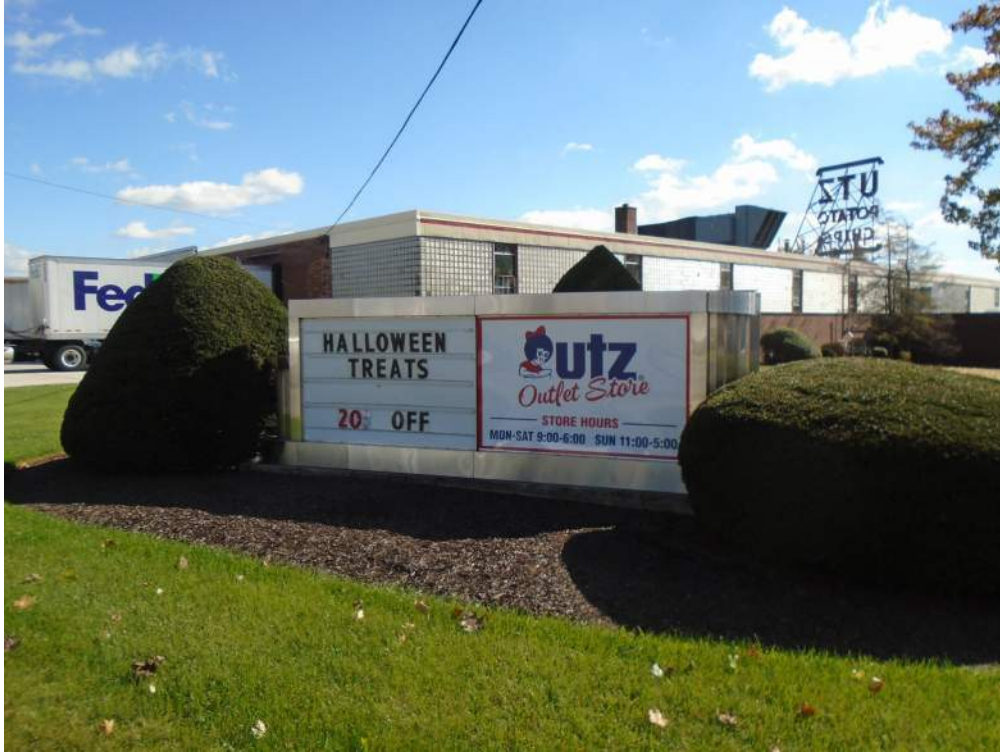
**Photograph 13:** The V-shaped, polished aluminum signage, located at the northeast corner lawn. Looking southeast.

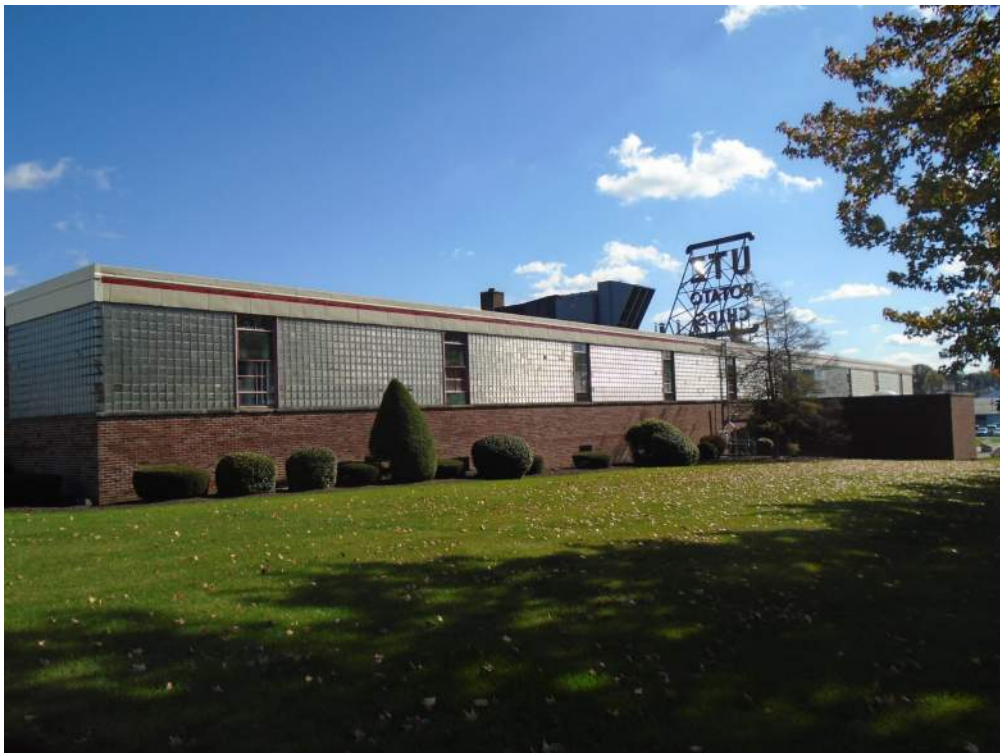
**Photograph 14:** The west elevation of the c. 1949 building, showing the band of glass block glazing with interspersed steel windows. Looking southeast.

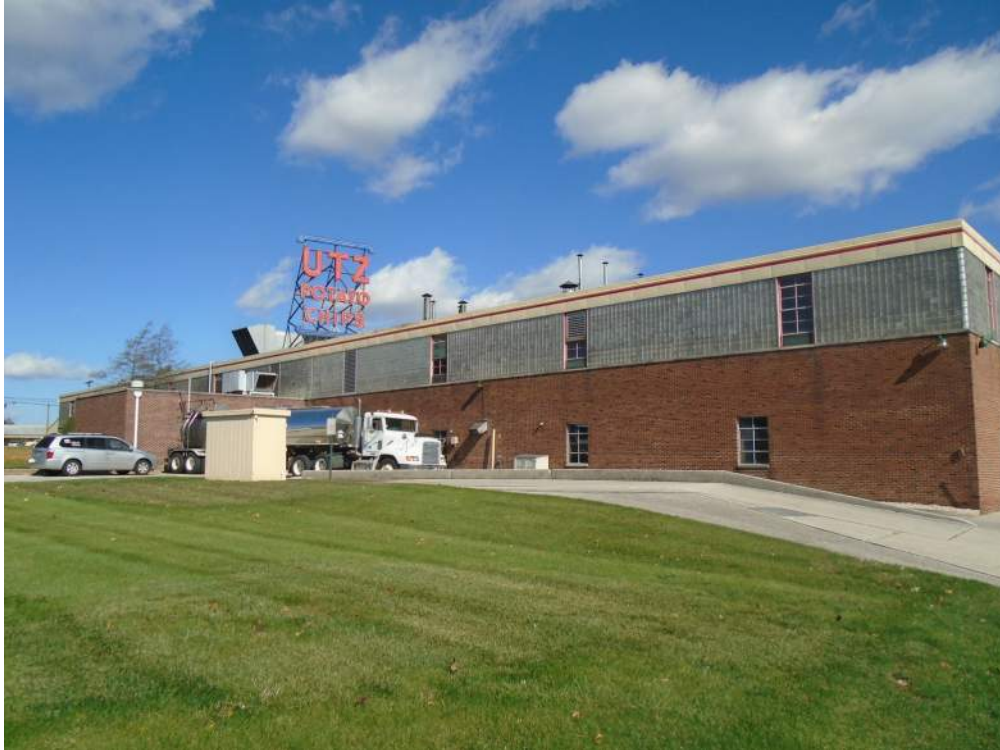
**Photograph 15:** The west elevation of the 1953 addition, showing continuation of the window fenestration, gradation change, and rooftop signage. Looking northeast.

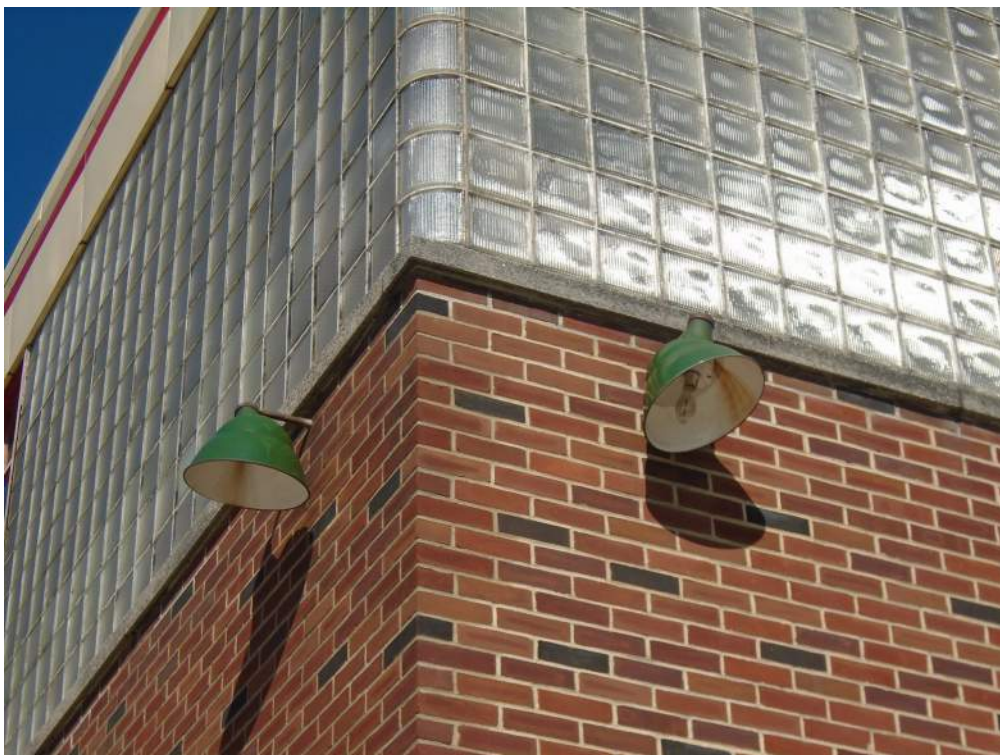
**Photograph 16:** Detail view of the southwest corner, showing the curved glass block and original light fixtures. Looking northeast.

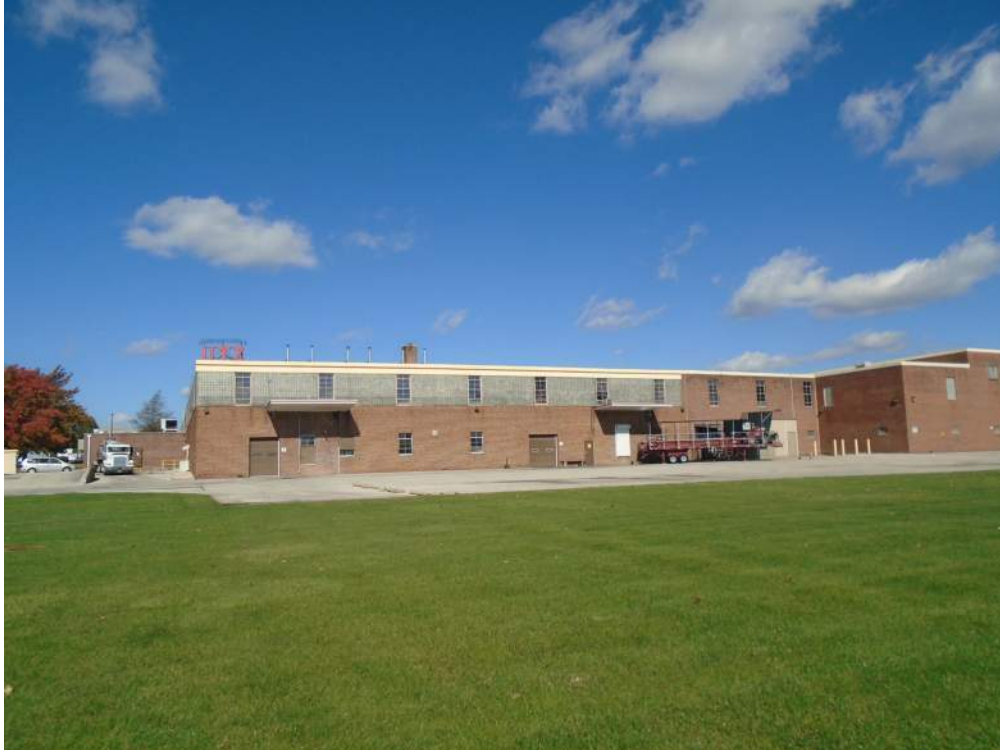
**Photograph 17:** The 1953 and 1956 additions (from left to right), differentiated by the termination of the glass block. The 1956 addition includes the ell with the lower roofline at the far right. Looking north.

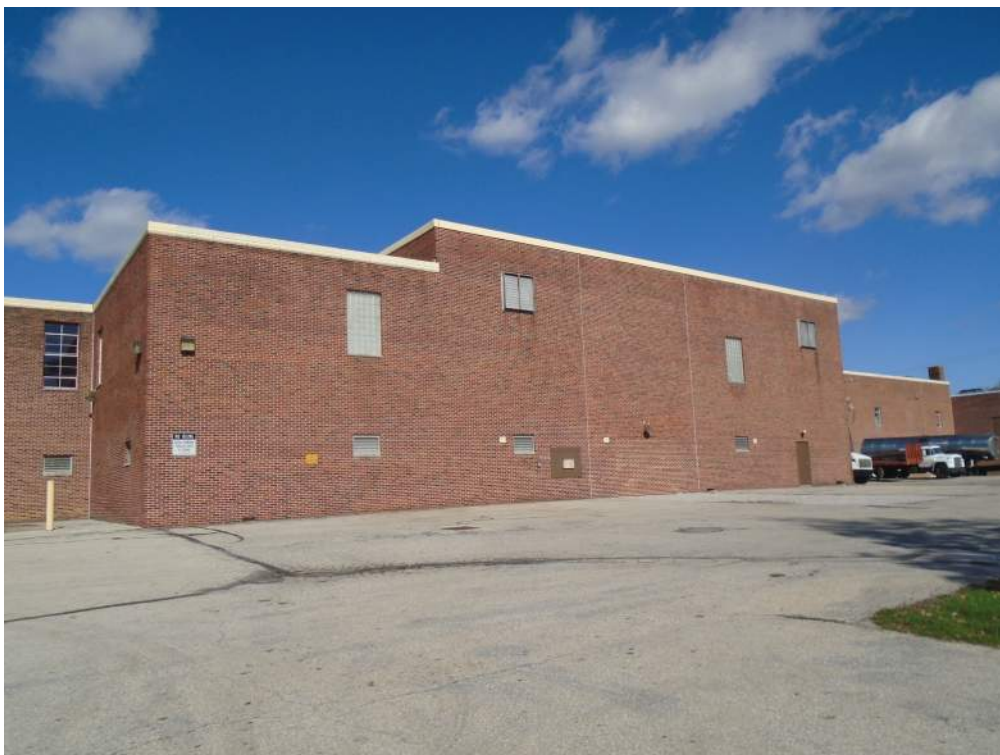
**Photograph 18:** The 1956 ell (left), 1958 ell (center), and 1967 addition (far right), at the south side of the complex. Looking northeast.

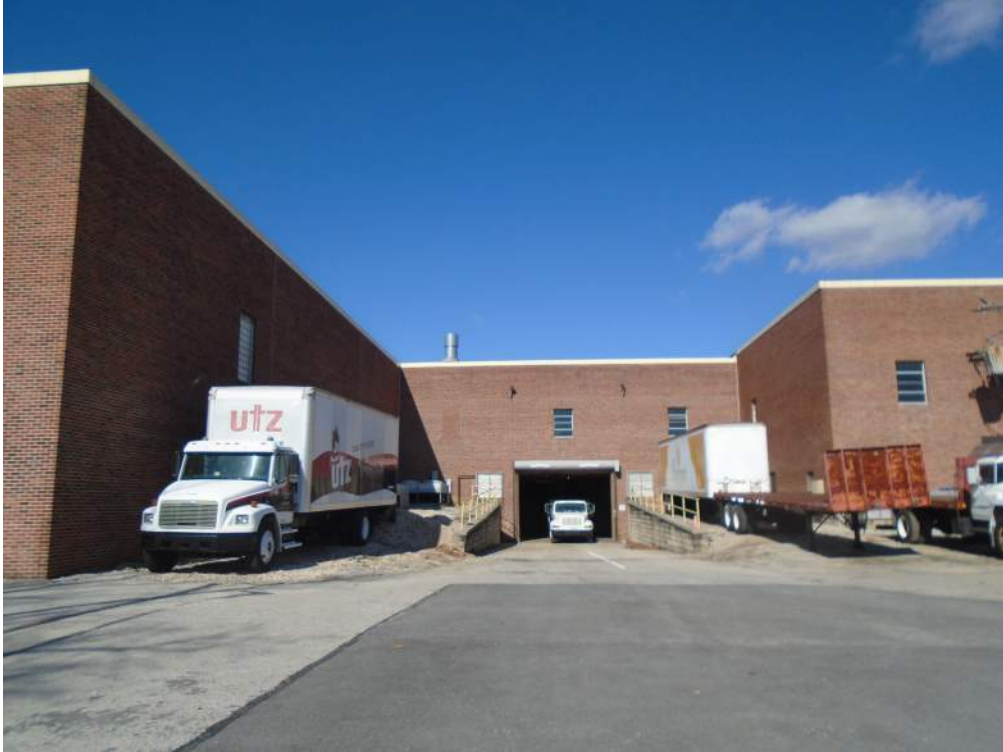
**Photograph 19:** The 1958 addition, showing the ell to the left, a central truck entrance, and truck-loading docks. Looking north.

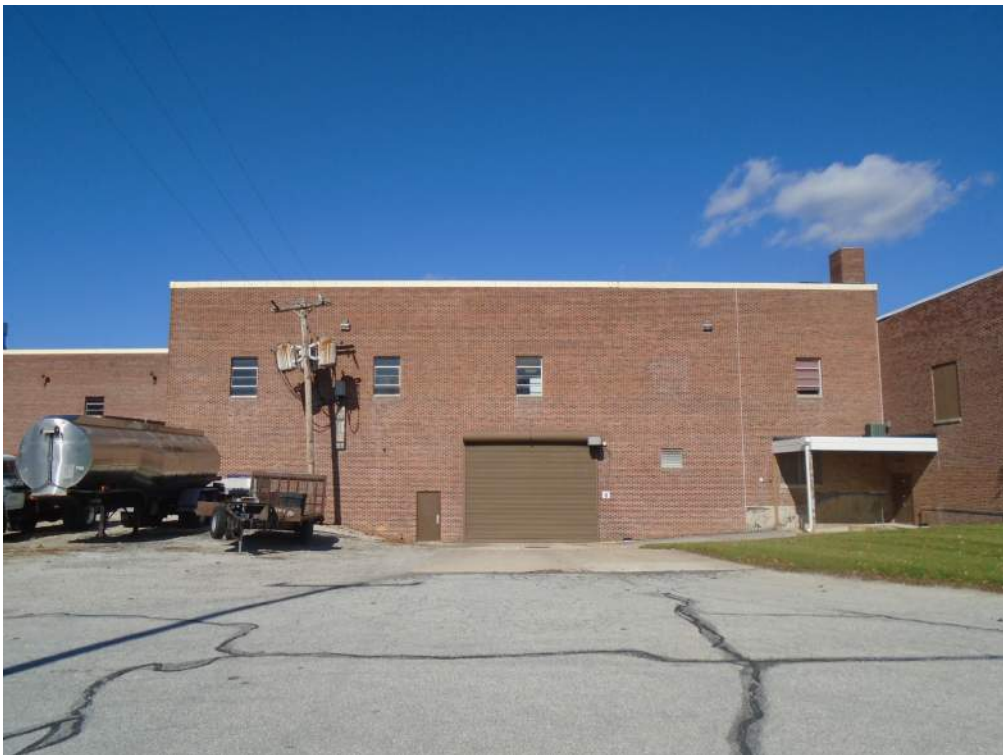
**Photograph 20:** The south elevation of the 1967 addition, showing the west elevation of the 1971 addition to the far right. Looking north.

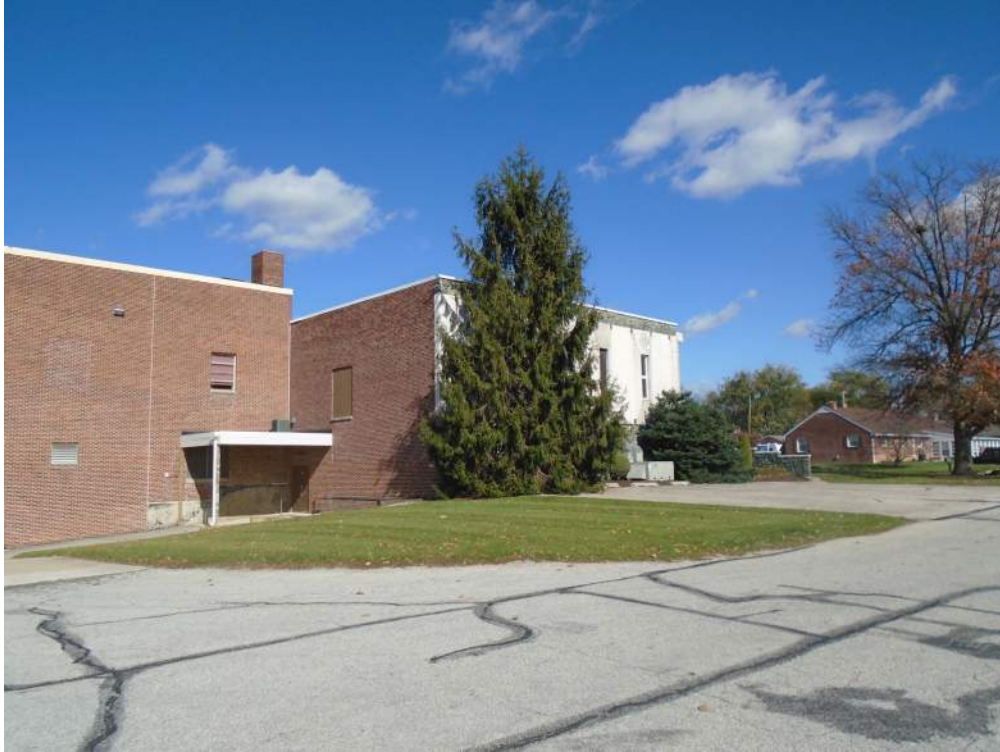
**Photograph 21:** The 1967 and 1971 additions (from left to right). Looking northeast.

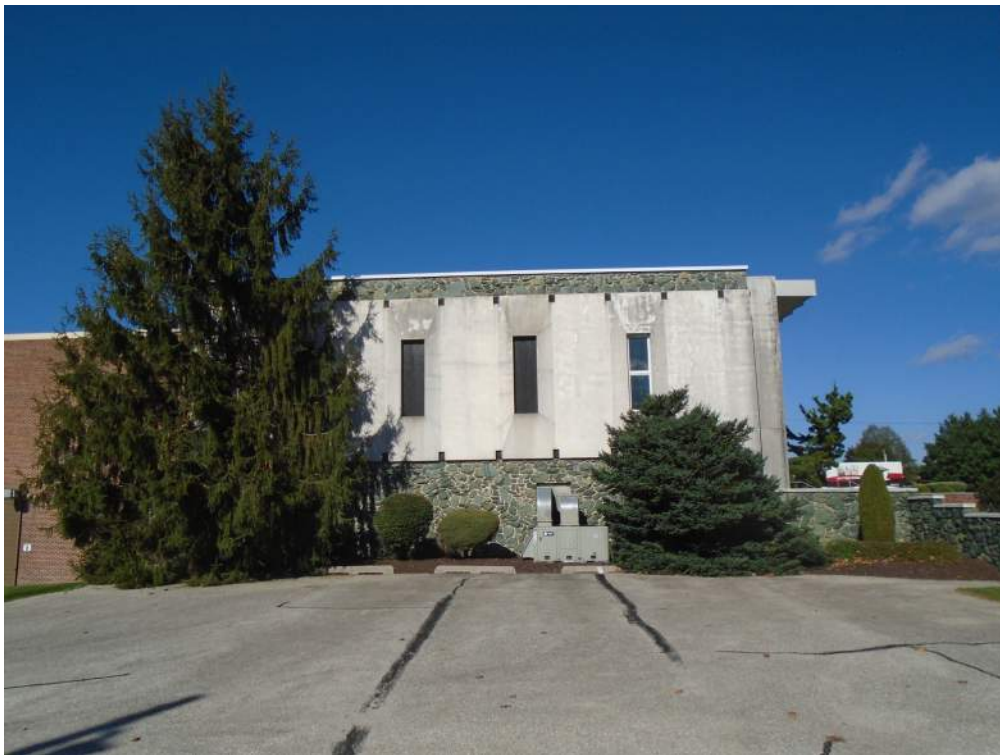
**Photograph 22:** The south elevation of the 1971 addition from the adjacent parking lot, showing the stone-clad retaining wall and steps at the far right. Looking north.

The south elevation has four concrete panels with inset openings of which the interior two are infilled with the black, coarse aggregate concrete (*Photographs 22 and 23*). The elevation is bordered by a planting bed and adjacent a paved parking area. Mechanical equipment (HVAC) sits in the plant bed and connects to the building at the base.

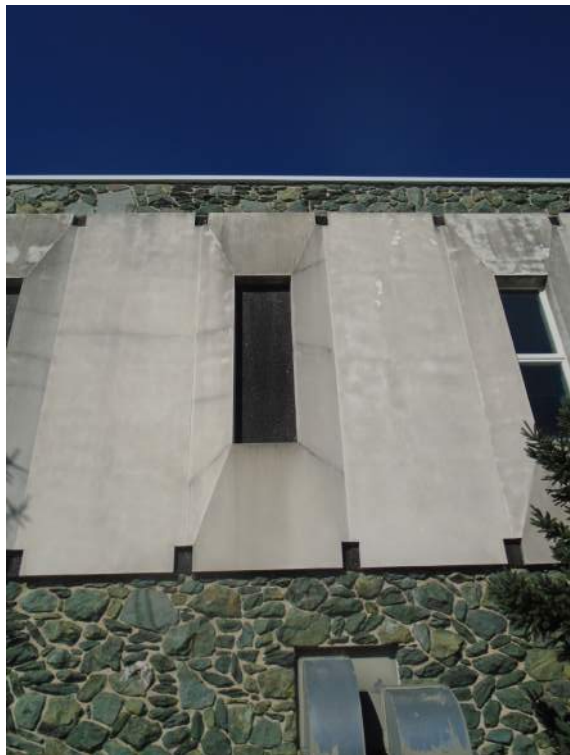
**Photograph 23:** Detail view of the pyramidal concrete panels and coarse-aggregate concrete opening infill at the south elevation of the 1971 addition. Looking north.

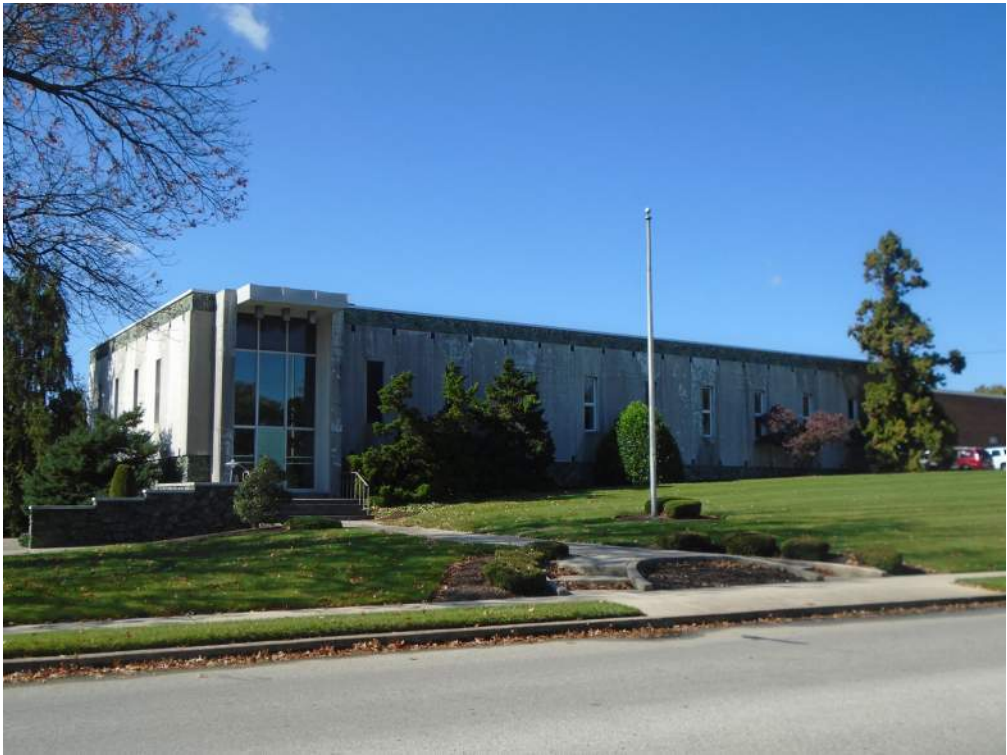
**Photograph 24:** The 1971 corporate office addition, showing the retaining wall at the left, half-circle path from the sidewalk, and east elevation. Looking west.

A stepped retaining wall constructed of the same green fieldstone turns the corner to the east elevation and features a stylized light fixture (*Photographs 24 and 25*). From the street, a paved half-circle path and surrounding landscaping transects the main sidewalk and leads in a straight path to the grand entrance near the southeast corner of the building. The entrance is characterized by a double-height, aluminum-framed, glass wall surmounted by a cantilevered, scalloped overhang (*Photograph 26*). Three rectangular cannister light fixtures attach to the underside of the canopy. The entrance is framed by shallow, concrete-clad walls; and simple granite steps with slender, stylized railings (*Photograph 27*). The door has been replaced with a solid, six-panel door. The east elevation features nine concrete panels with openings, three of which are infilled. Specifically, the first, second, and fifth openings are infilled (south to north).

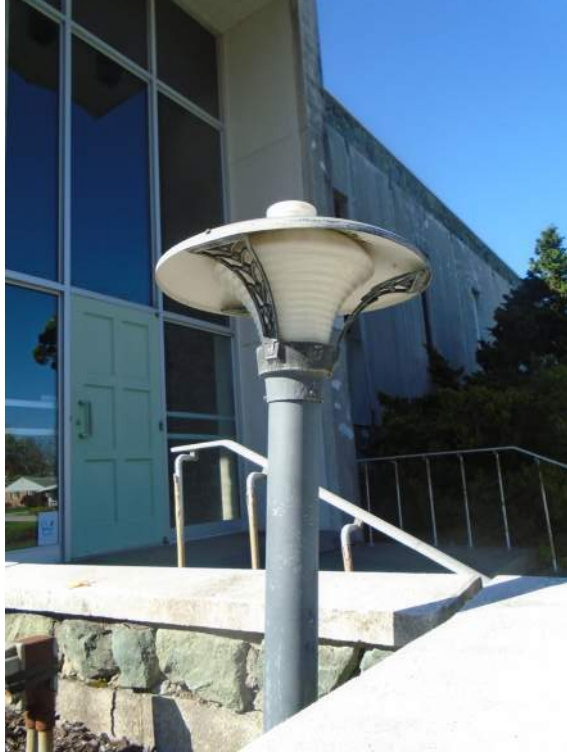
**Photograph 25:** Detail view of the stylized light fixture located at the north corner of the retaining wall, showing the double-height entrance behind. Looking northwest.

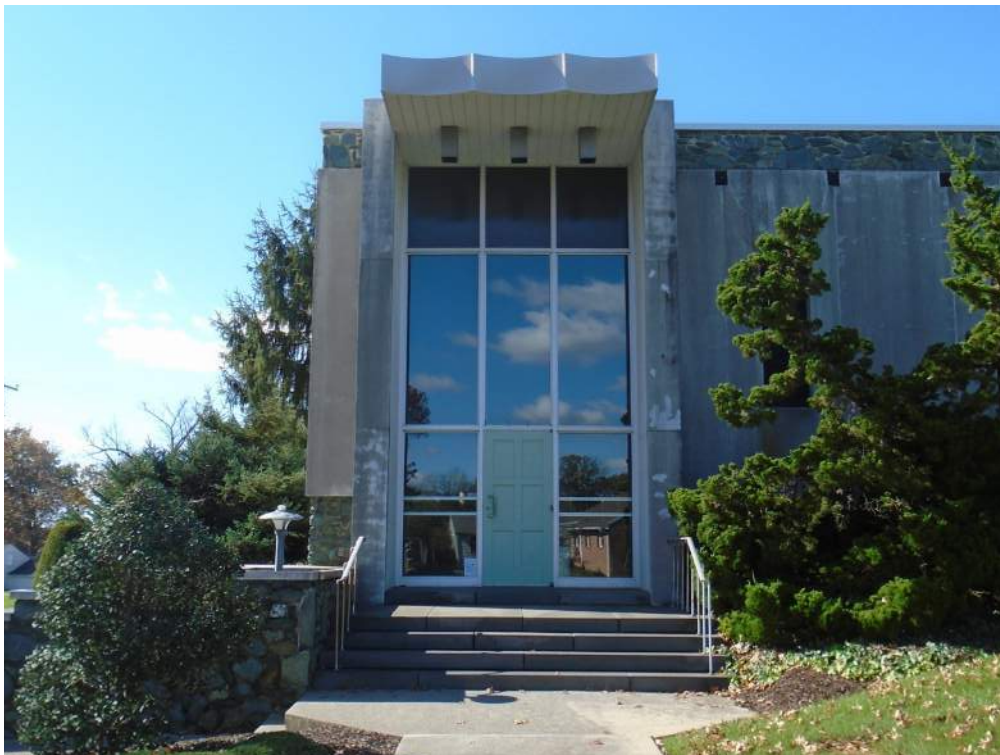
**Photograph 26:** Detail view of the double-height entrance at the east elevation of the 1971 addition. Looking west.

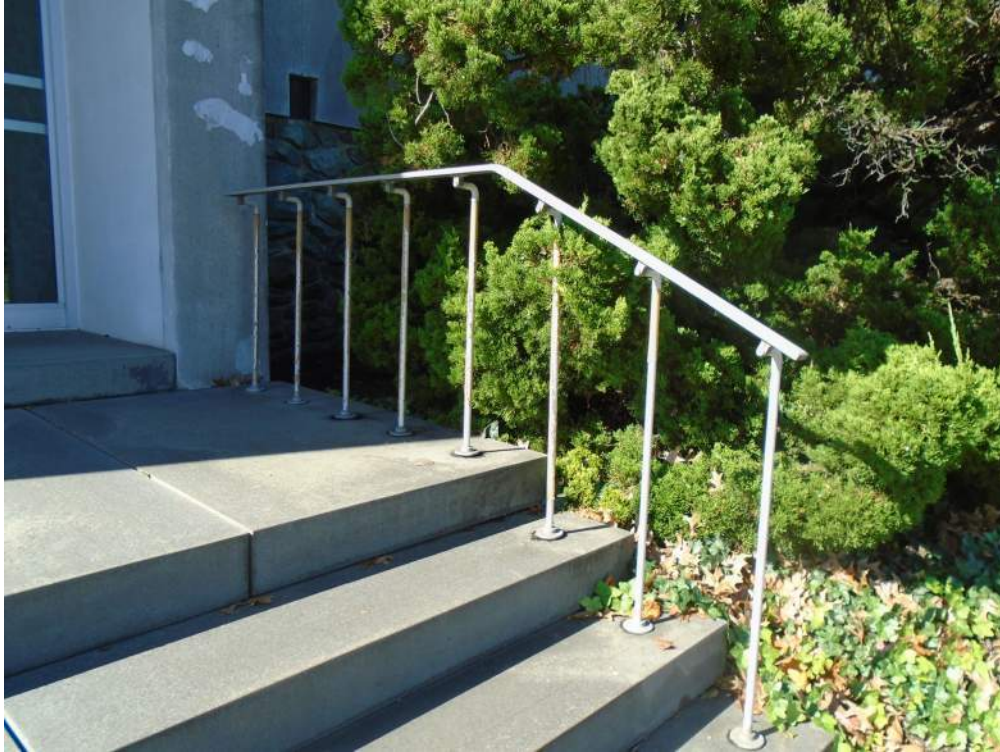
**Photograph 27:** Detail view of the stylized railings and granite steps at the 1971 addition entrance. Looking northwest.

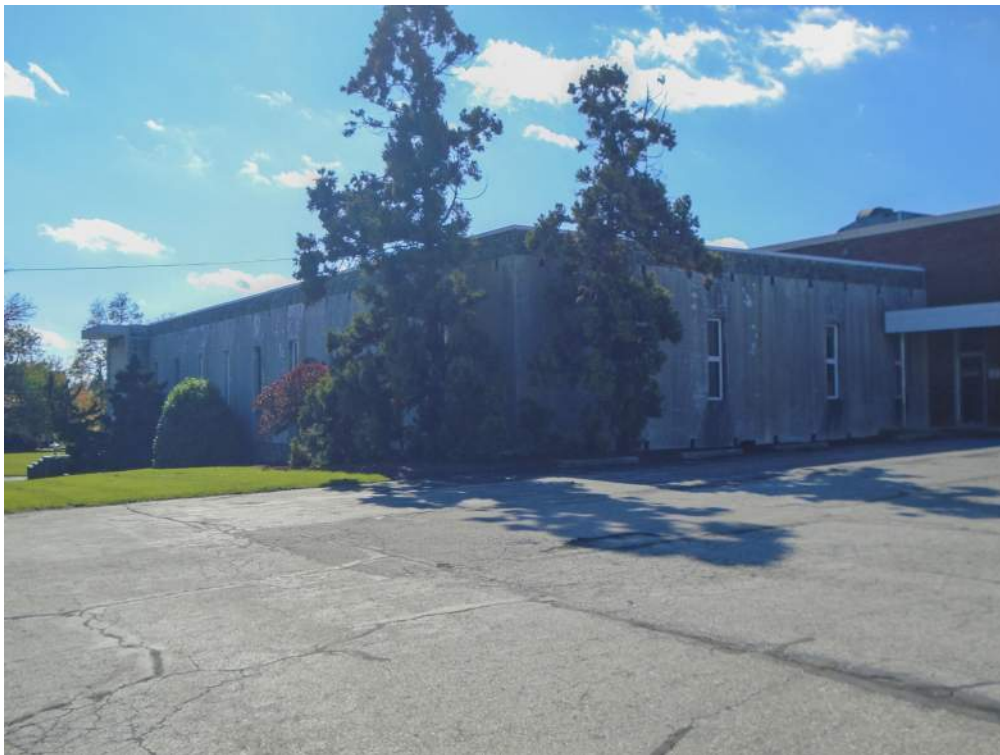
**Photograph 28:** The east and north elevations of the 1971 addition. Looking southwest.

The grade inclines moving northward on the east side; consequently, the north elevation of the 1971 addition has the green fieldstone only at the cornice level above the precast concrete panels (*Photograph 28*). The concrete panels terminate at grade, and the elevation has four panels with windows and no infilled openings.

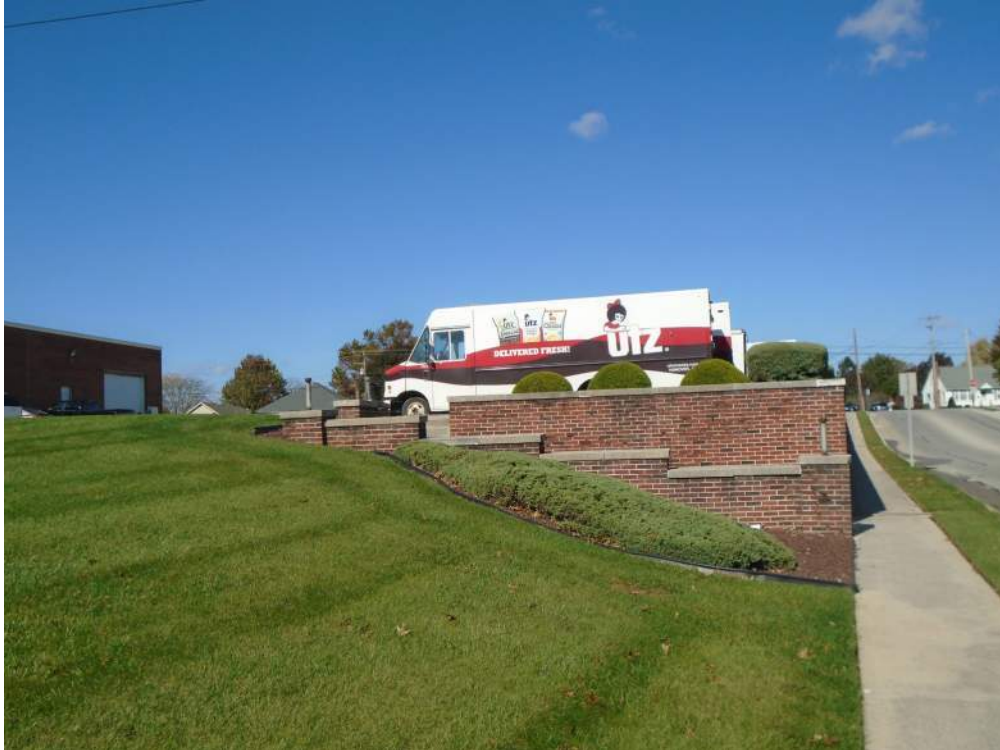
**Photograph 29:** The retaining wall on the east side of the complex north, located northwest of the 1971 addition. Looking north.

Due to the change in grade, another retaining wall, constructed of red brick with concrete coping, and concrete steps connects the sidewalk to the parking lot on the north side of the 1971 addition (*Photograph 29*).

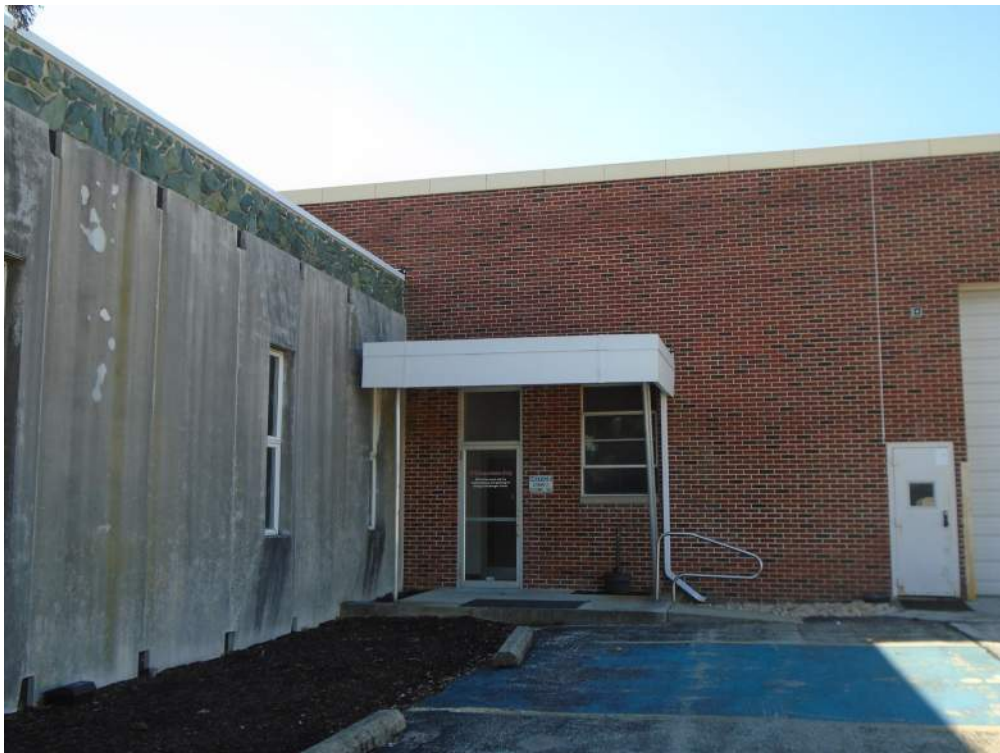
**Photograph 30:** View of the intersection of the 1971 addition (the north elevation at left) and 1968 addition (the east elevation at left), showing the metal canopy at the corner. Looking west.

The east elevation of the 1967 addition has a small, metal overhang sheltering a glass door at the corner of the 1971 and 1967 additions (*Photograph 30*). This elevation features two, large vehicle entrance doors and four one-over-two-over-one metal windows (*Photograph 31*). The lowest sash of the windows is awning style. A solid, metal door is located at the northernmost corner.

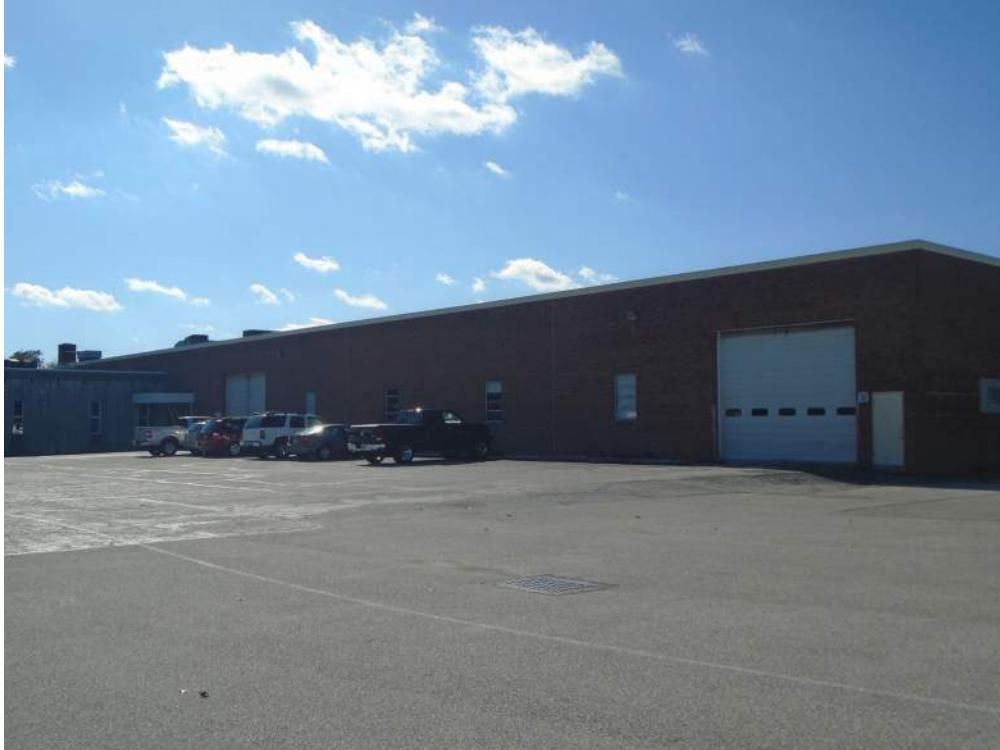
**Photograph 31:** The east elevation of the 1968 addition. Looking southwest.
